DOCUMENT 009113 - ADDENDA

- A. Addendum No. 002.

- A. Project Name: The Barrington Exterior Refinishing
- B. Owner: The Barrington Condominium Association, Inc.
- C. Architect: Purser & Company, PA.
- D. Architect Project Number: 20230809001.
- E. Date of Addendum: 6/18/24.

Between August 12 and September 2, 2020 Dennis Walters, CSI, CDT, CCCA, Principal, Central Building Consultants, LLC visited the building and through Ms. Beth Hartness' introductions to the unit owners, observed the existing interior conditions of the windows and terrace enclosures of each of the four units on floors 3 through 9.

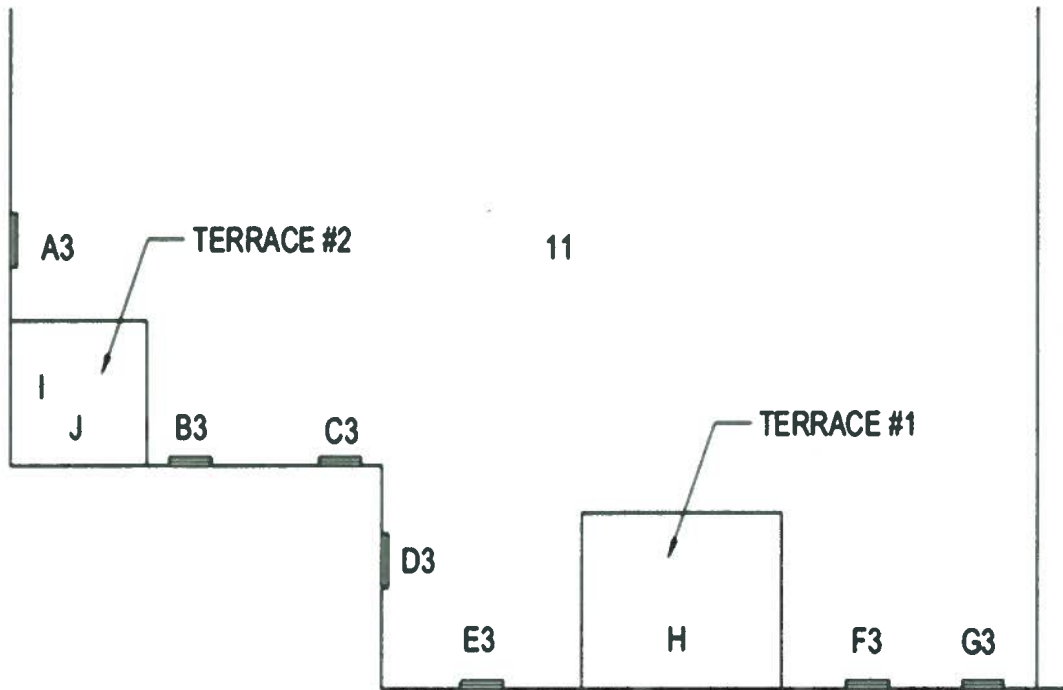
<p>1. Unit A3.</p>

Window units are identified as A3 through G3 plus the Living Room terrace (Terrace 1) and the Master Bedroom terrace (Terrace 2). Common deficiencies include loose seals at the glass, water stains at head, jambs and sills, damaged finishes, loose joints and the windows have been painted shut. In general, the windows of this unit are in poor condition.

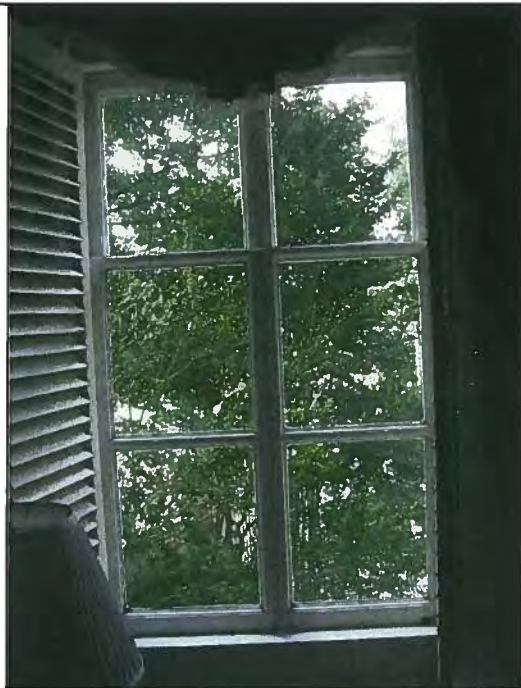
8. Unit B3.

9. Damaged finish and water stain on sill/jamb and frame of Unit B3.

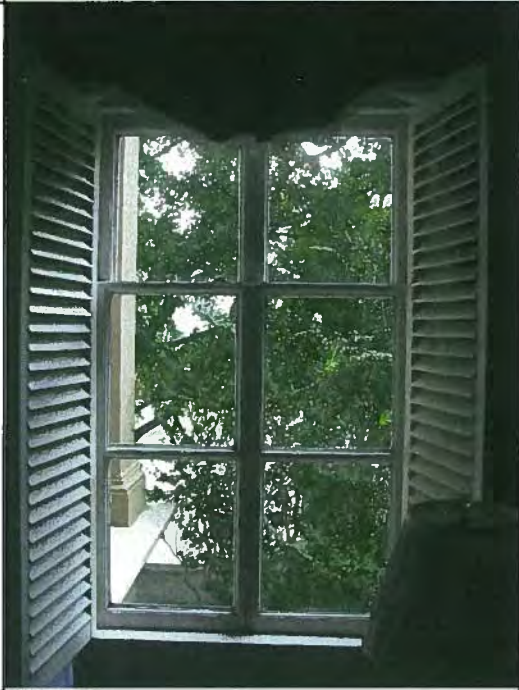
13. Unit C3.

<p>14. Loose seal at glass and water stain on fixed sash on unit C3.</p>

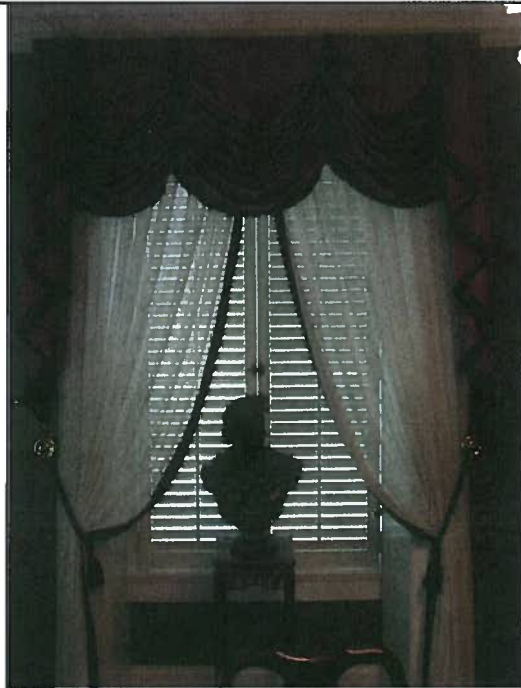
17. Unit D3.

18. Water stain on sill of unit D3.

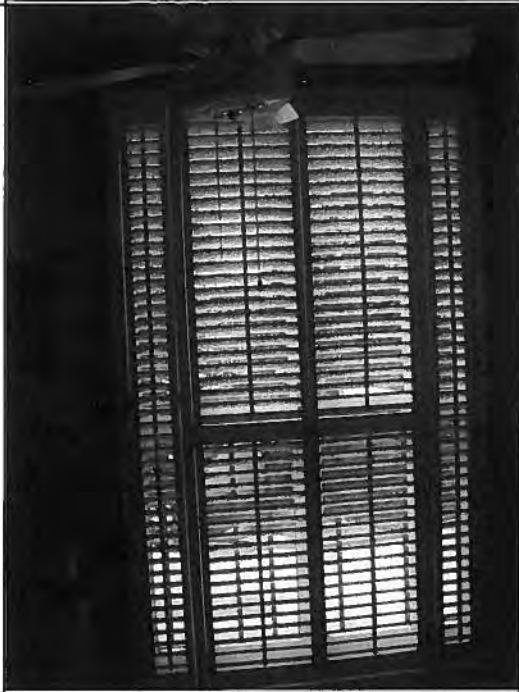
45. Unit J (Terrace 2).

<p>46. Water stain on frame of Unit J (Terrace 2).</p>

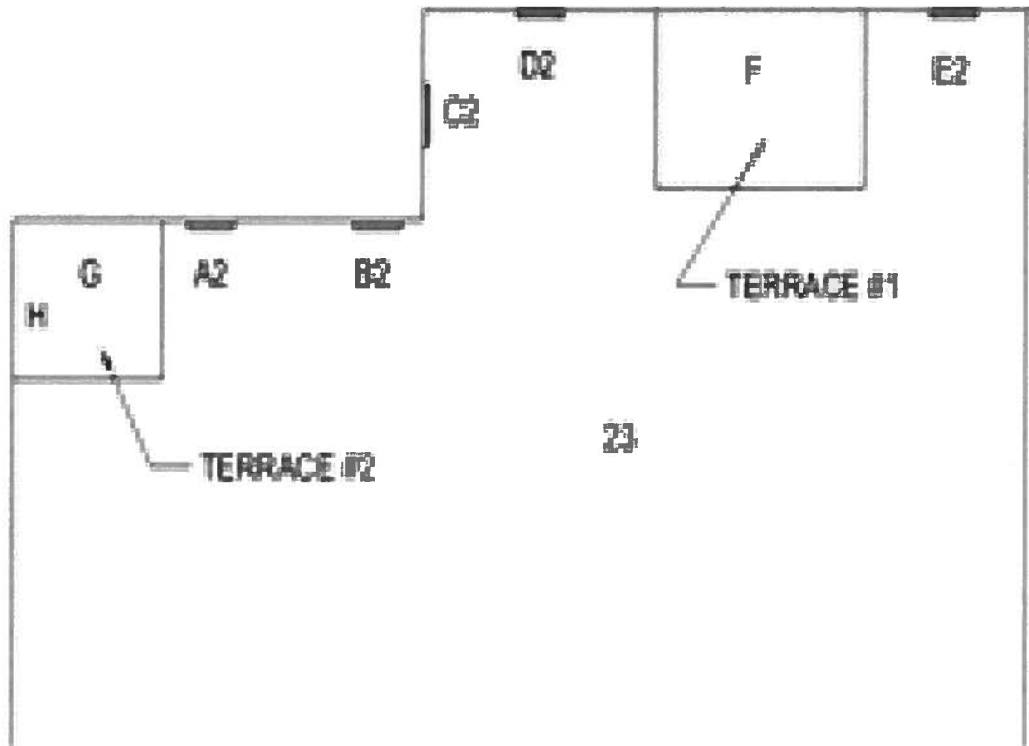
<p>52. Unit A2.</p>

Window units are identified as A2 through E2 plus the Living Room terrace (Terrace 1) and the MBR terrace (Terrace 2). Generally, the windows are in fair condition, however the casement enclosures at Terrace 2 are poor because the design with an open joint that extends from the exterior sill below the casement windows above to the interior of the lower fixed panels below.

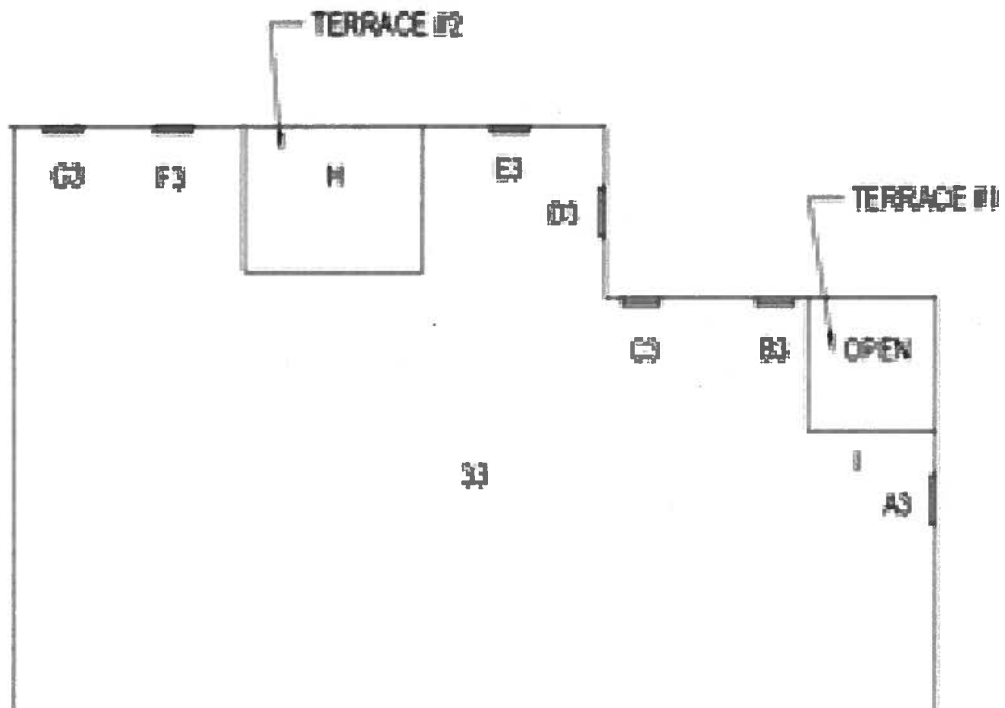
70. Unit A3.

Window units are identified as A3 through G3 plus the Living Room terrace (Terrace 1). The Master Bedroom terrace has not been enclosed. The door from the MBR to the terrace is protected by the terrace cover. Common deficiencies include loose seals at the glass, water stains at head, jambs and sills, damaged finishes, loose joints and the windows have been painted shut. In general, the windows of this unit are in fair to poor condition.

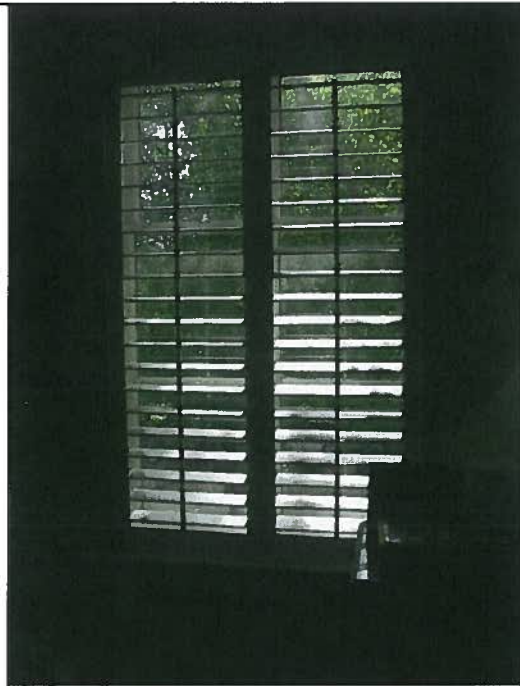
71. Damaged finish and water stain on
frame of Unit A3.

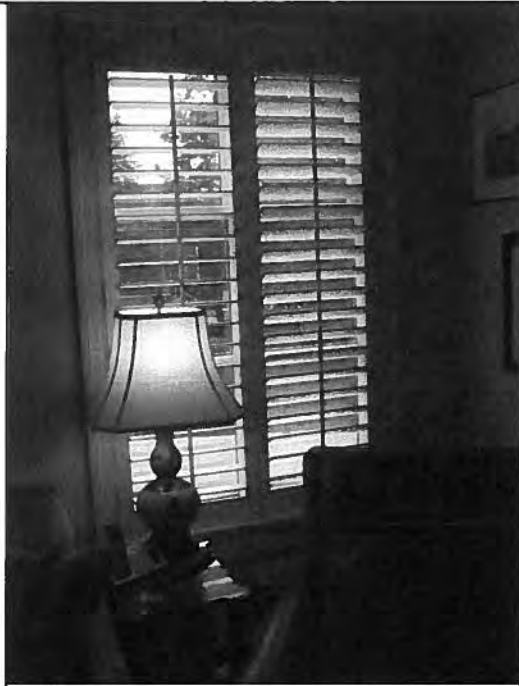
72. Unit B3.

73. Water stain on frame of Unit B3.

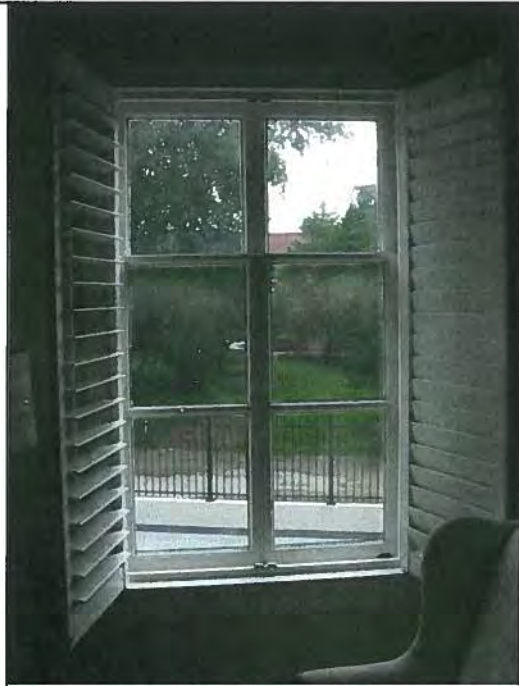
81. Unit F3.

82. Water stain on frame of Unit F3.

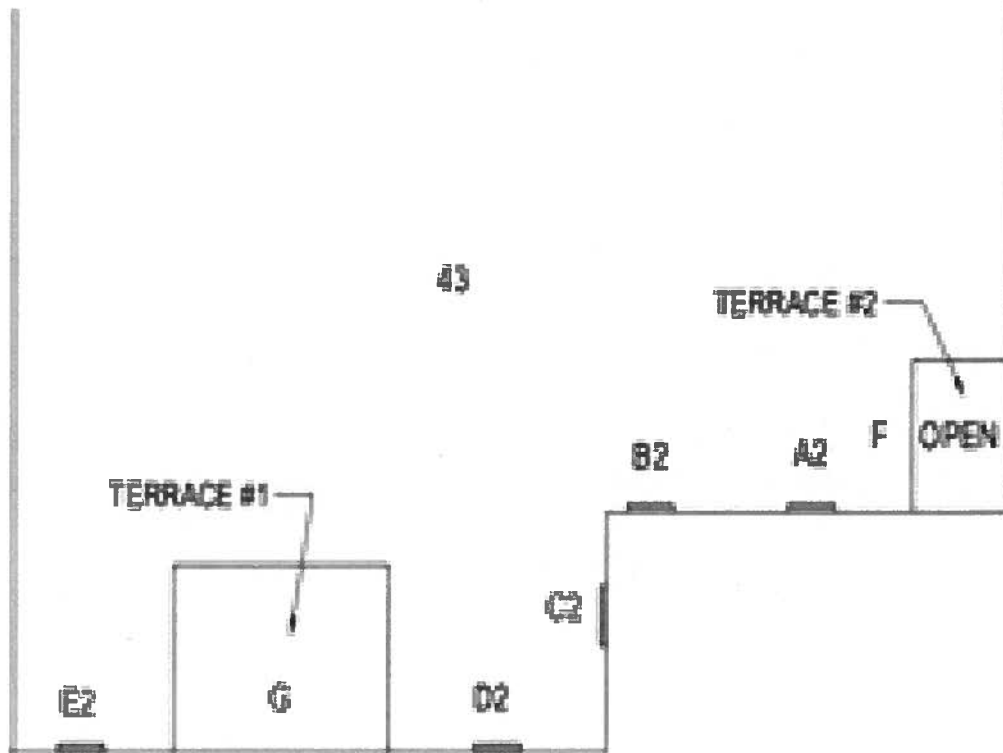
Window units are identified as A2 through E2 plus the Living Room terrace (Terrace 1). The Master Bedroom terrace (Terrace 2) has not been enclosed. Common deficiencies include loose seals at the glass, water stains at head, jambs and sills, damaged finishes, loose joints and the windows have been painted shut. Generally, the windows are in poor condition.

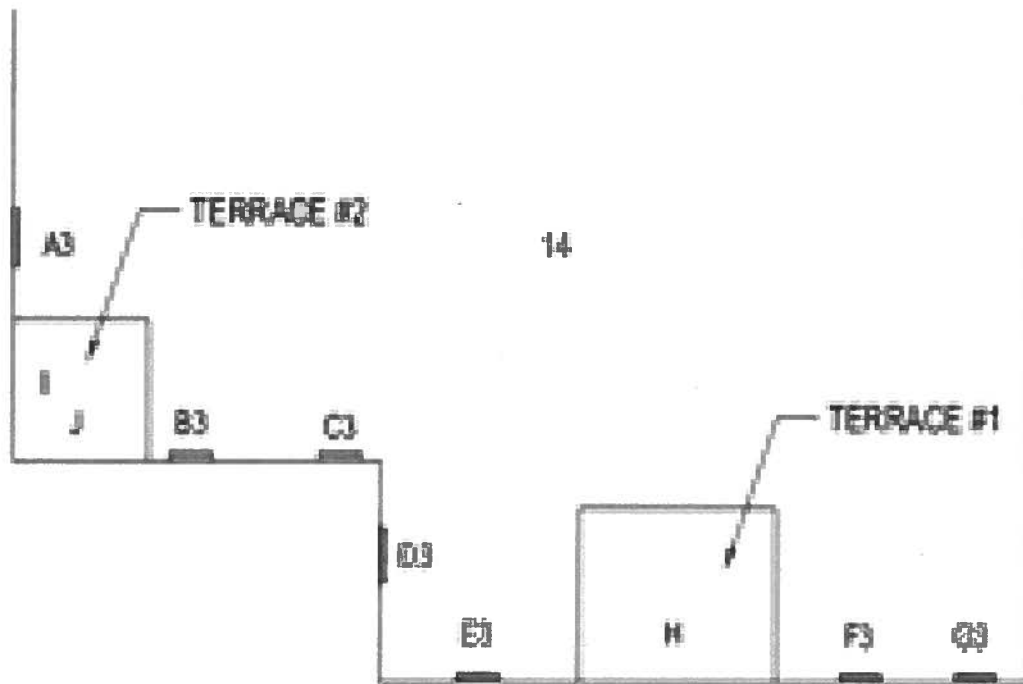
<p>1. Unit A3.</p>

Window units are identified as A3 through G3 plus the Living Room terrace (Terrace 1) and the Master Bedroom terrace (Terrace 2). The enclosures on the MBR terrace are both fully fixed glass. Common deficiencies include loose seals at the glass, water stains at head, jambs and sills, damaged finishes, loose joints and the windows have been painted shut. In general, the windows of this unit are in fair condition.

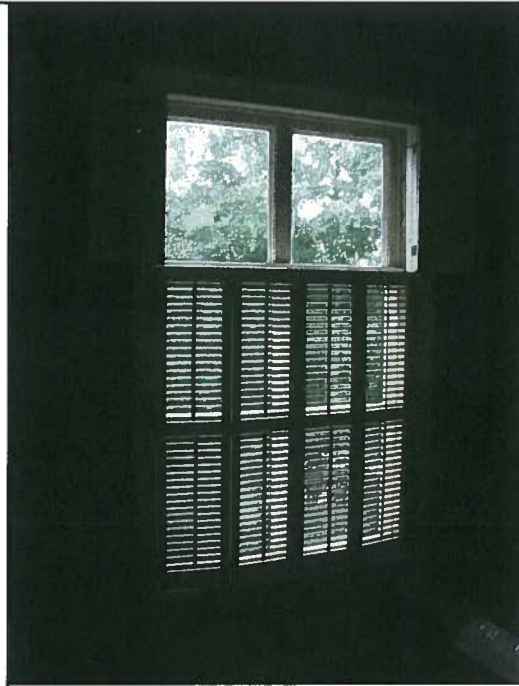
4. Unit B3.

5. Loose joint on Unit B3.

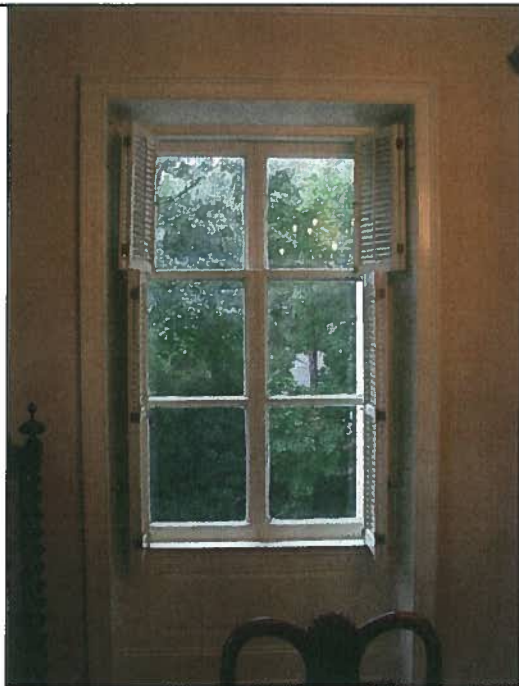
12. Unit E3.

13. Rust on exterior jamb on Unit E3.

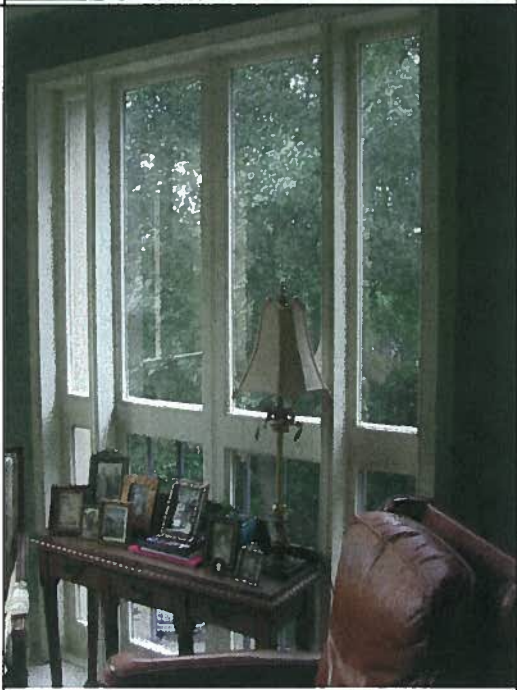
21. Unit I (Terrace 2).

22. Damaged finish on Unit I.

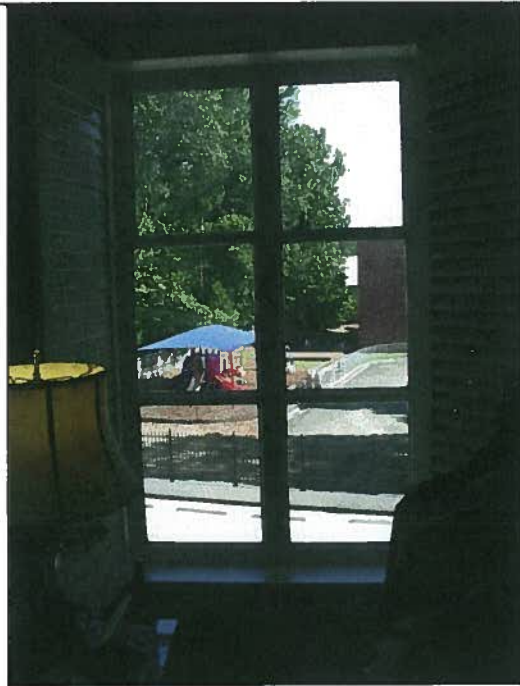
30. Unit B2.

31. Water stain on frame of Unit B2.

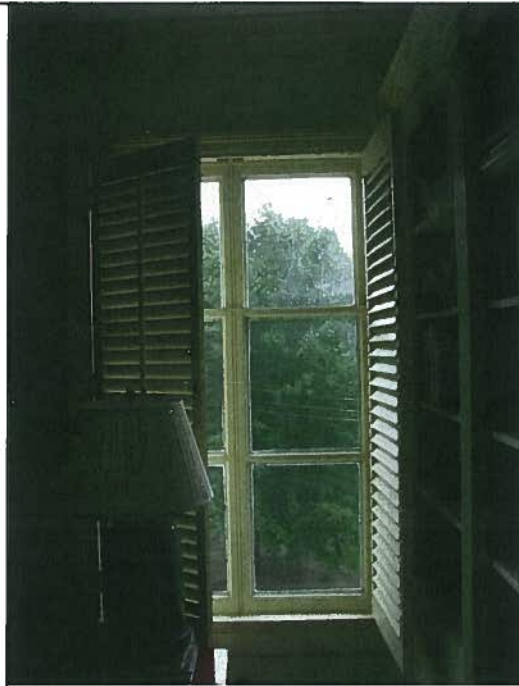
49. Unit B3.

50. Water stain with mildew on frame and jamb of Unit B3.

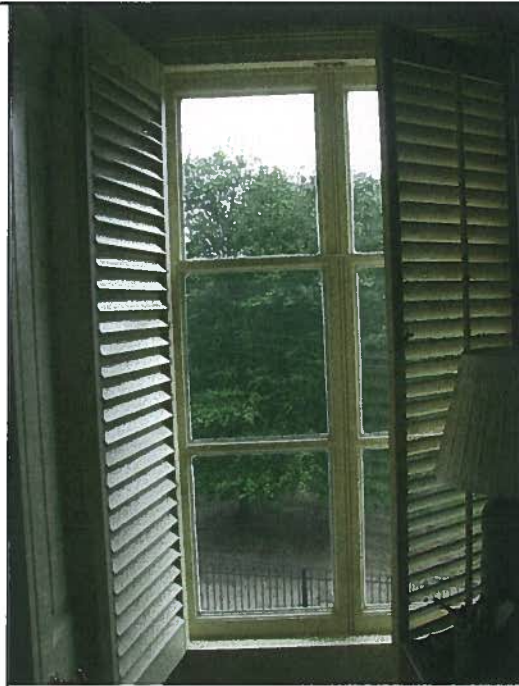
52. Unit C3.

53. Damaged slide of Unit C3.

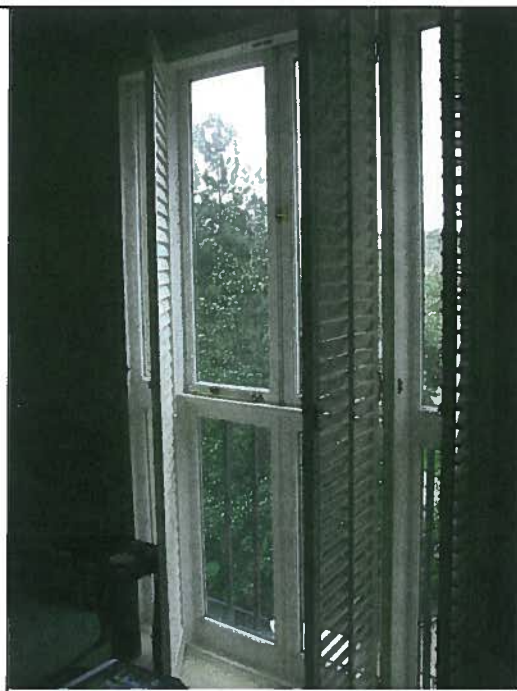
<p>80. Unit I.</p>

<p>81. Loose joint in Unit I.</p>

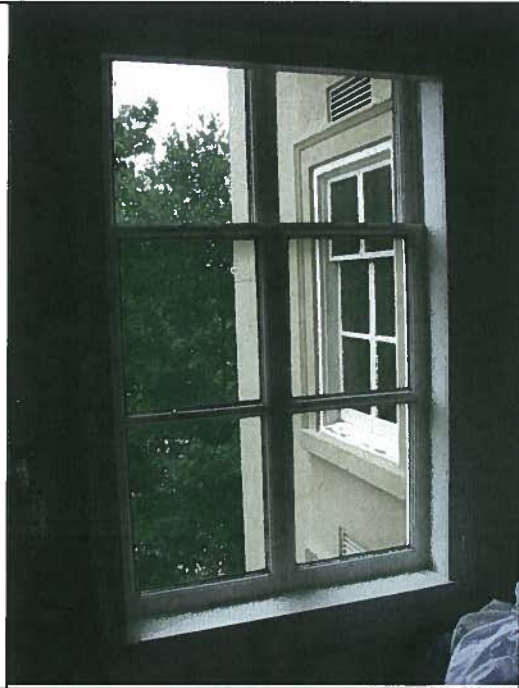
94. Unit B2.

95. Water stain on frame at head of
Unit B2.

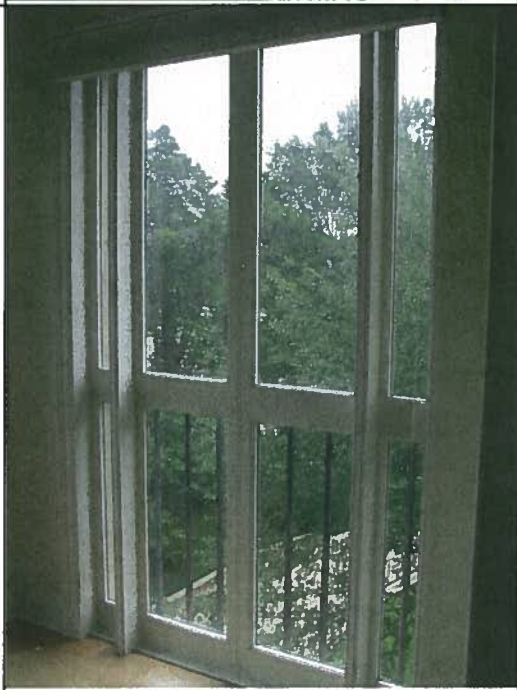
107. Unit F.

<p>108. Water stain on sill of Unit F.</p>

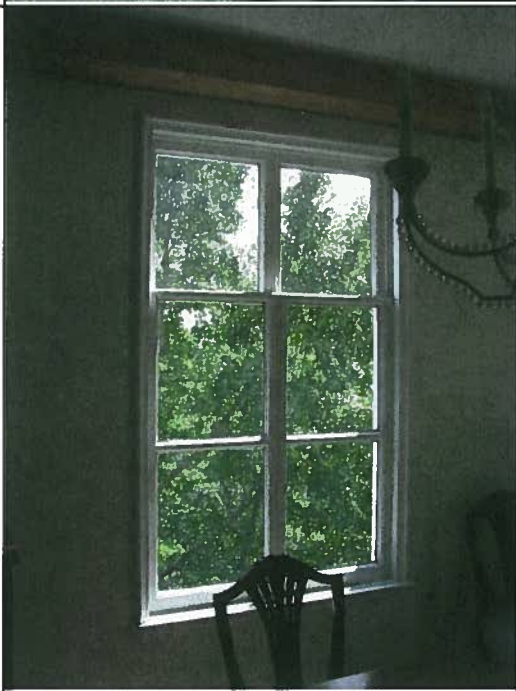
<p>11. Unit E3.</p>

12. Loose seal at glass of Unit E3.

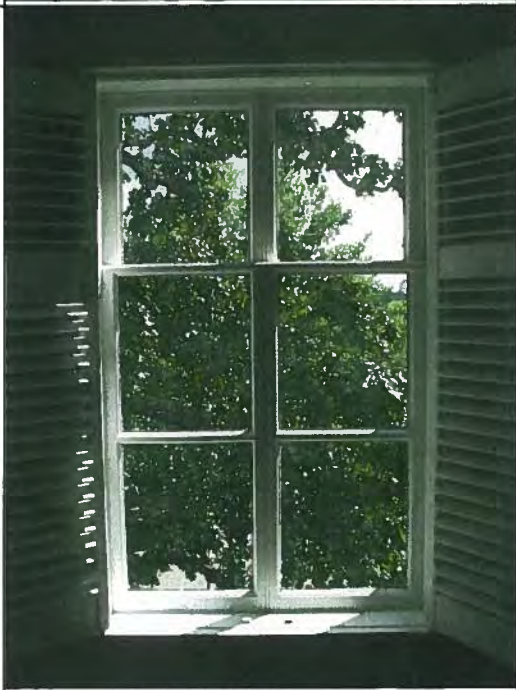
14. Unit F3.

15. Loose seal at glass of Unit F3.

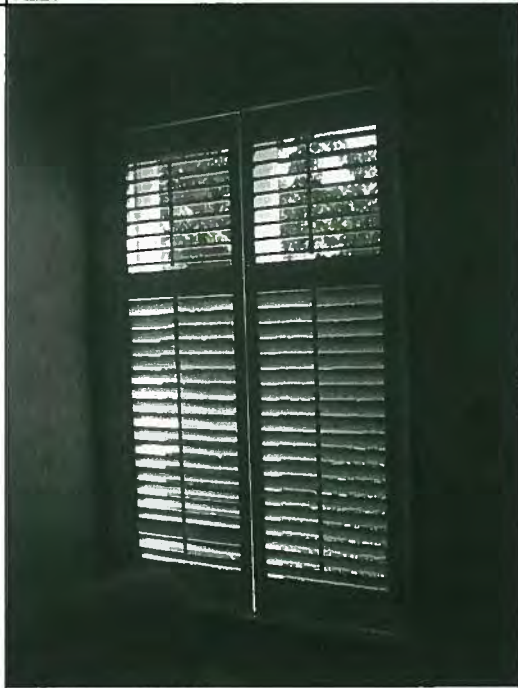
17. Unit G3.

<p>18. Loose seal at glass of Unit G3.</p>

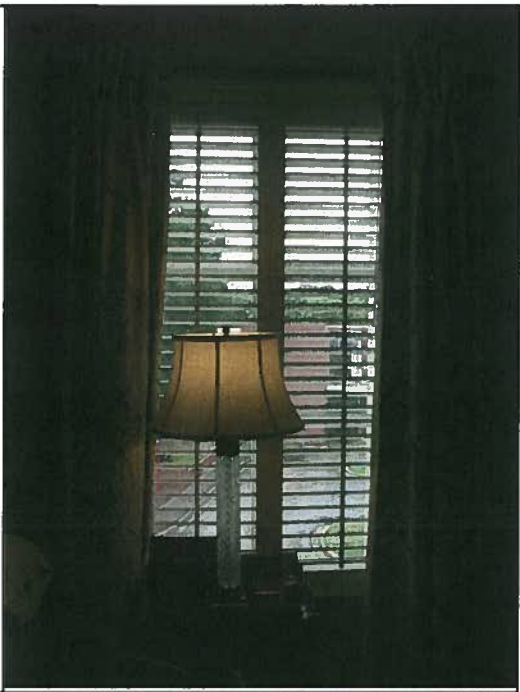
<p>35. Unit B2.</p>

A photograph showing a window with white horizontal shutters. A lamp with a beige shade is positioned in front of the window. The room is dimly lit, with light coming from the window.
<p>36. Water stain on sill of Unit B2.</p>

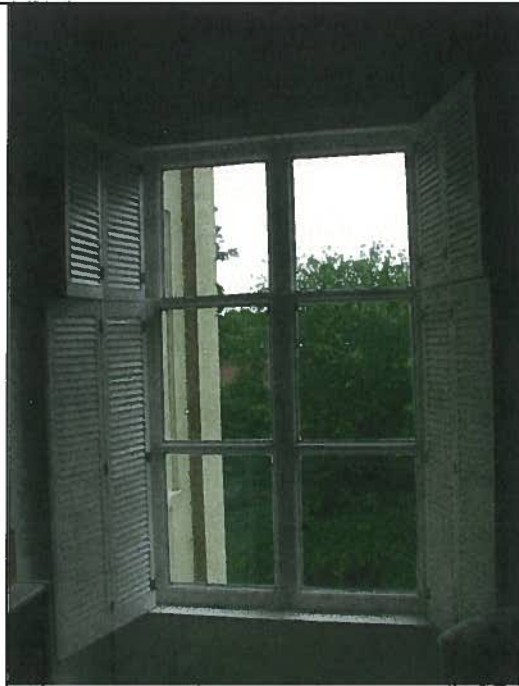
74. Unit C3.

75. Water stain on frame of Unit C3.

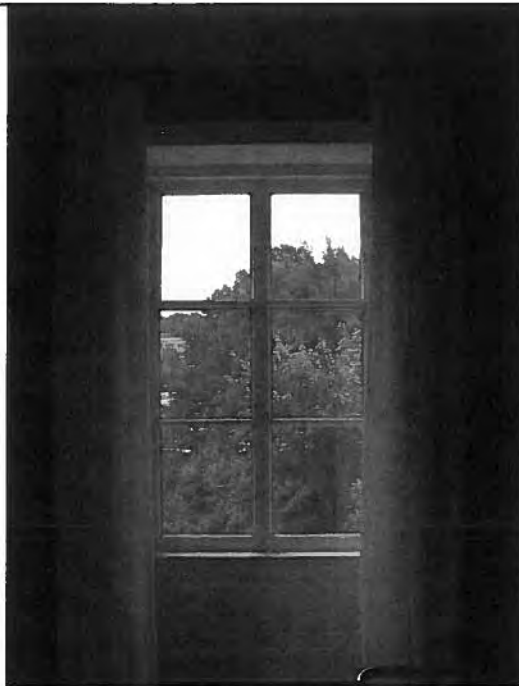
76. Unit D3.

77. Water stain on frame of Unit D3.

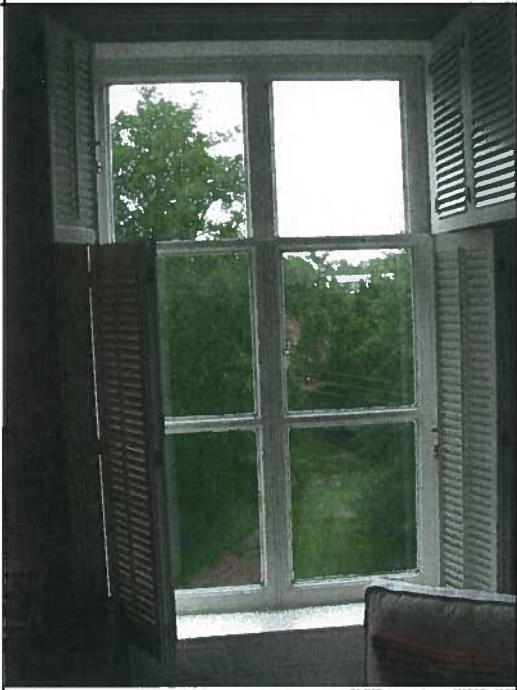
83. Unit F3.

<p>84. Water stain on sill of Unit F3.</p>

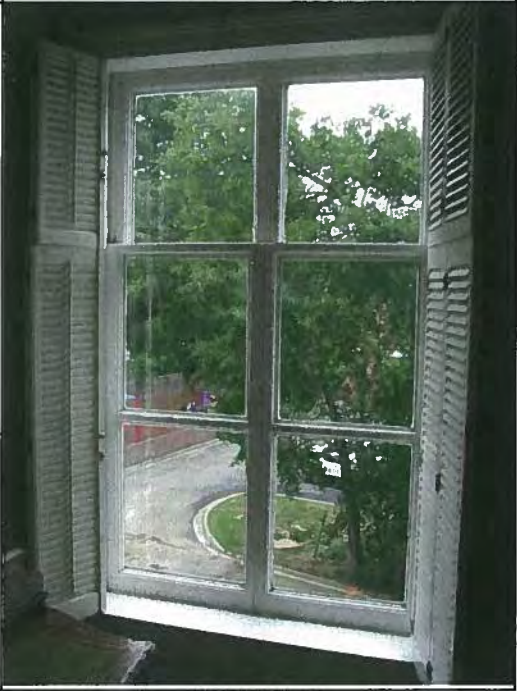
<p>86. Unit G3.</p>

<p>87. Water stain on sill of Unit G3.</p>

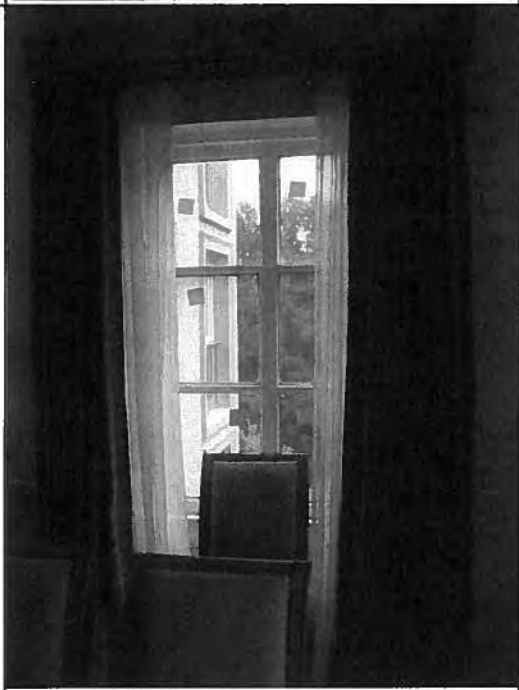
104. Unit C2.

<p>105. Damaged finish on frame of Unit C2.</p>

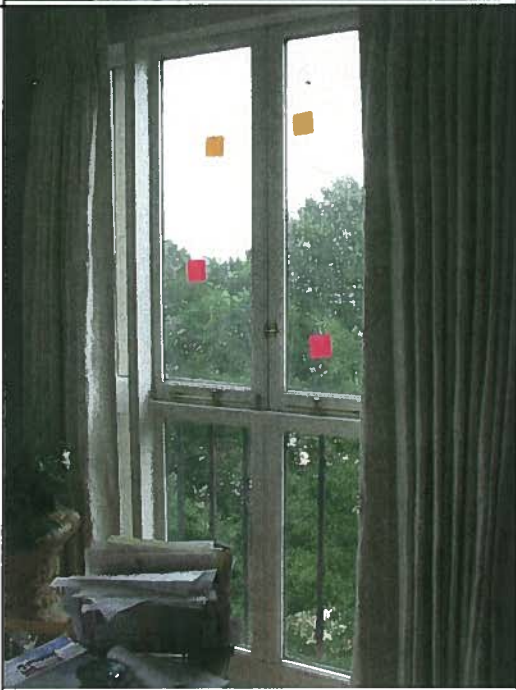
121. Unit F.

<p>122. Water stain on sill at loose joint on Unit F.</p>

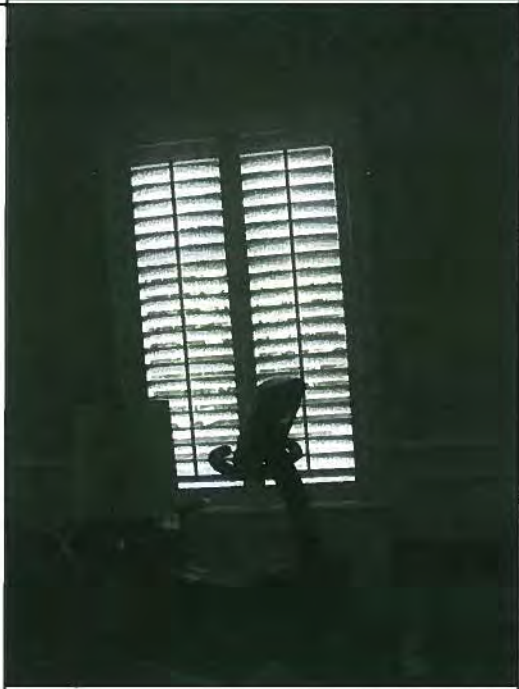
39. Unit D2.

<p>40. Stain by other than water on frame on Unit D2.</p>

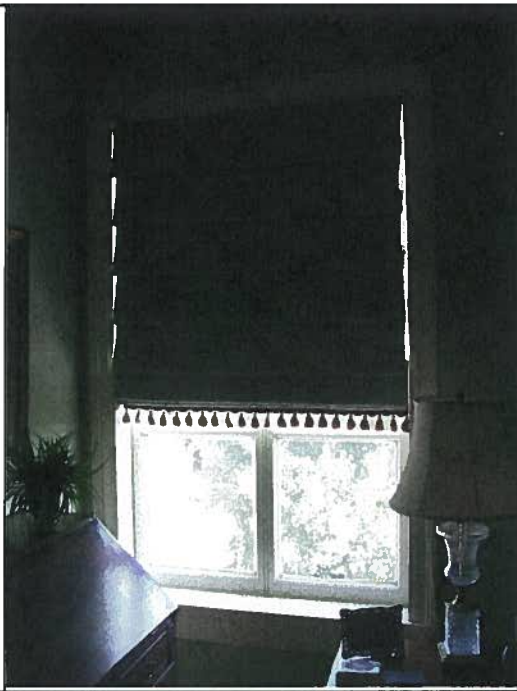
<p>62. Unit G3.</p>

<p>63. Damaged finish on sill and jamb on Unit G3.</p>

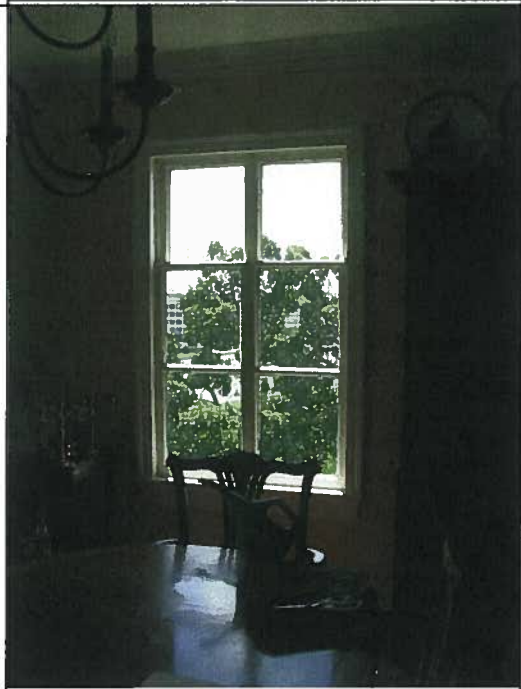
84. Unit D2.

<p>85. Rust on concealed mull at latch on Unit D2.</p>

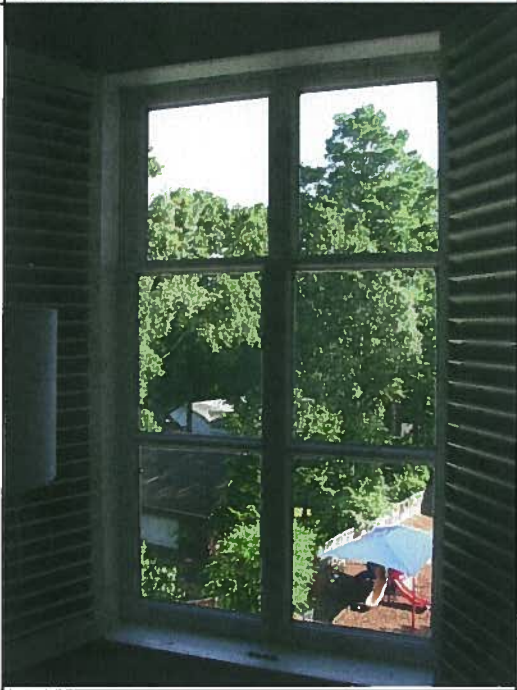
<p>38. Unit B2.</p>

<p>39. Damaged finish and water stain on frame of Unit B2.</p>

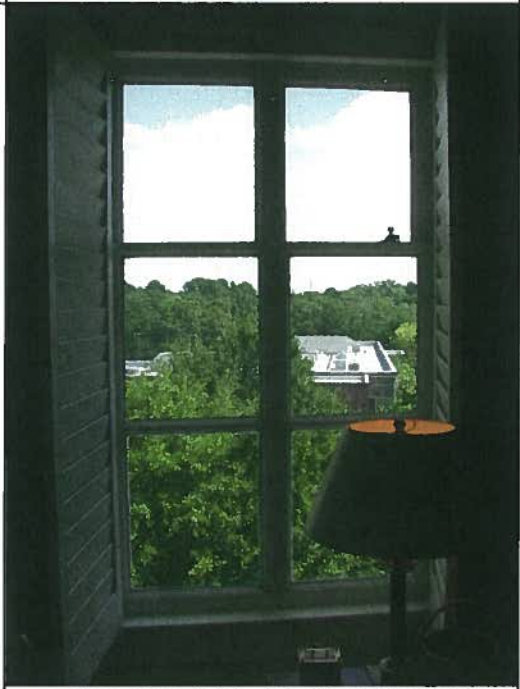
<p>70. Unit C3.</p>

71. Water stain on sill and jamb at loose joint of Unit C3.

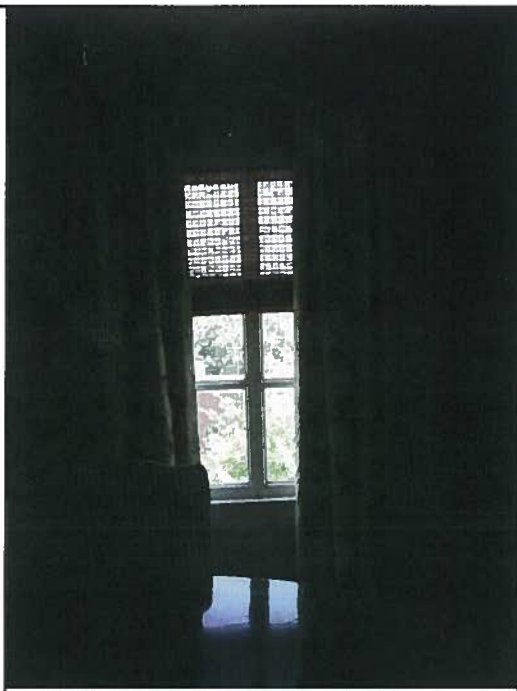
<p>76. Unit E3.</p>

A photograph showing the interior of a room with a window. The window has a dark frame and is partially covered by dark curtains. The room is dimly lit, with light coming from the window.
<p>77. Water stain on frame at loose joint of Unit E3.</p>

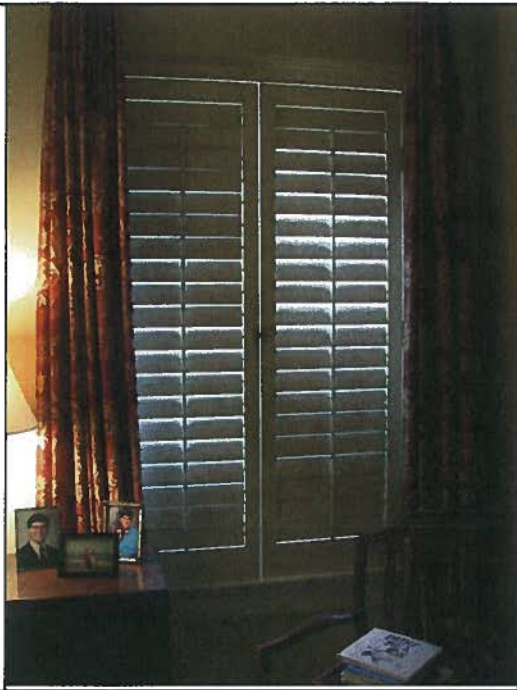
<p>79. Unit F3.</p>

A photograph showing a window with white shutters and dark curtains. A desk with a laptop and framed photos is visible in the foreground.
<p>80. Water stain on sill of Unit F3.</p>

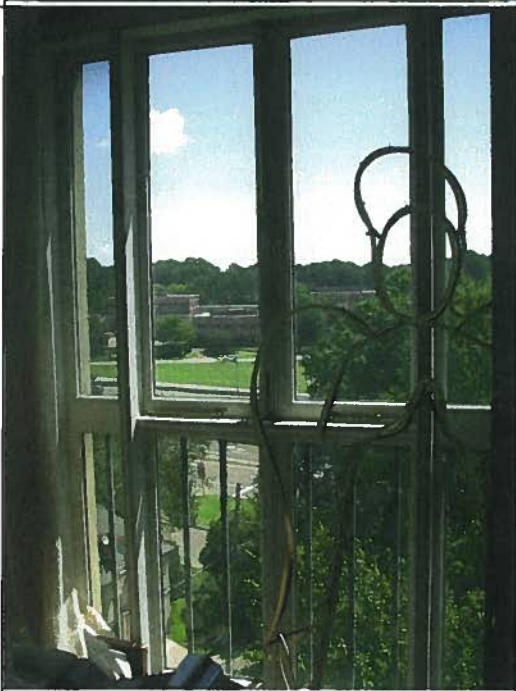
<p>90. Unit I.</p>

<p>91. Water stained draperies over Unit I.</p>

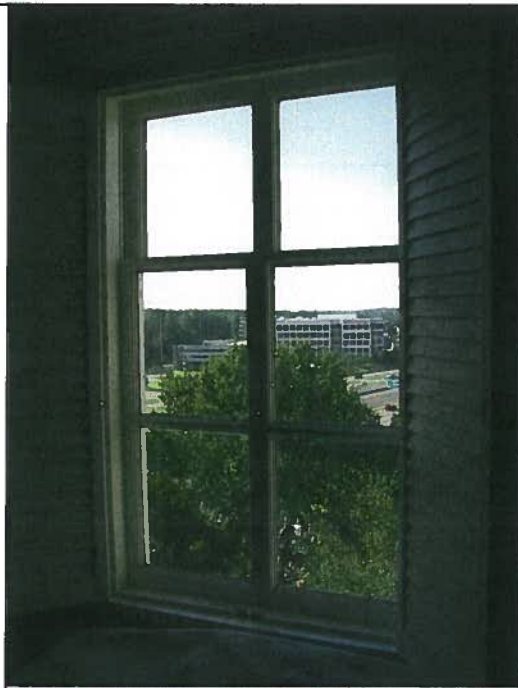
103. Water stain and damaged finish on
frame and sill of Unit A2.

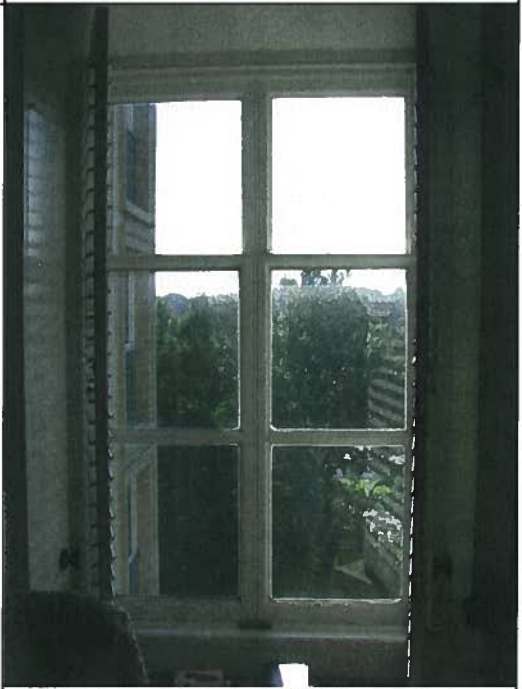
<p>110. Unit C2.</p>

<p>111. Loose seal at glass of Unit C2.</p>

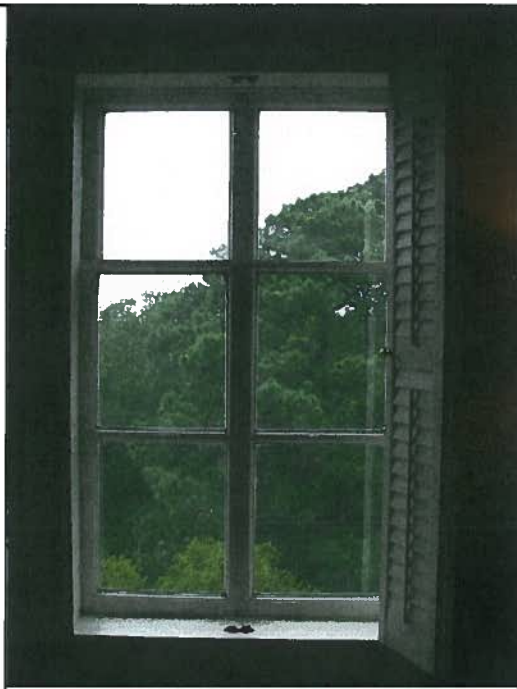
<p>2. Damaged finish and loose joint in frame of Unit A3.</p>

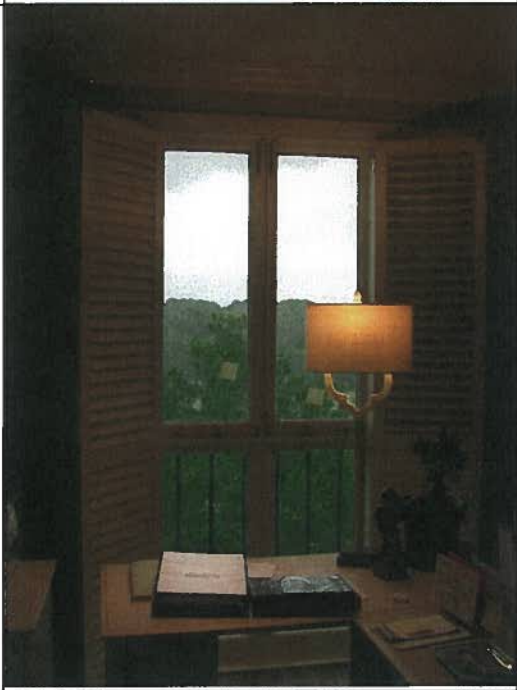
123. Unit H.

<p>124. Water stain on frame of Unit H.</p>

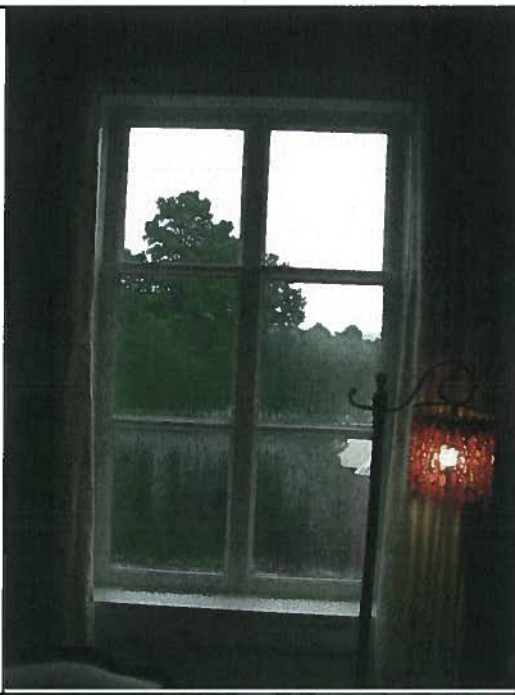
<p>34. Broken glass in Unit A2.</p>

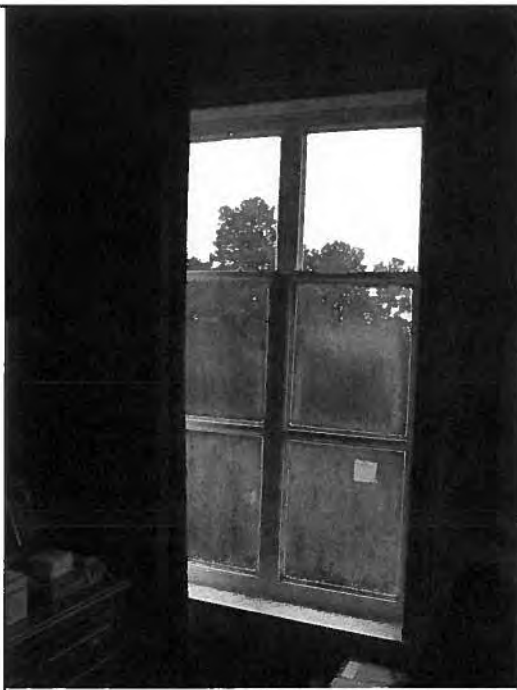
<p>48. Unit E2.</p>

A black and white photograph showing the interior of a room looking out through a window. The window is a double-hung style with four panes. Outside, trees and a bright sky are visible. The room is dark, and the window frame is dark.
<p>49. Water stain on sill of Unit E2.</p>

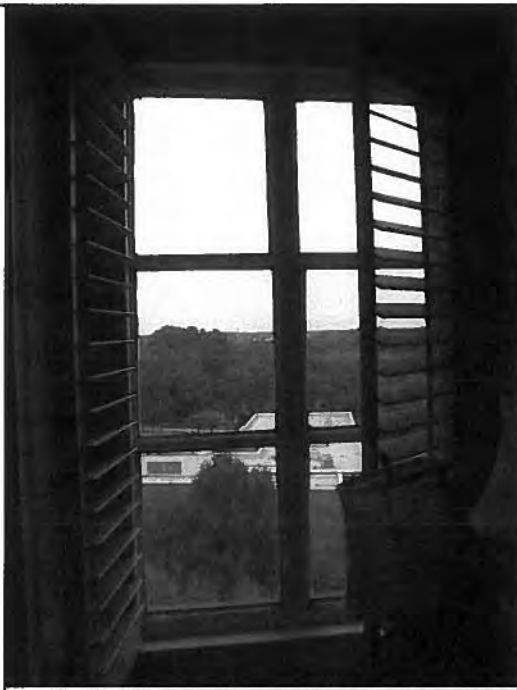
<p>60. Unit C3.</p>

<p>61. Water stain on sill of Unit C3.</p>

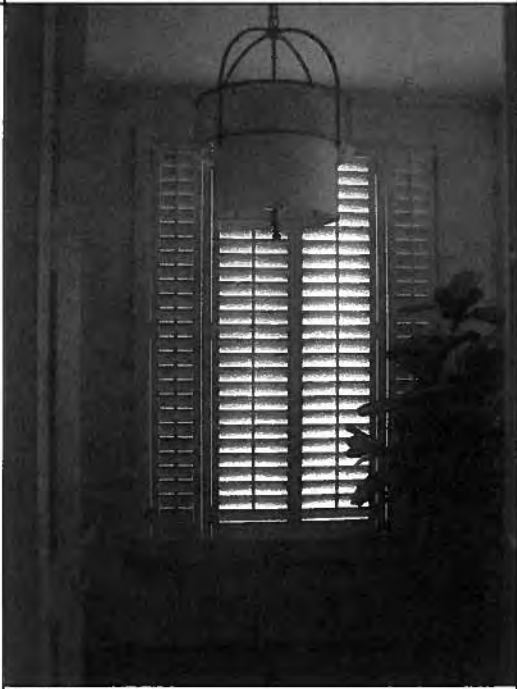
<p>124. Water stain at head of Unit I.</p>
