DOCUMENT 009113 - ADDENDA

- A. Addendum No. 002.

- A. Project Name: The Barrington Exterior Refinishing
- B. Owner: The Barrington Condominium Association, Inc.
- C. Architect: Purser & Company, PA.
- D. Architect Project Number: 20230809001.
- E. Date of Addendum: 6/18/24.

Between August 12 and September 2, 2020 Dennis Walters, CSI, CDT, CCCA, Principal, Central Building Consultants, LLC visited the building and through Ms. Beth Hartness' introductions to the unit owners, observed the existing interior conditions of the windows and terrace enclosures of each of the four units on floors 3 through 9.

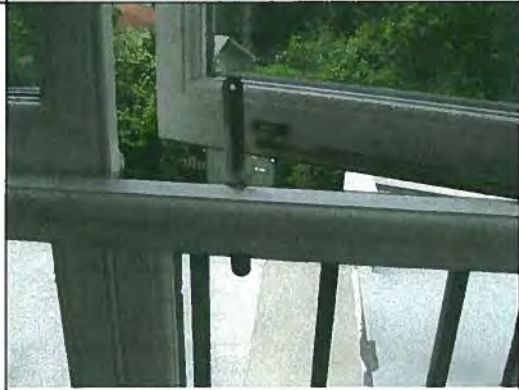
Window units are identified as A2 through E2 plus the Living Room terrace (Terrace 1) and the MBR terrace (Terrace 2). Generally, the windows are in fair condition, however the casement enclosures at Terrace 2 are poor because the design with an open joint that extends from the exterior sill below the casement windows above to the interior of the lower fixed panels below.

68. Open joint by poor design of Unit H.

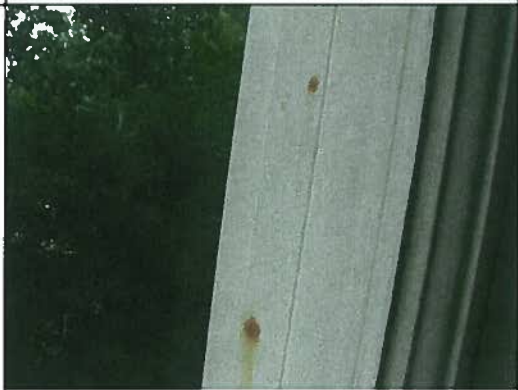
117. Rust on exterior jamb of Unit E2.

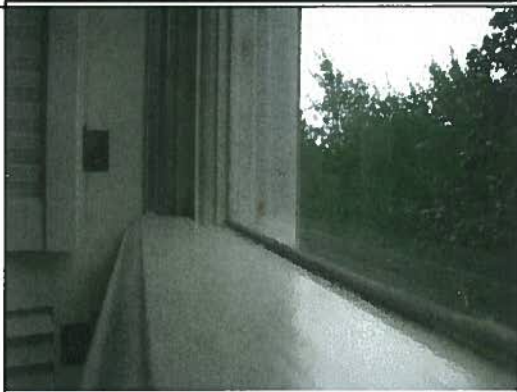
17. Rust at exterior jamb of Unit G3.

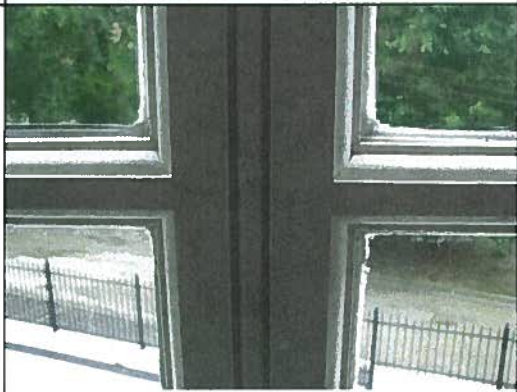
63. Water stain on frame of Unit E3.

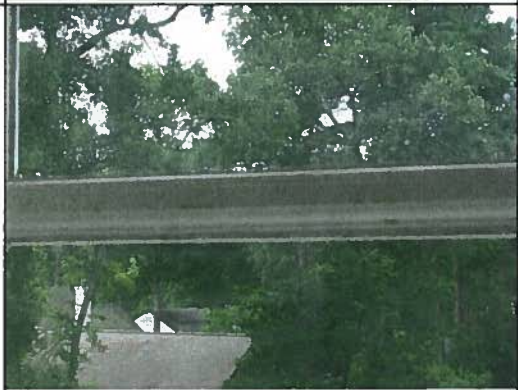
34. Water stain on frame of Unit A2.

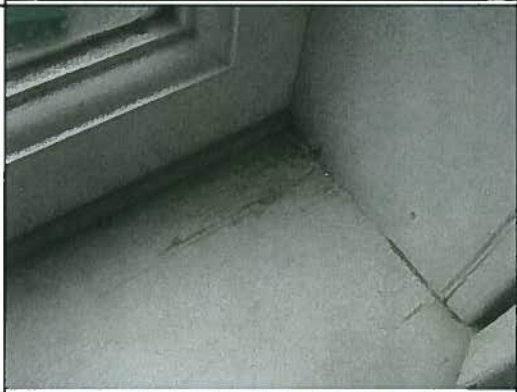
48. Damaged finish of sill of Unit E2.

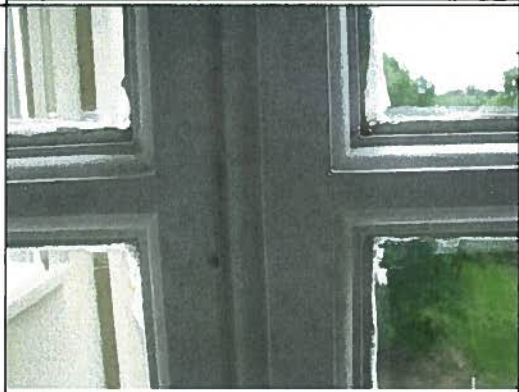
75. Water stain on frame of Unit C3.

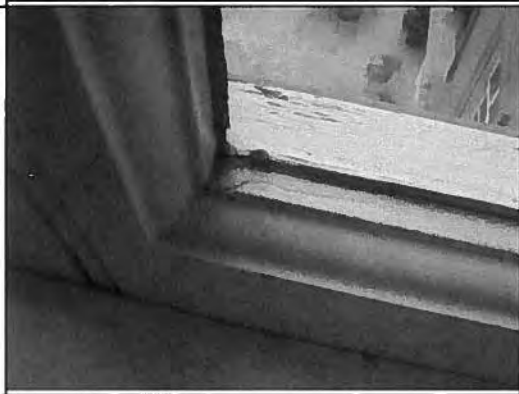
77. Water stain on frame of Unit D3.

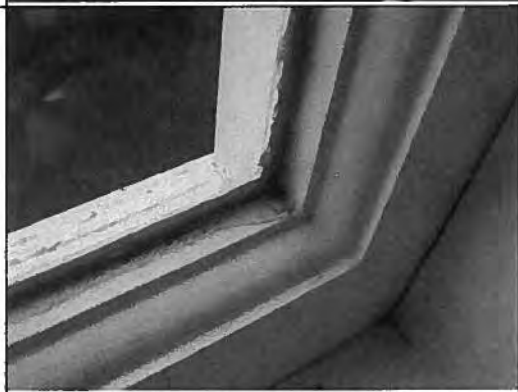
118. Water stain on frame and jamb with mildew on Unit E2.

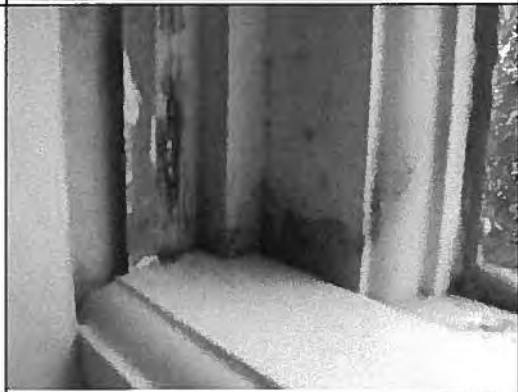
119. Mildew stain on frame of Unit E2.

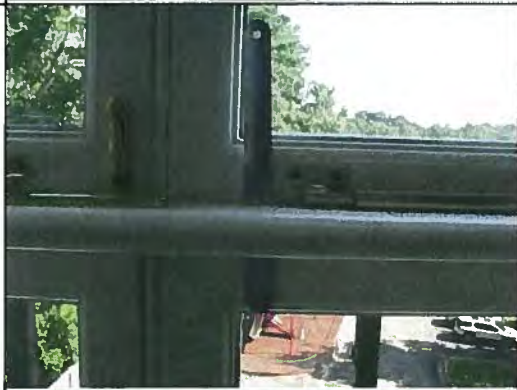
53. Open joint from below casement leaf to interior of lower fixed panel on Unit G.

Window units are identified as A3 through G3 plus the Living Room terrace (Terrace 1) and the Master Bedroom terrace (Terrace 2). The casement enclosures at MBR terrace are poor because of the design with an open joint that extends from the exterior sill below the casement windows above to the interior of the lower fixed panels below. Common deficiencies include loose seals at the glass, water stains at frames, jambs and sills, loose joints and damaged finishes. In general, the windows of this unit are in poor to fair condition.

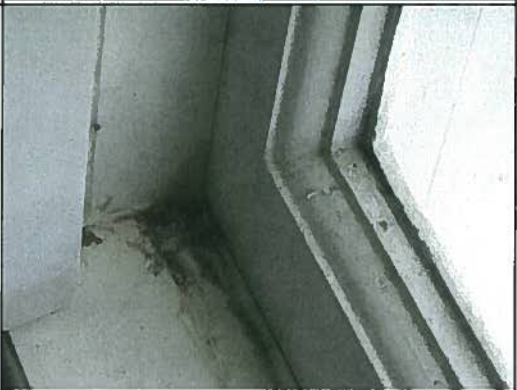
67. Water stain on sill, jamb and frame of Unit B3.

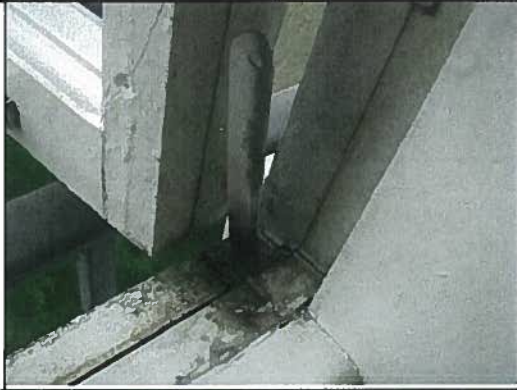
121. Decayed wood in frame of Unit G.

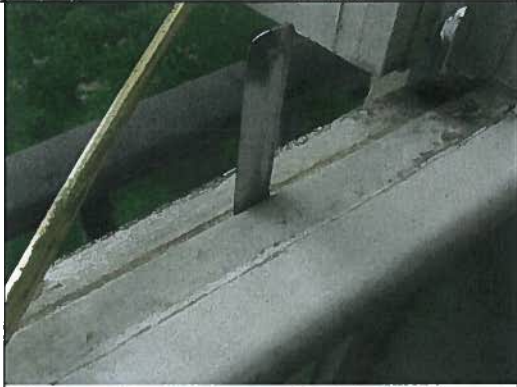
122. Open joint from below the casement leaf to the interior of the lower frame of Unit G.
