DOCUMENT 009113 - ADDENDA

- A. Addendum No. 002.

- A. Project Name: The Barrington Exterior Refinishing
- B. Owner: The Barrington Condominium Association, Inc.
- C. Architect: Purser & Company, PA.
- D. Architect Project Number: 20230809001.
- E. Date of Addendum: 6/18/24.

Between August 12 and September 2, 2020 Dennis Walters, CSI, CDT, CCCA, Principal, Central Building Consultants, LLC visited the building and through Ms. Beth Hartness' introductions to the unit owners, observed the existing interior conditions of the windows and terrace enclosures of each of the four units on floors 3 through 9.

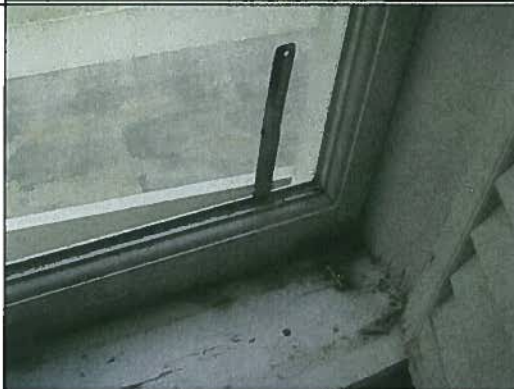
<p>3. Damaged finish at sill on unit A3.</p>

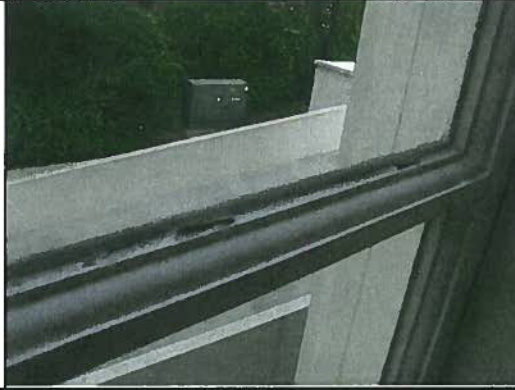
<p>5. Stain at head of Unit A3.</p>

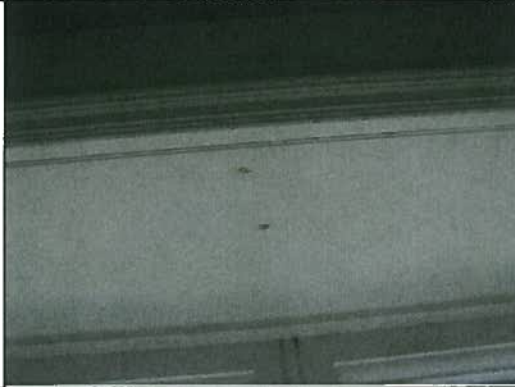
<p>6. Damaged finish and stain on head/jamb of Unit A3.</p>

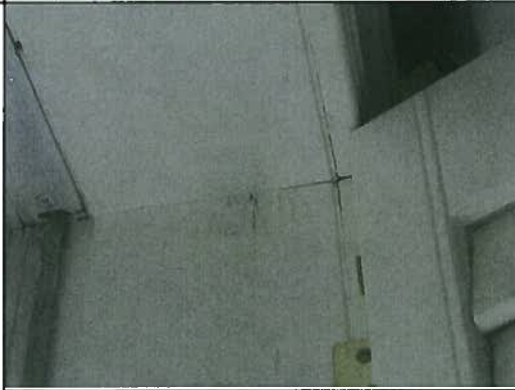
<p>7. Excessive sealant applied to exterior of frame on Unit A3. This is typical for the entire building.</p>

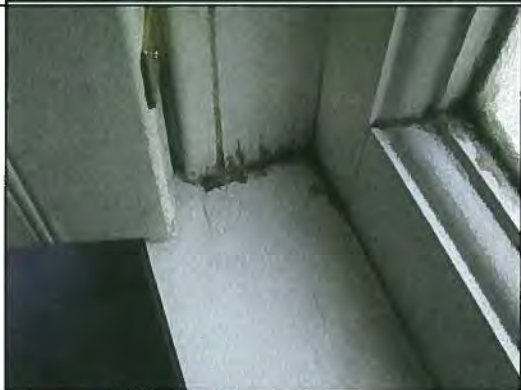
10. Loose seal at glass on unit B3.

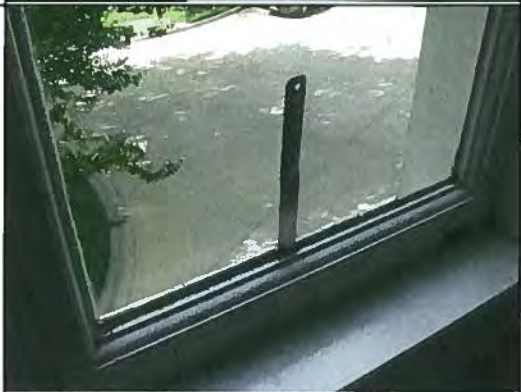
11. Exterior rust on jamb on unit B3.

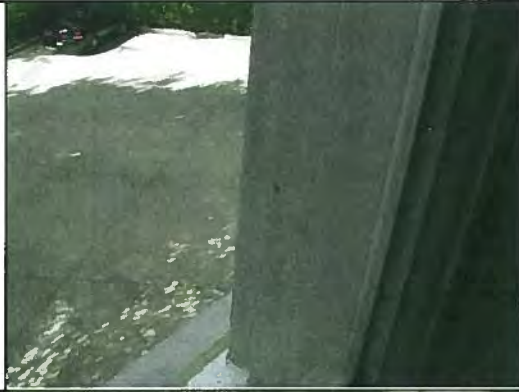
12. Damaged EIFS with poor repair below Unit B3.

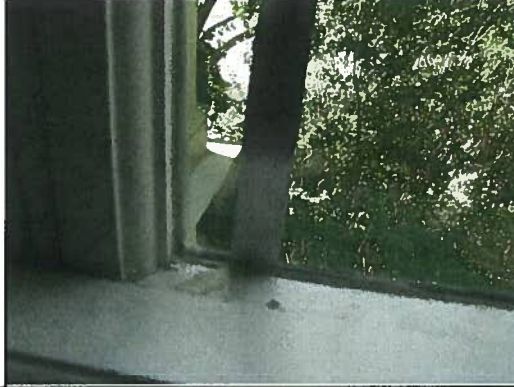
<p>15. Water stain on frame on unit C3.</p>

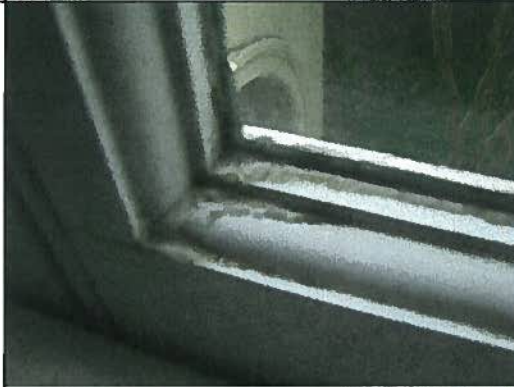
<p>16. Stain on jamb of Unit C3.</p>

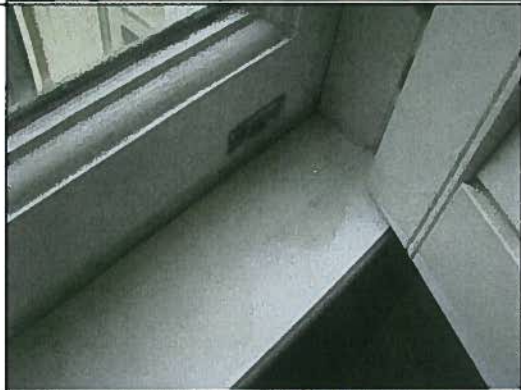
19. Loose seal at glass on unit D3.

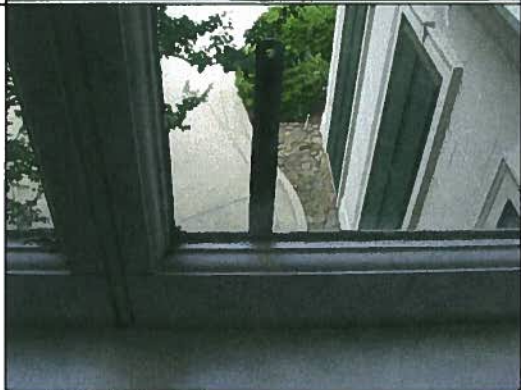
<p>20. Damaged finish and loose joint on Unit D3.</p>

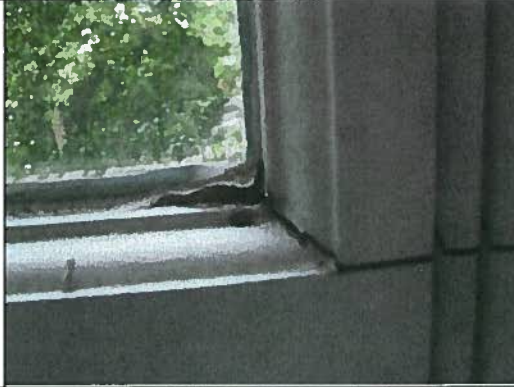
<p>21. Water stain on slide cover of Unit D3.</p>

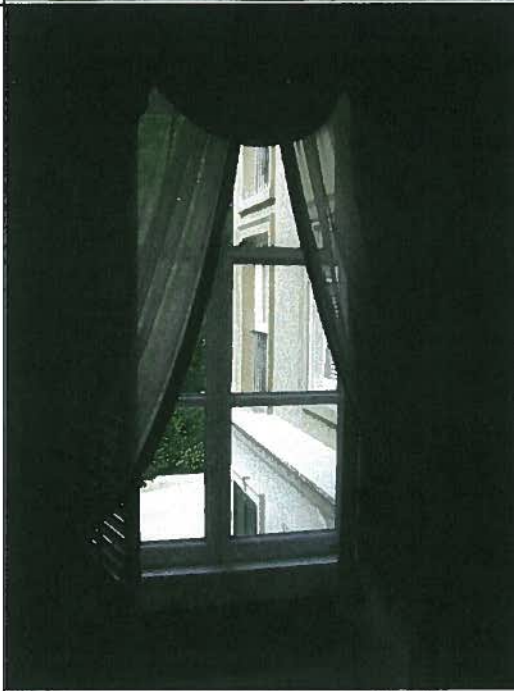
<p>23. Loose joints of unit E3.</p>

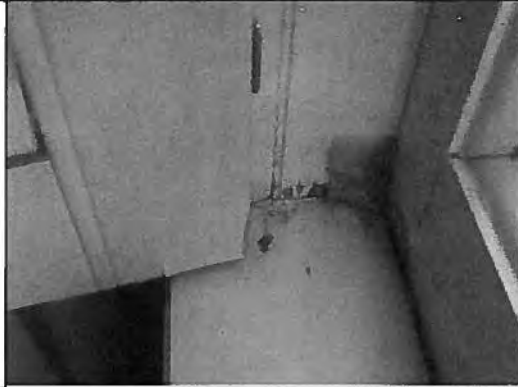
<p>25. Poor fit on Unit E3.</p>

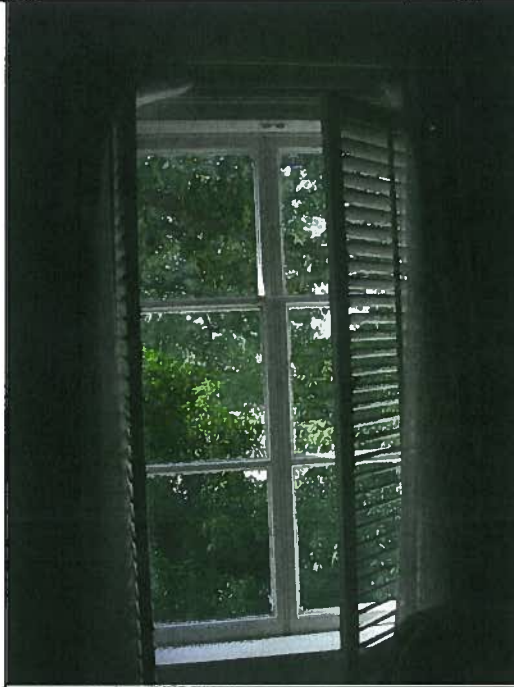
<p>27. Damaged finish and water stain on sill of Unit F3.</p>

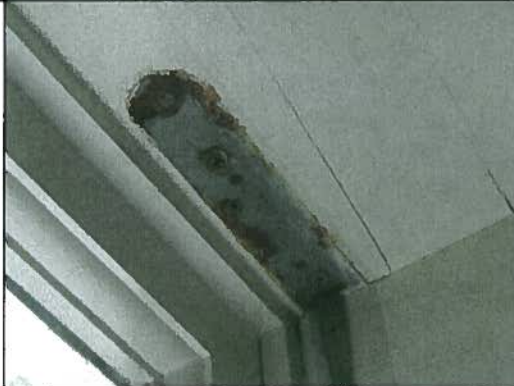
<p>29. Damaged slide on unit F3.</p>

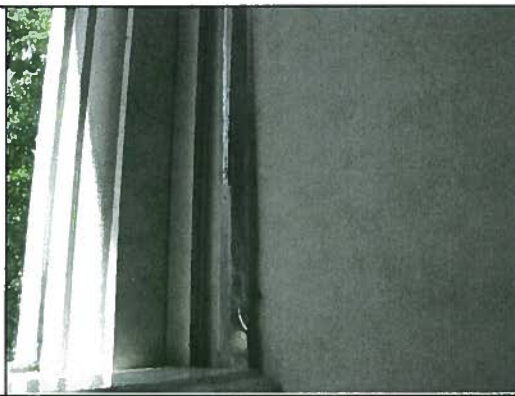
<p>30. Rust on the exterior jamb of Unit F3.</p>

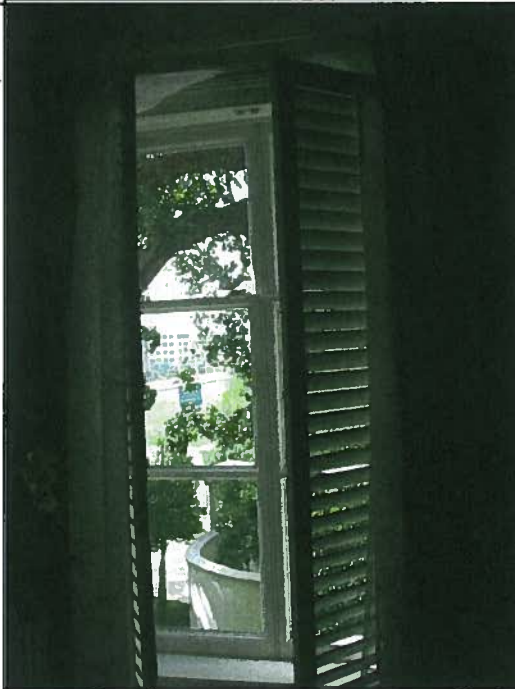
<p>32. Loose seal at glass on unit G3.</p>

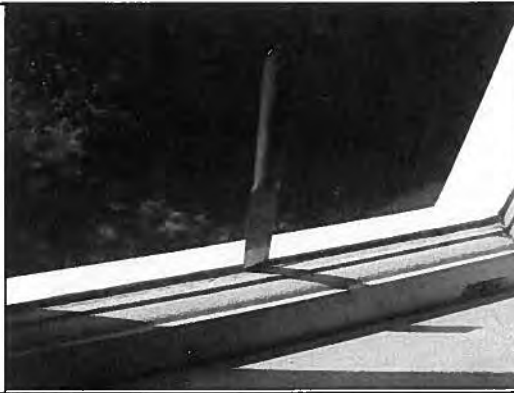
<p>33. Damaged finish and water stain on frame of Unit G3.</p>

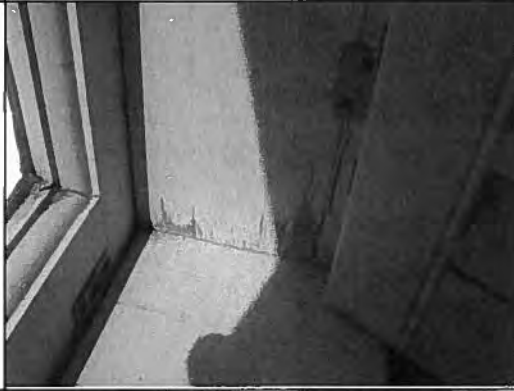
<p>34. Poor fit of Unit G3.</p>

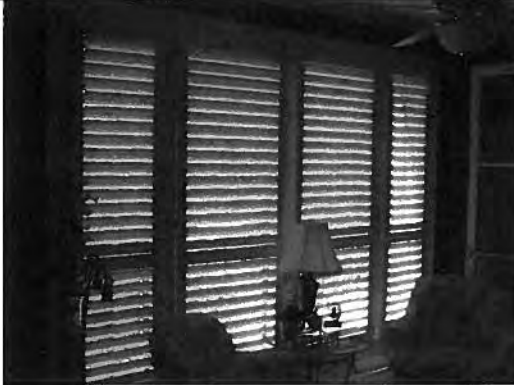
<p>36. Damaged finish on unit H (Terrace 1).</p>

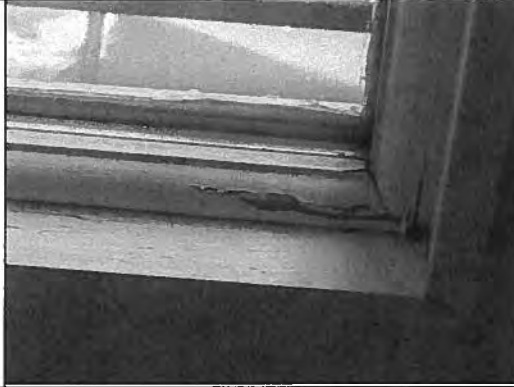
<p>37. Loose joints on unit H (Terrace 1).</p>

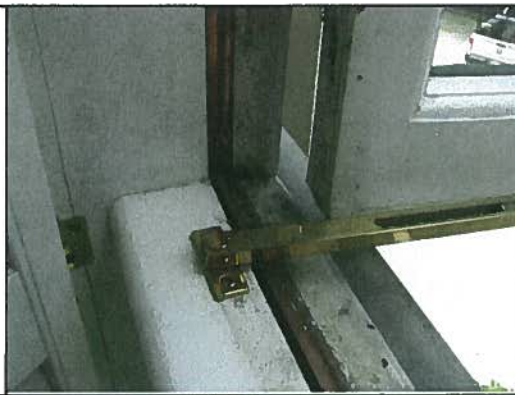
A close-up photograph of a window casing. A yellow level bar is placed horizontally across the casing to check for levelness. The casing appears to be made of wood or a similar material.
<p>40. Water stain on frame of Unit I (Terrace 2).</p>

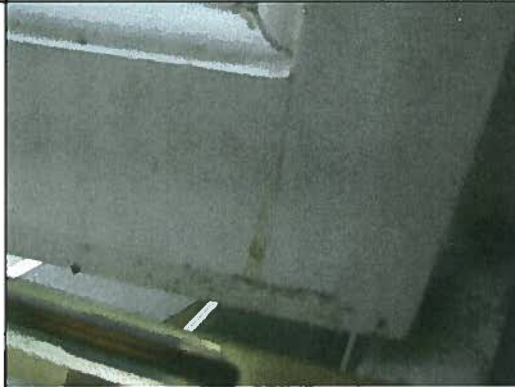
A close-up photograph of a window frame. A distinct brownish water stain is visible on the white-painted frame, indicating a leak or moisture problem.
<p>41. Water stain on jamb of Unit I (Terrace 2).</p>

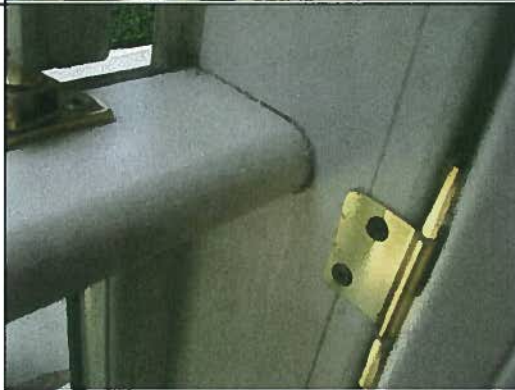
A close-up photograph of a window jamb. A water stain is visible on the white-painted jamb, near a yellow hinge or latch mechanism.
<p>42. Decayed wood on Unit I (Terrace 2).</p>

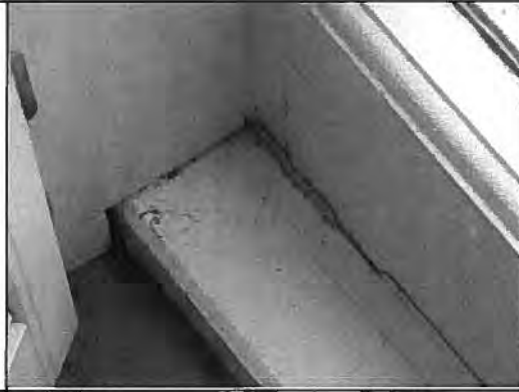
44. Poor fit on Unit I (Terrace 2).

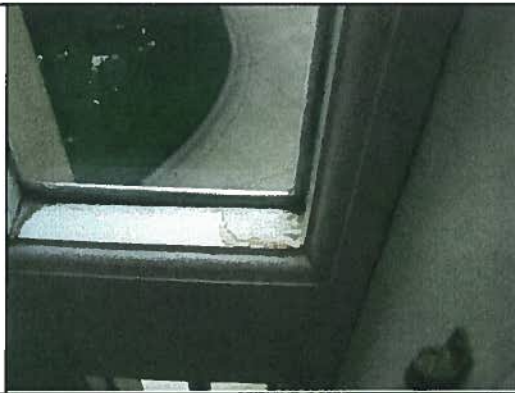
<p>46. Water stain on frame of Unit J (Terrace 2).</p>

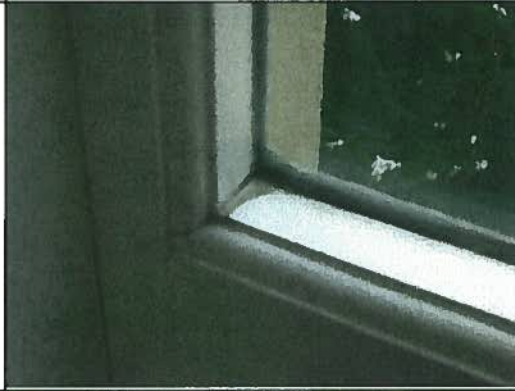
<p>47. Loose joint on Unit J (Terrace 2).</p>

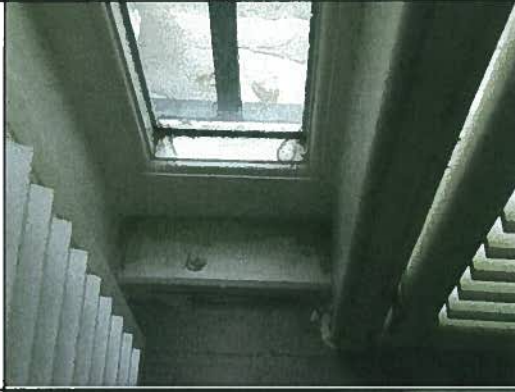
<p>48. Water stain on sill of Unit J (Terrace 2).</p>

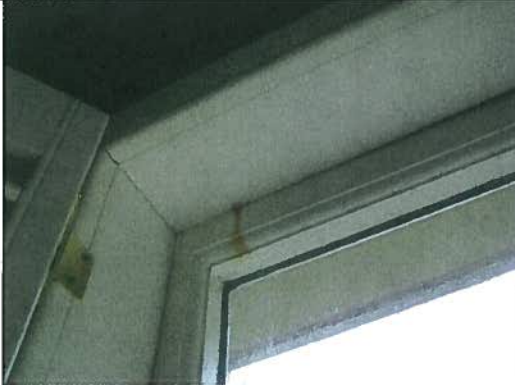
<p>49. Rusty stain on head of unit J (Terrace 2).</p>

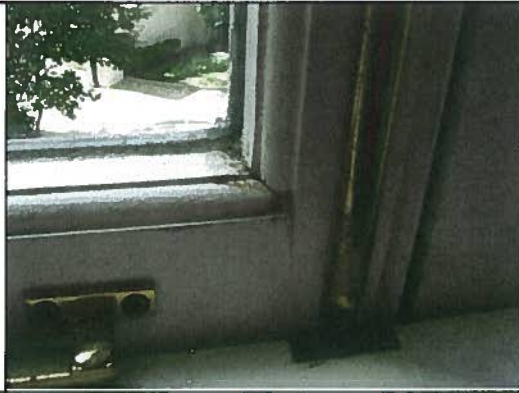
50. Loose joint and water stain on frame
of Unit J (Terrace 2).

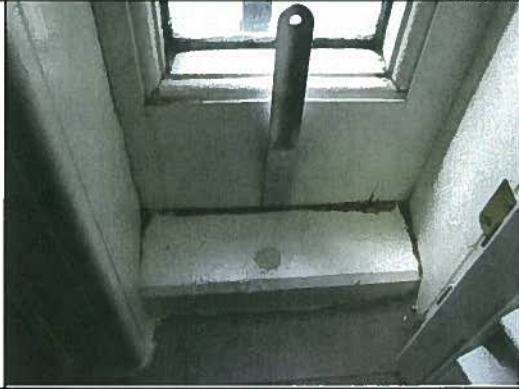
51. Poor fit and water stains on unit J
(Terrace 2).

Window units are identified as A2 through E2 plus the Living Room terrace (Terrace 1) and the MBR terrace (Terrace 2). Generally, the windows are in fair condition, however the casement enclosures at Terrace 2 are poor because the design with an open joint that extends from the exterior sill below the casement windows above to the interior of the lower fixed panels below.

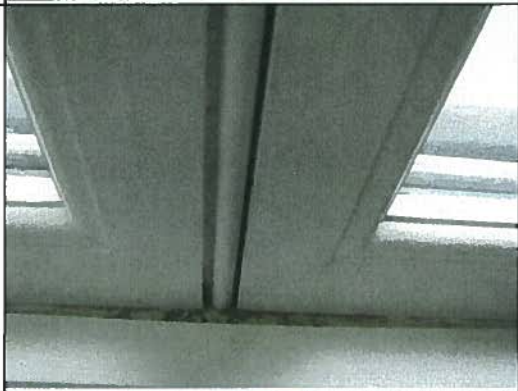
<p>64. Poor closing of Unit G.</p>

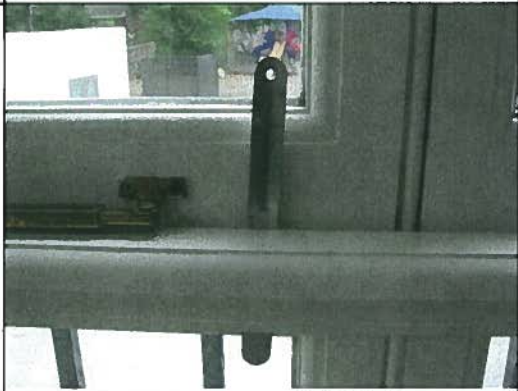
<p>65. Open joint by poor design of Unit G.</p>

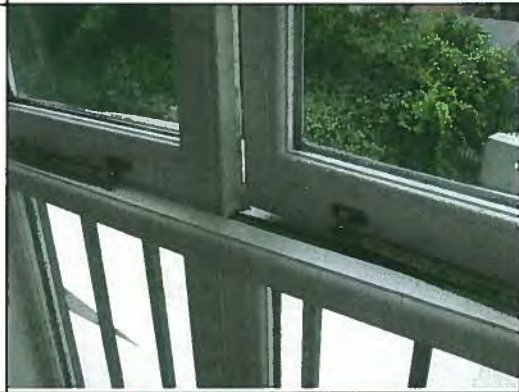
67. Poor closing of Unit H.

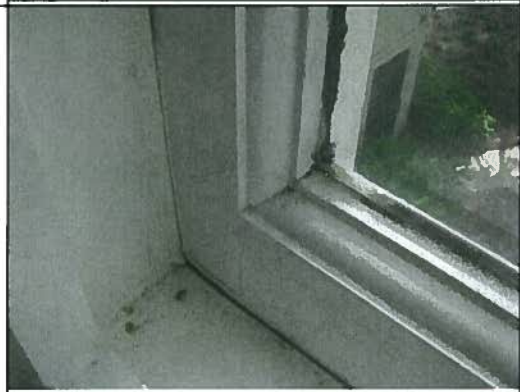
71. Damaged finish and water stain on
frame of Unit A3.

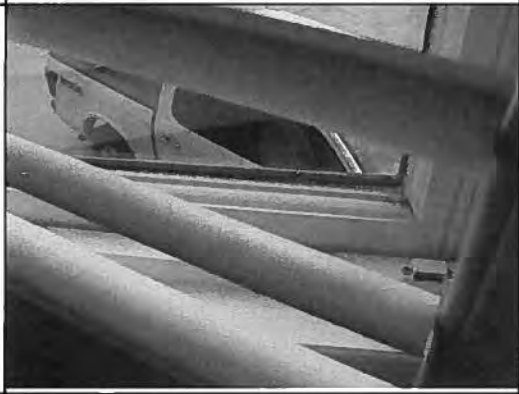
73. Water stain on frame of Unit B3.

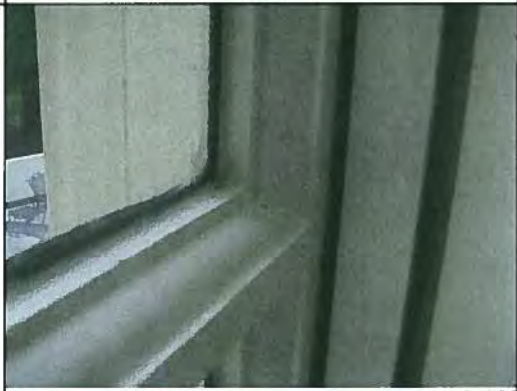
<p>75. Water stain on frame of Unit C3.</p>

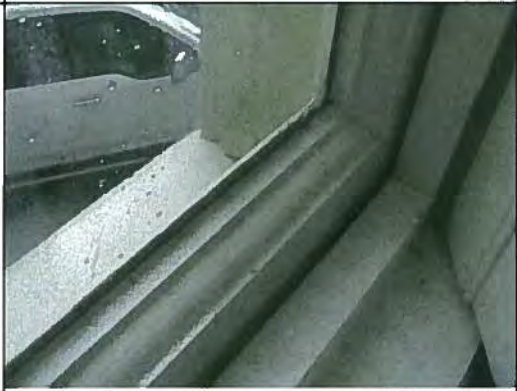
<p>76. Water stain on frame and sill of Unit C3.</p>

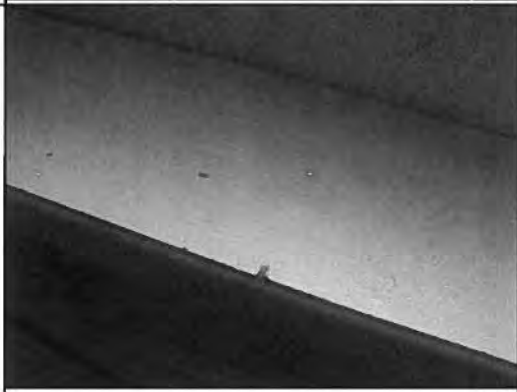
78. Water stain on sill of Unit D3.

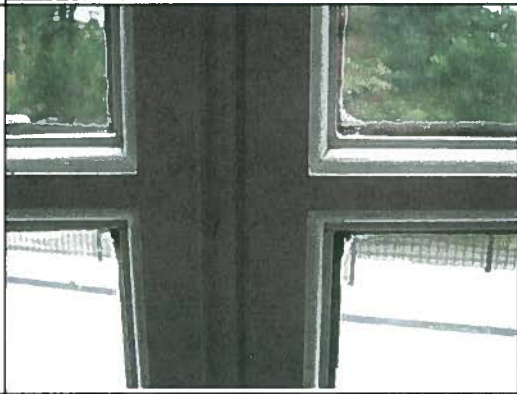
80. Excessive exterior sealant on Unit E3, but typical of all windows in building.

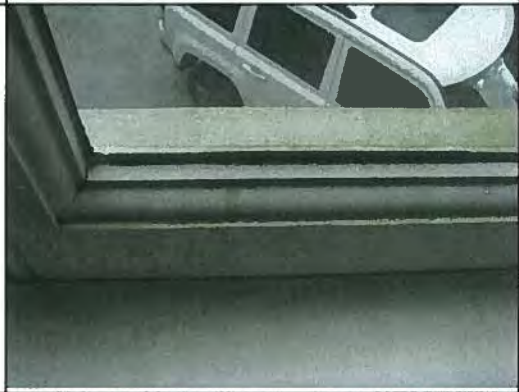
82. Water stain on frame of Unit F3.

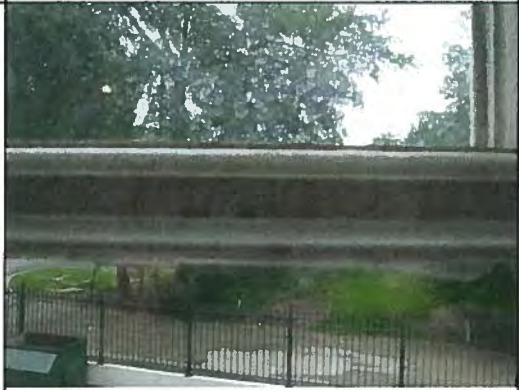
83. Water stain on frame of Unit F3.

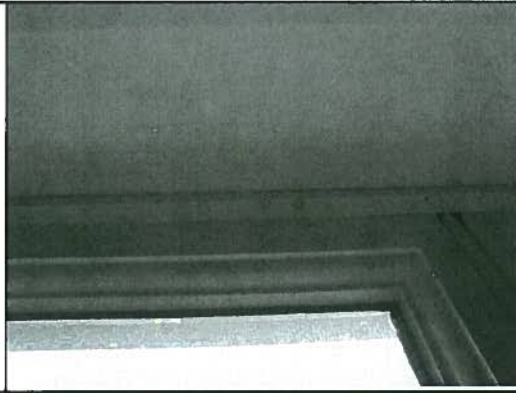
84. Water stain on head of Unit F3.

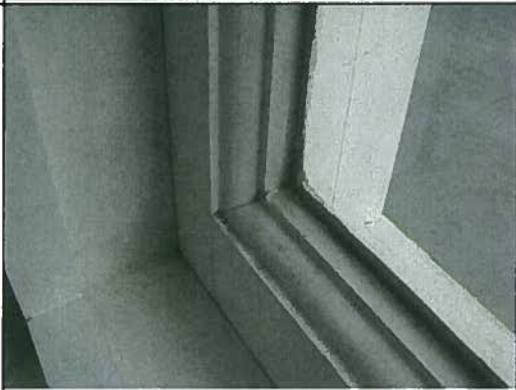
86. Water stain on frame at loose joint
of Unit G3.

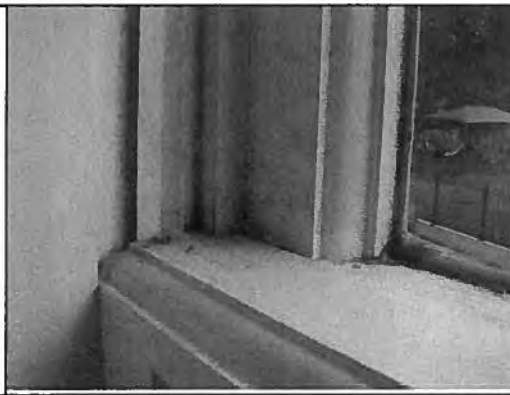
<p>87. Water stain on frame and jamb of Unit G3.</p>

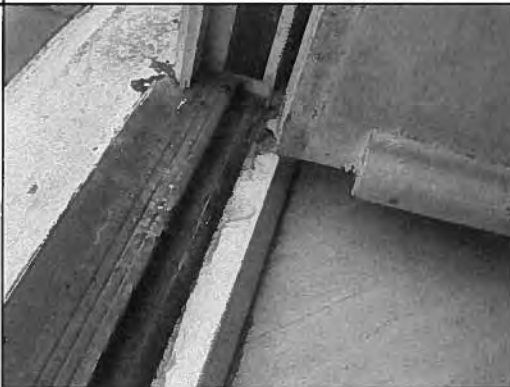
<p>90. Water stain at threshold of Unit H.</p>

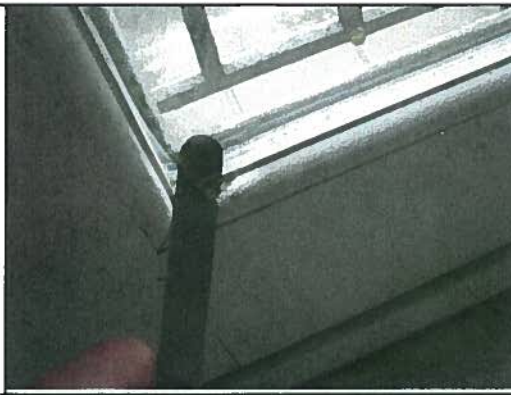
<p>91. Loose solar film on Unit H.</p>

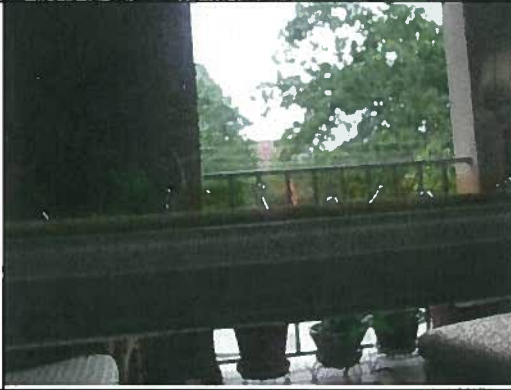
<p>93. Blistered solar film on Unit I.</p>

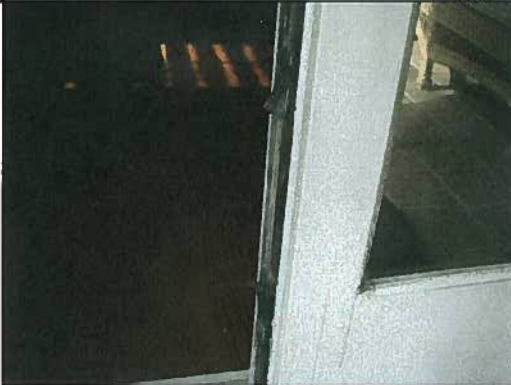
<p>94. Damaged weather stripping on Unit I.</p>

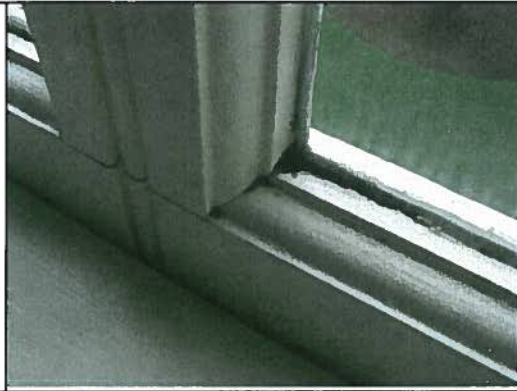
99. Loose joint on Unit A2.

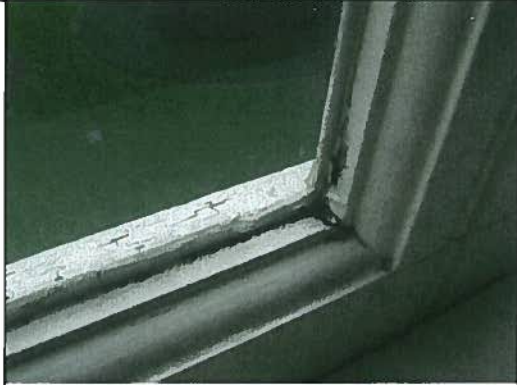
100. Damaged finish on Unit A2.

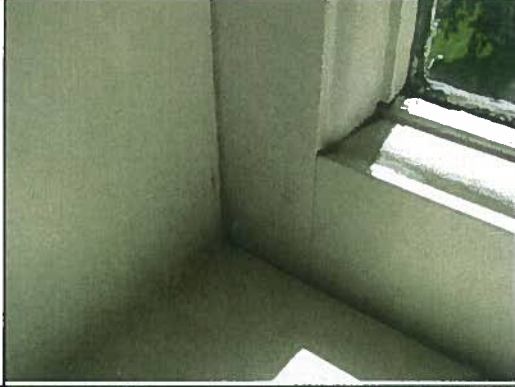
<p>102. Water stain on jamb and damaged finish on Unit B2.</p>

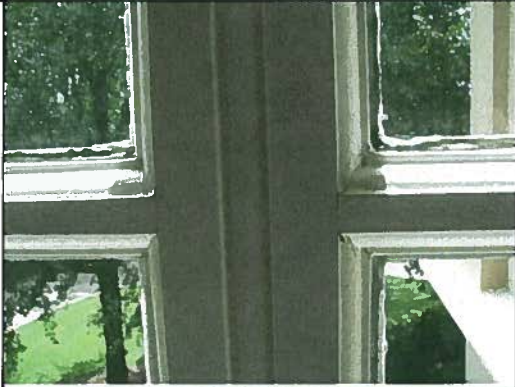
<p>103. Excessive exterior sealant and a loose joint on Unit B2.</p>

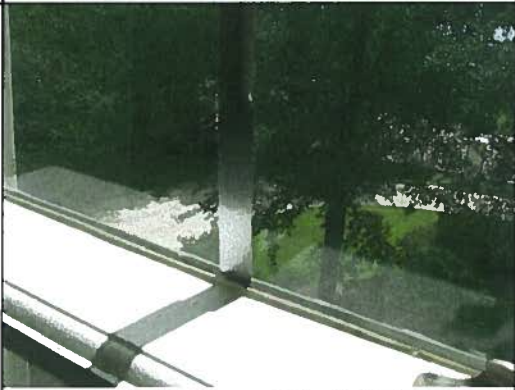
<p>104. Loose seal at glass on Unit B2.</p>

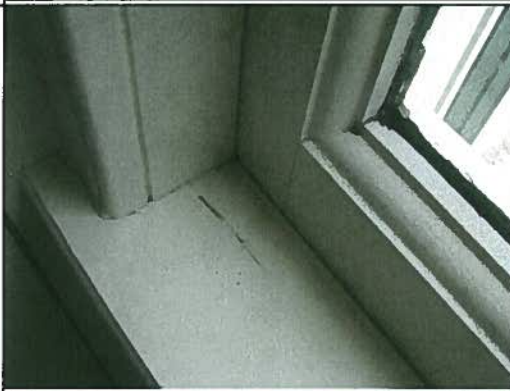
A photograph of a window with white horizontal blinds. The window is set in a dark frame. Through the blinds, green foliage and a white fence are visible outside.
<p>106. Damaged finish on Unit C2.</p>

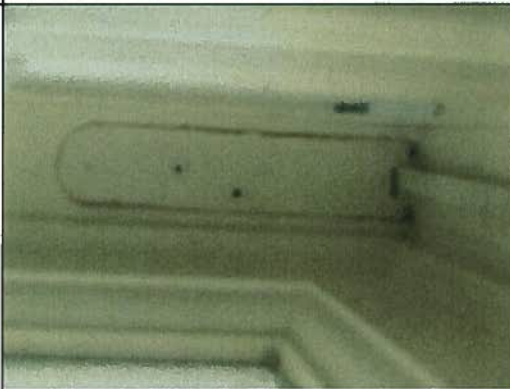
A close-up photograph of a window sill. The white paint or finish on the sill is chipped and peeling away, revealing a darker material underneath.
<p>107. Stain at head slide cover of Unit C2.</p>

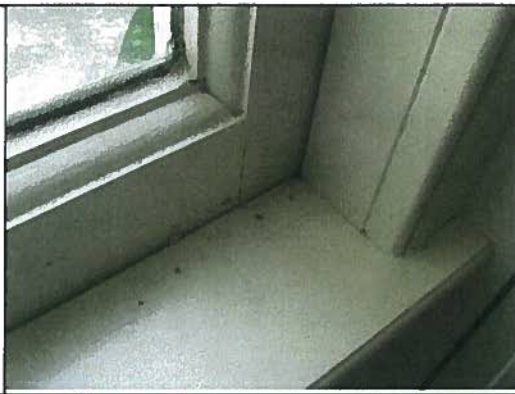
<p>108. Water stain on frame of Unit C2.</p>

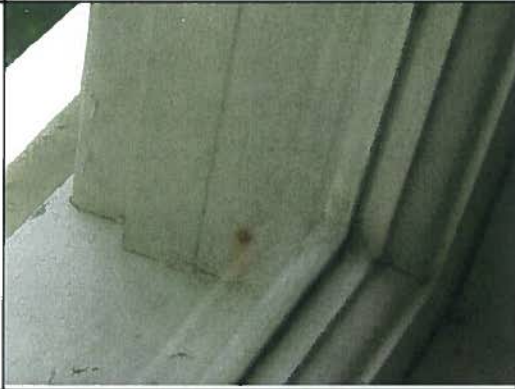
<p>109. Rust on exterior jamb of Unit C2.</p>

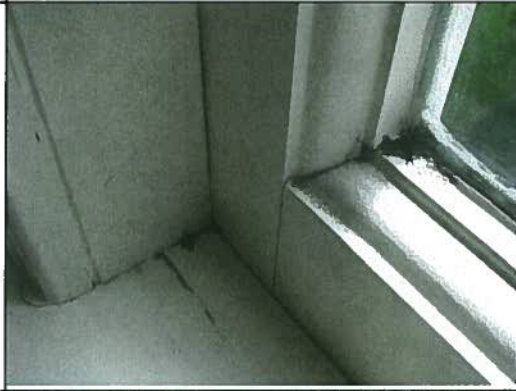
<p>112. Loose joint on Unit D2.</p>

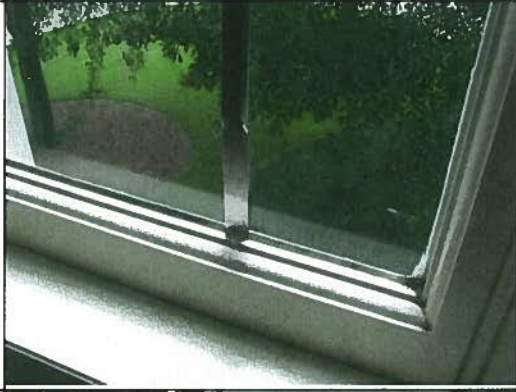
<p>113. Loose seal at glass on Unit D2.</p>

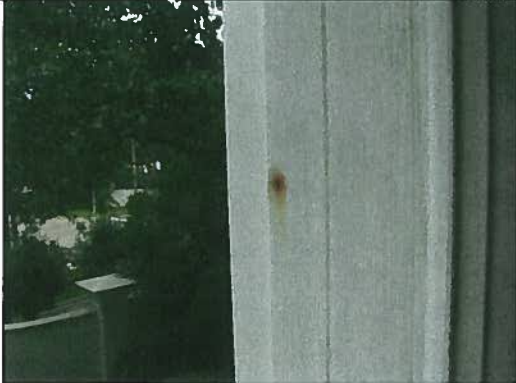
<p>114. Rust on exterior jamb of Unit D2.</p>

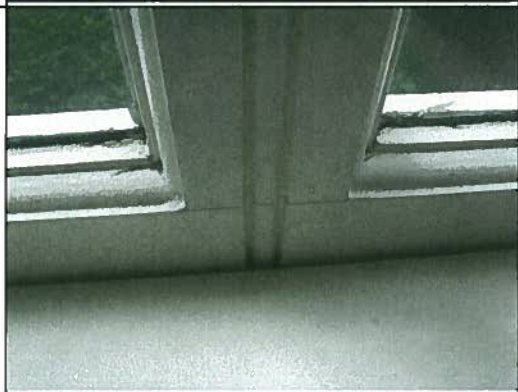
116. Loose joint of Unit E2.

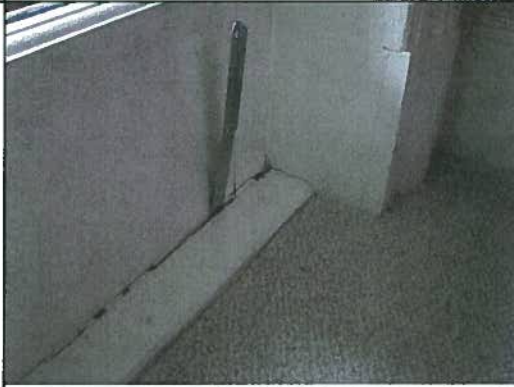
<p>119. Poor fit of Unit F.</p>

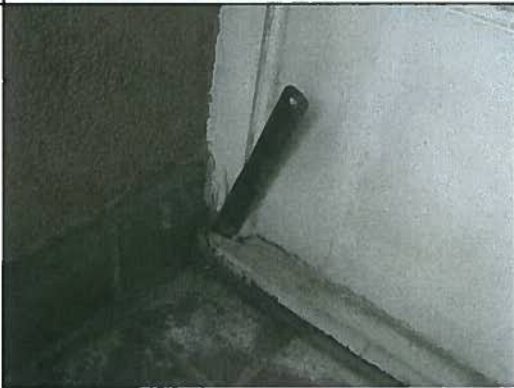
<p>120. Decayed wood on terrace at Unit F.</p>

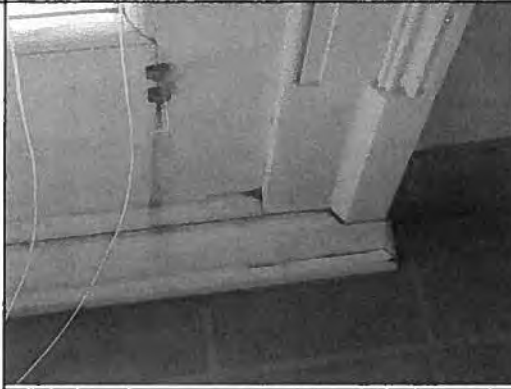
<p>123. Water stain on frame and sill of Unit G.</p>

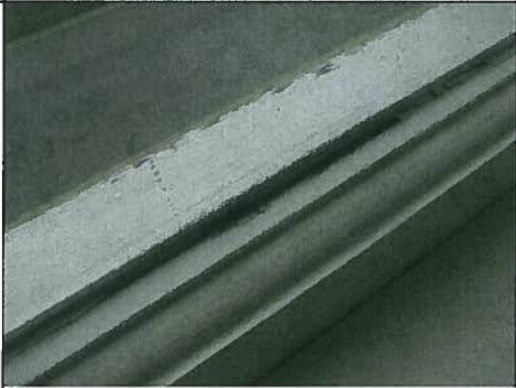
A close-up photograph of the window unit's frame, showing significant damage to the white finish. The surface is cracked and peeling, revealing a darker material underneath.
<p>3. Loose seal at glass on Unit A3.</p>

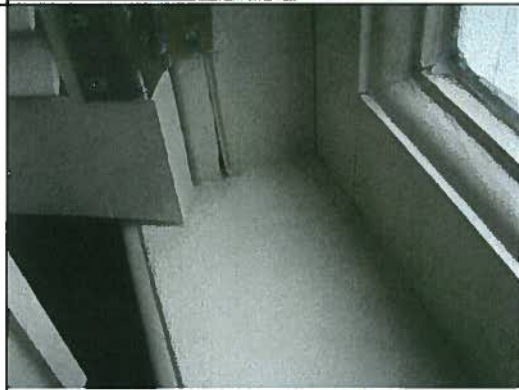
5. Loose joint on Unit B3.

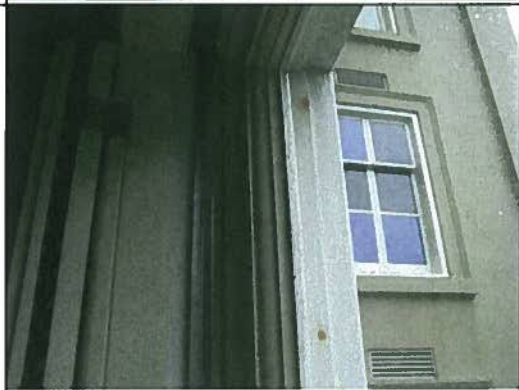
6. Rust on exterior jamb of Unit B3.

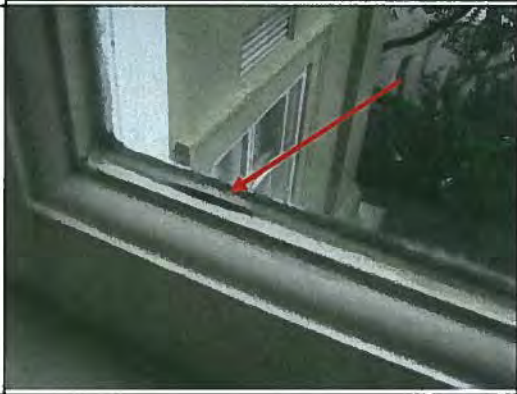
8. Loose seal at glass on Unit C3.

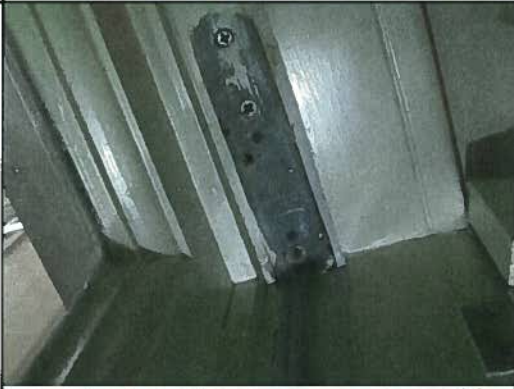
<p>10. Rusty water stain at slide cover on head of Unit D3.</p>

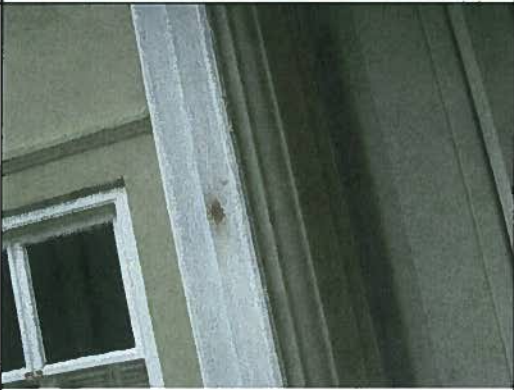
<p>11. Rust at exterior jamb on Unit D3.</p>

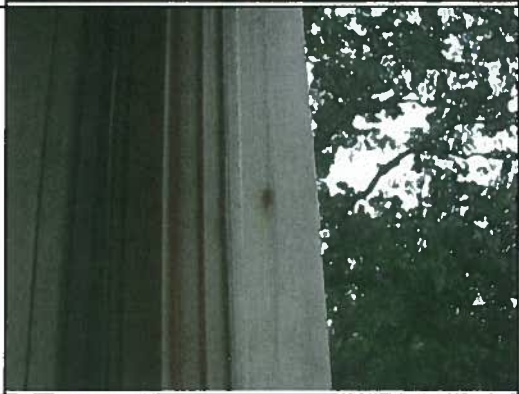
13. Rust on exterior jamb on Unit E3.

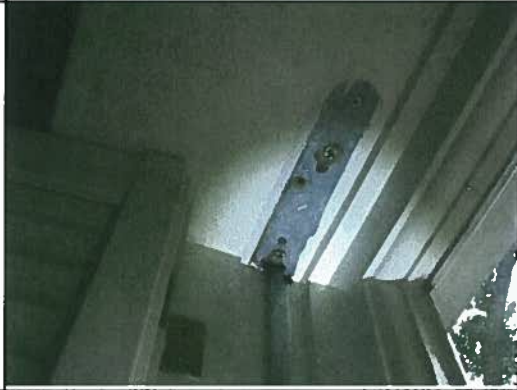
15. Rusty water stain on slide cover on
Unit F3.

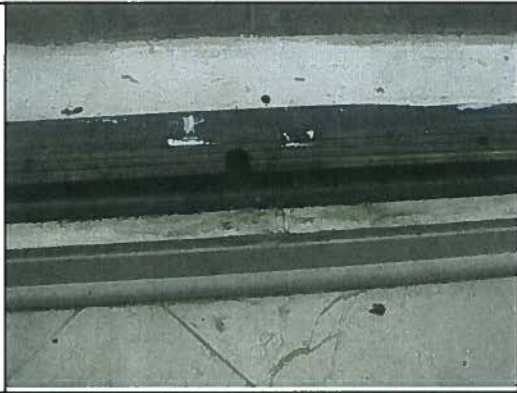
19. Water stain at threshold of Unit H.

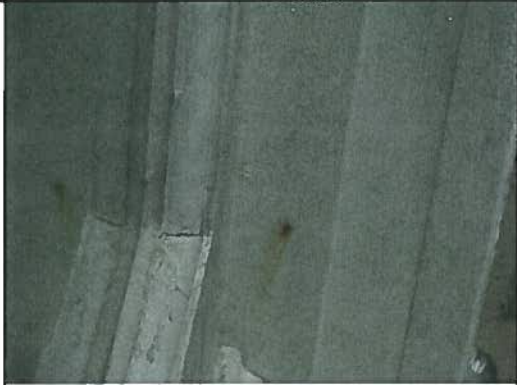
20. Rust on exterior jamb of Unit H.

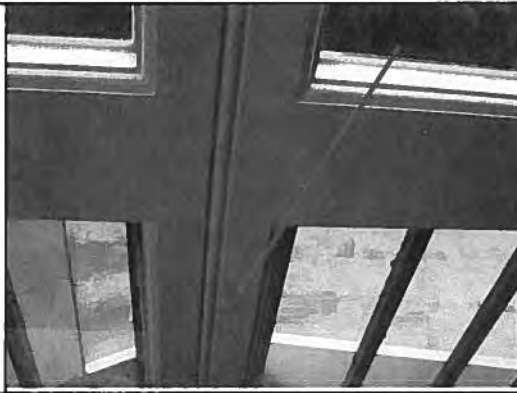
22. Damaged finish on Unit I.

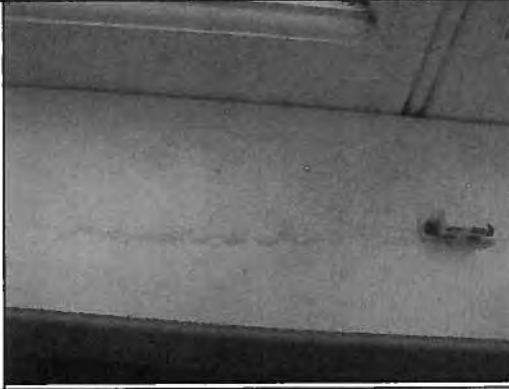
A black and white photograph of a window with dark, closed shutters. The shutters have horizontal slats. The window is set in a dark frame.
<p>25. Water stain on sill of Unit A2.</p>

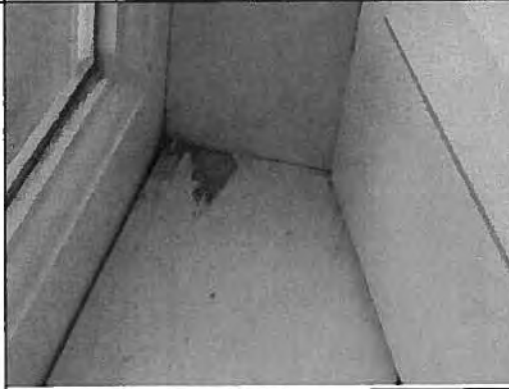
A black and white close-up photograph of a window sill. A dark, irregular water stain is visible on the light-colored surface of the sill.
<p>26. Damaged finish and water stain on sill of Unit A2.</p>

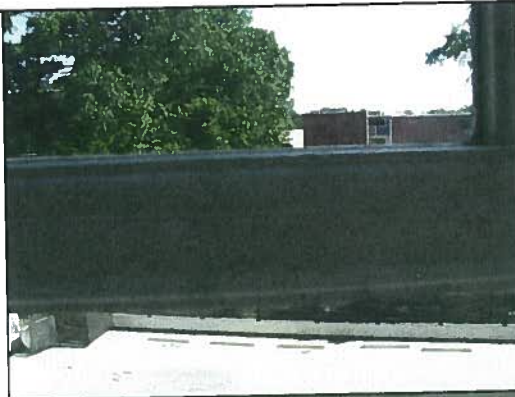
27. Water stain on frame of Unit A2.

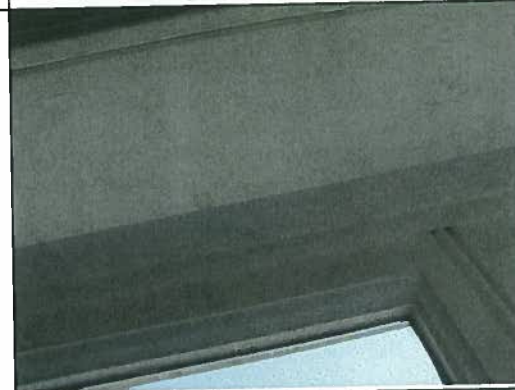
28. Water stain at head of Unit A2.

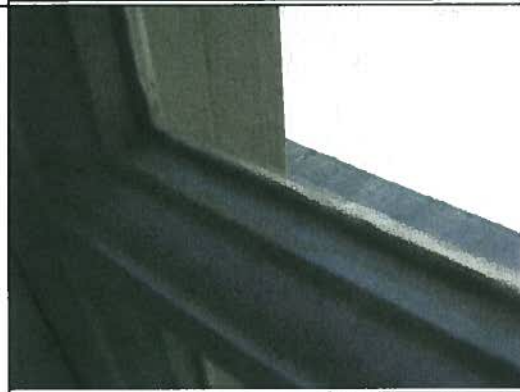
31. Water stain on frame of Unit B2.

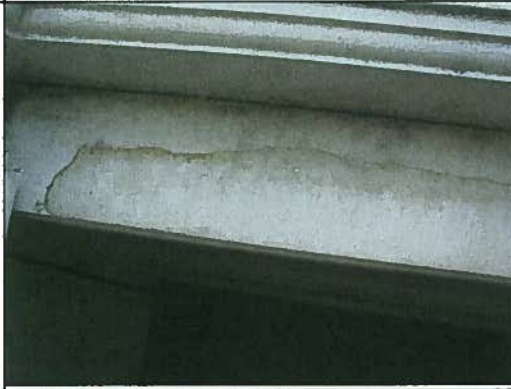
<p>33. Water stain on sill of Unit C2.</p>

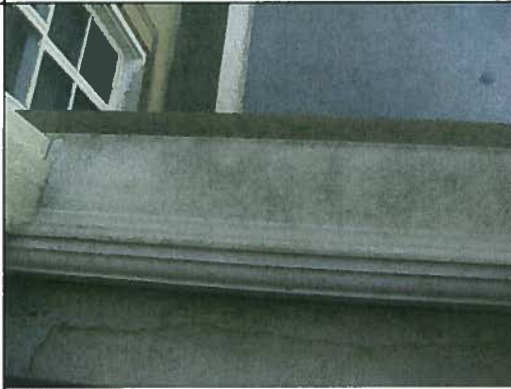
<p>34. Water stain on frame of Unit C2.</p>

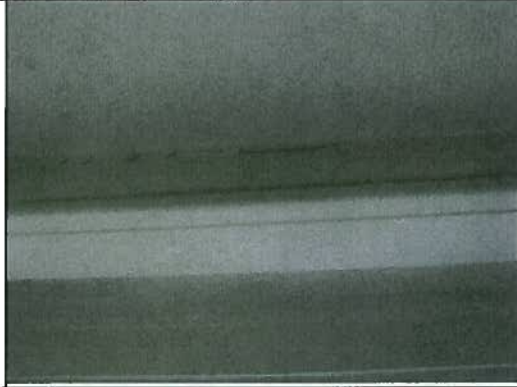
<p>35. Water damaged wall above head of Unit C2.</p>

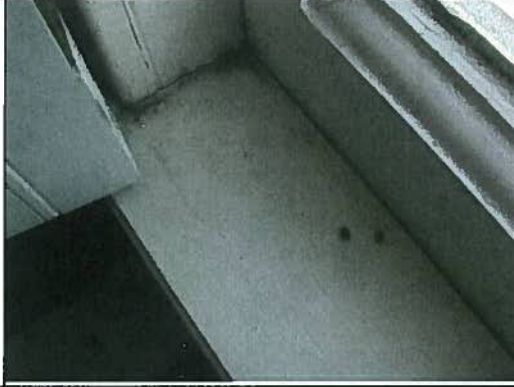
<p>38. Damaged finish at sill/jamb of Unit D2.</p>

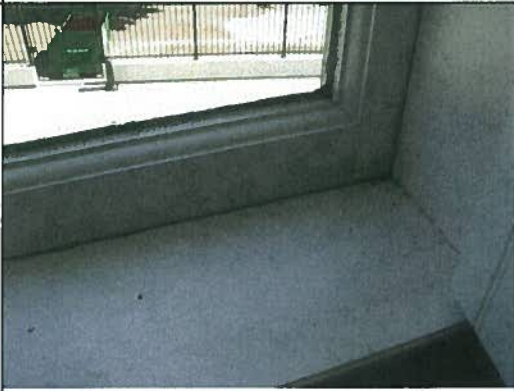
<p>40. Stain at sill and frame of Unit E2.</p>

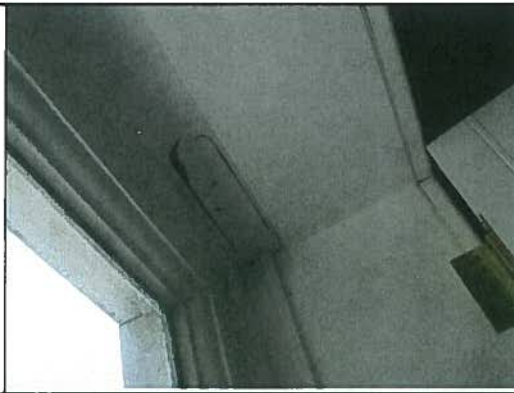
<p>41. Rust on slide cover at head of Unit E2.</p>

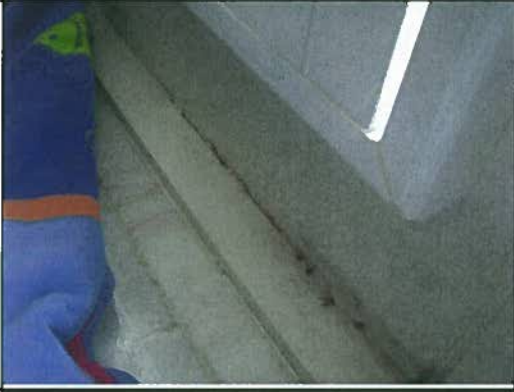
<p>43. Water stain on sill and frame of Unit F.</p>

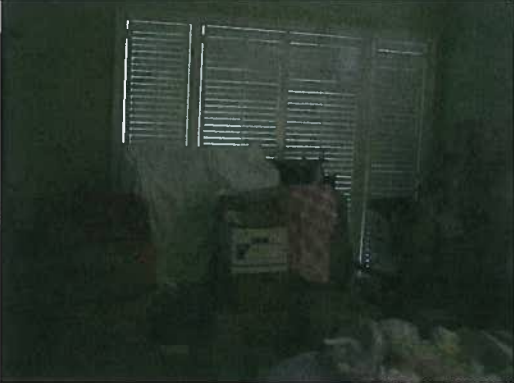
<p>44. Unit G. There was no access to this unit.</p>

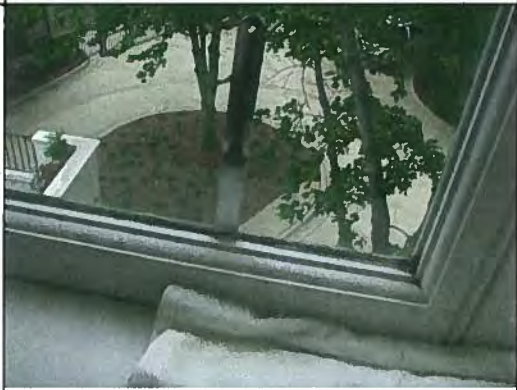
47. Loose seal at glass on Unit A3.

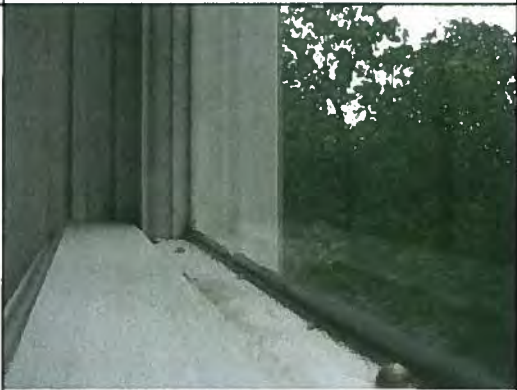
48. Water stain on frame of Unit A3.

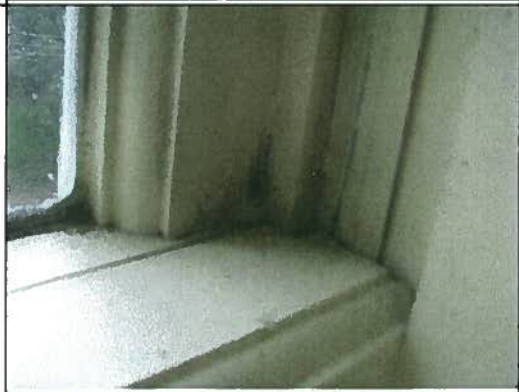
50. Water stain with mildew on frame and jamb of Unit B3.

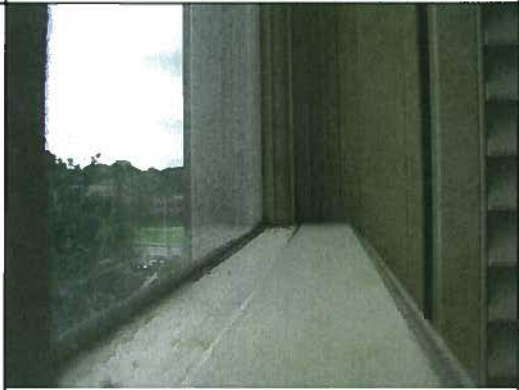
51. Water stain on frame of Unit B3.

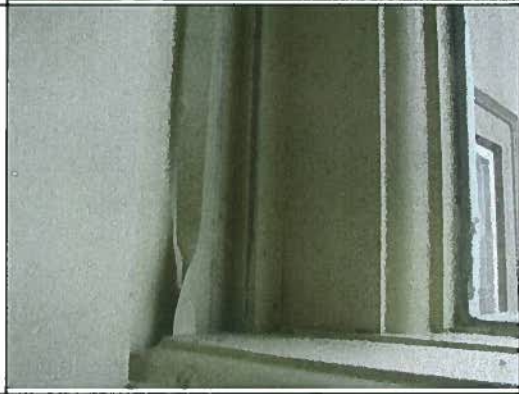
53. Damaged slide of Unit C3.

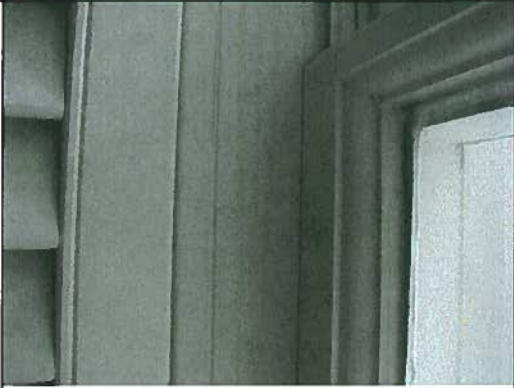
<p>57. Water stain at head and jamb of Unit D3.</p>

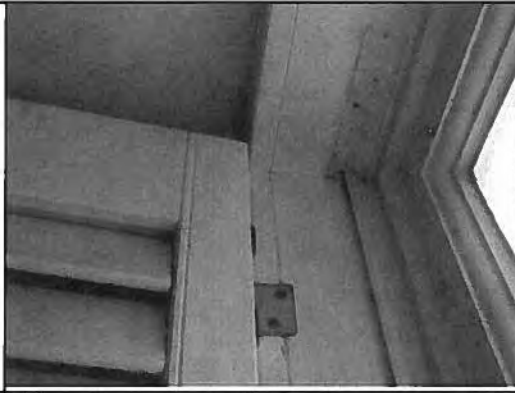
<p>58. Water stain and rust at head of Unit D3.</p>

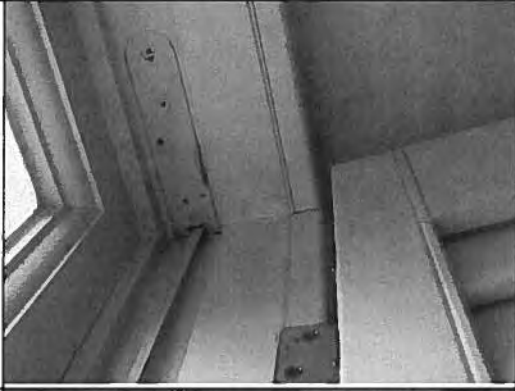
<p>59. Split exterior sill at Unit D3.</p>

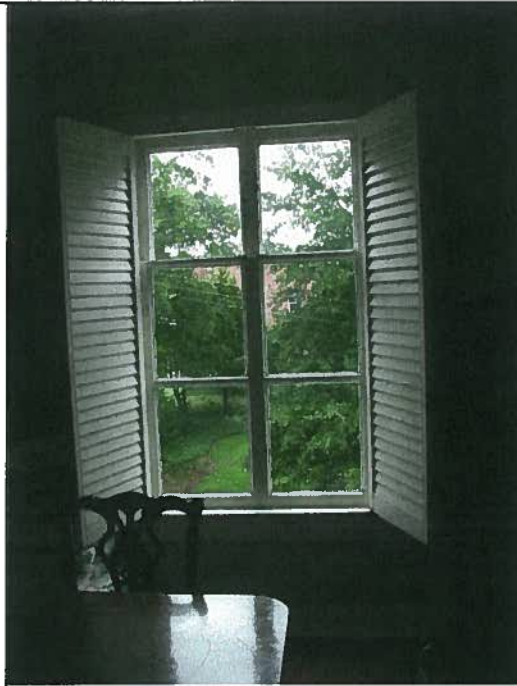
61. Damaged finish of Unit E3.

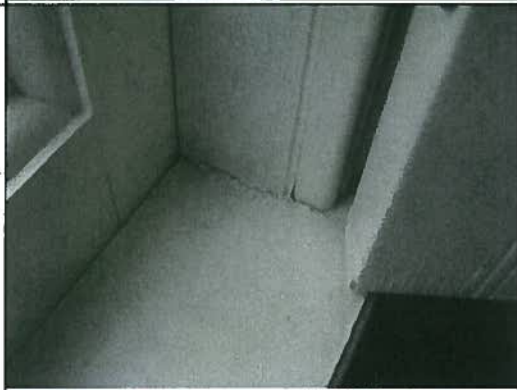
62. Excessive exterior sealant on Unit E3.

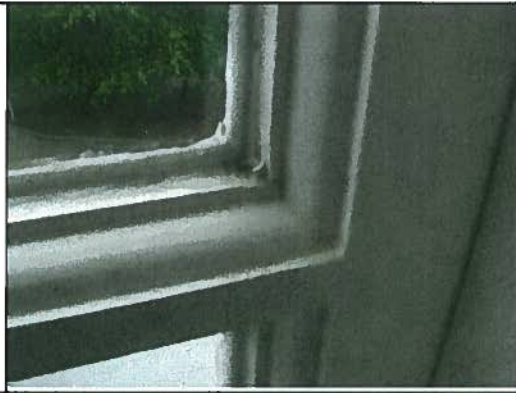
64. Water stain on head of Unit E3.

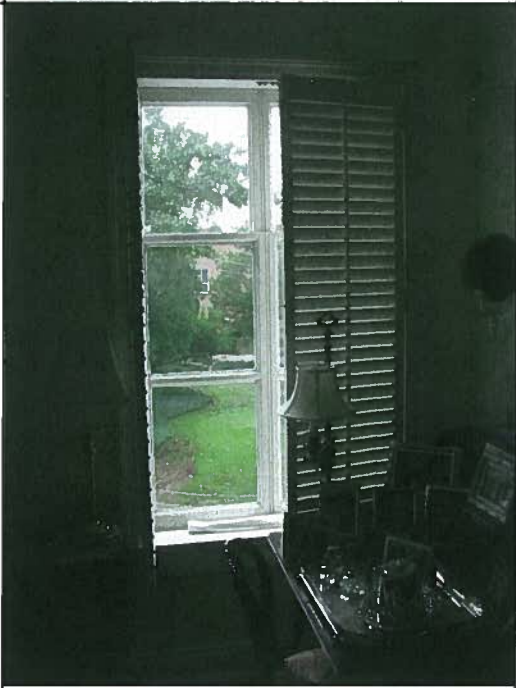
66. Damaged finish on Unit F3.
