DOCUMENT 009113 - ADDENDA

- A. Addendum No. 002.

- A. Project Name: The Barrington Exterior Refinishing
- B. Owner: The Barrington Condominium Association, Inc.
- C. Architect: Purser & Company, PA.
- D. Architect Project Number: 20230809001.
- E. Date of Addendum: 6/18/24.

Between August 12 and September 2, 2020 Dennis Walters, CSI, CDT, CCCA, Principal, Central Building Consultants, LLC visited the building and through Ms. Beth Hartness' introductions to the unit owners, observed the existing interior conditions of the windows and terrace enclosures of each of the four units on floors 3 through 9.

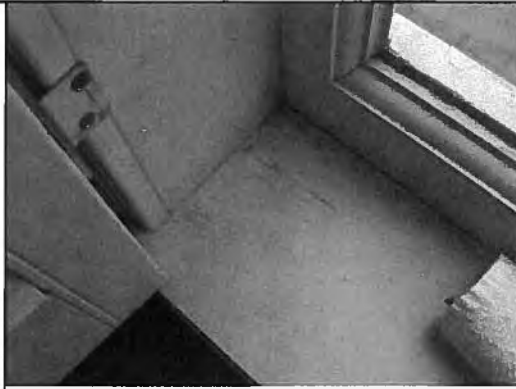
67. Water stain on frame of Unit F3.

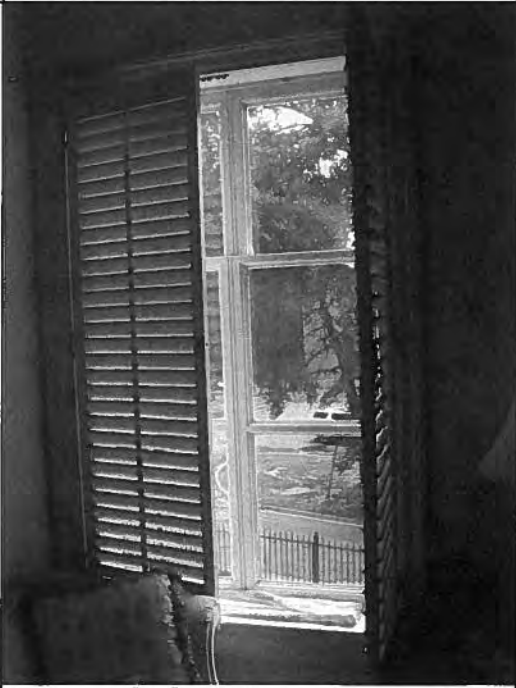
<p>69. Water stain on sill of Unit G3.</p>

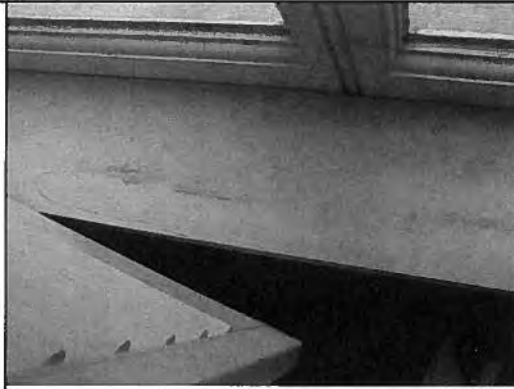
<p>70. Water stain on frame of Unit G3.</p>

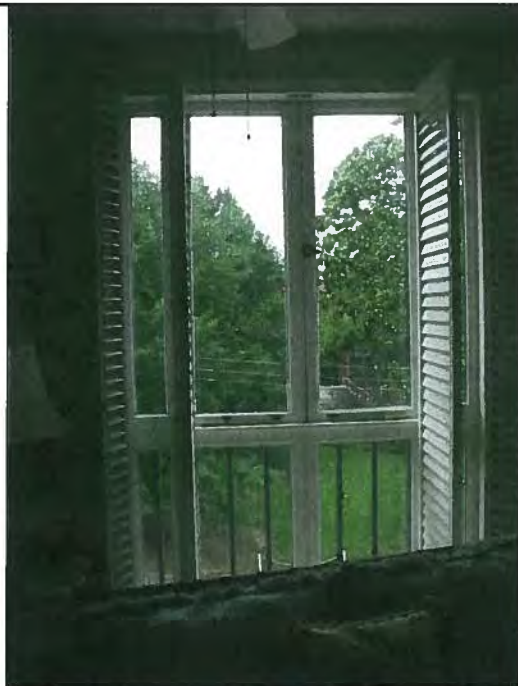
74. Damaged finish on sill of Unit H.

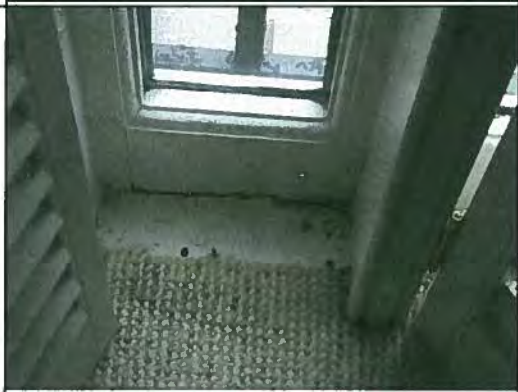
75. Poor fit of unit into opening at Unit H.

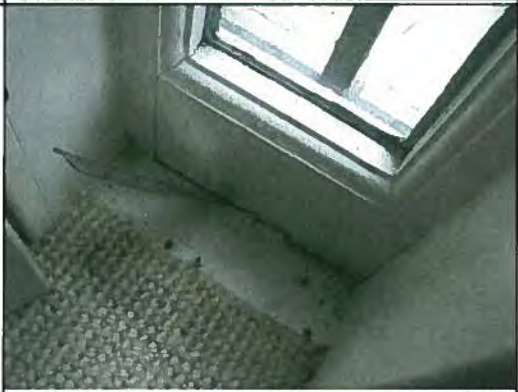
<p>76. Decayed wood at strike plate on Unit H.</p>

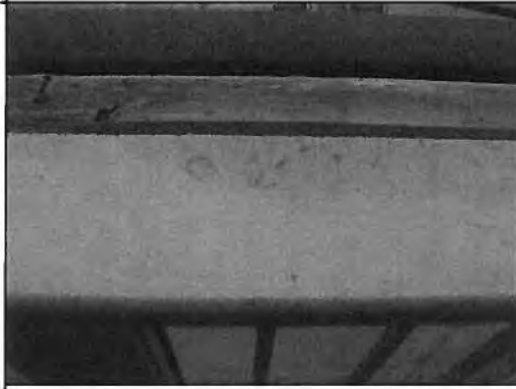
<p>78. Loose joint in frame of Unit H.</p>

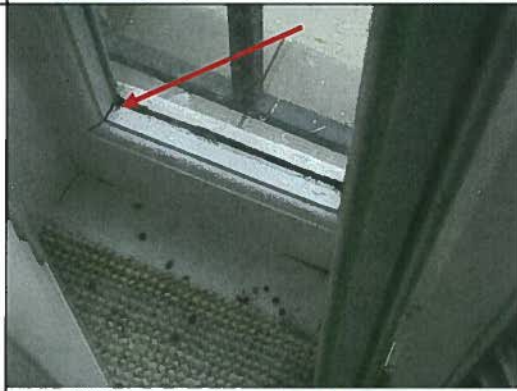
<p>82. Open joint of frame from exterior to interior (poor design) on Unit I.</p>

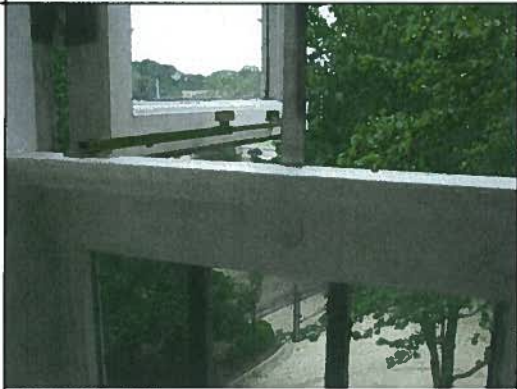
<p>83. Water stain on frame of Unit I.</p>

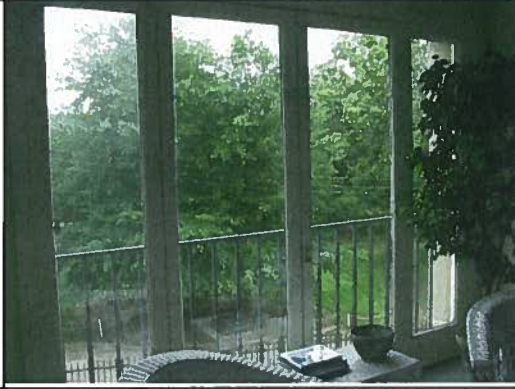
<p>85. Interior severely decayed wood at sill of Unit J.</p>

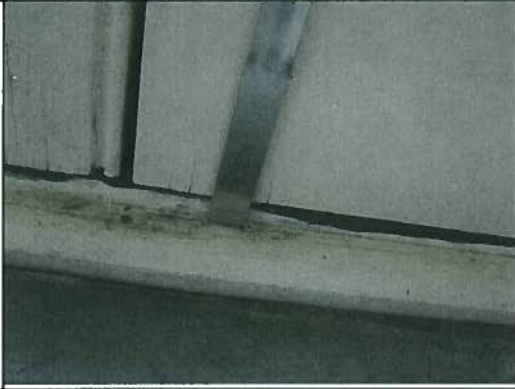
<p>86. Exterior severely decayed wood at sill of Unit J.</p>

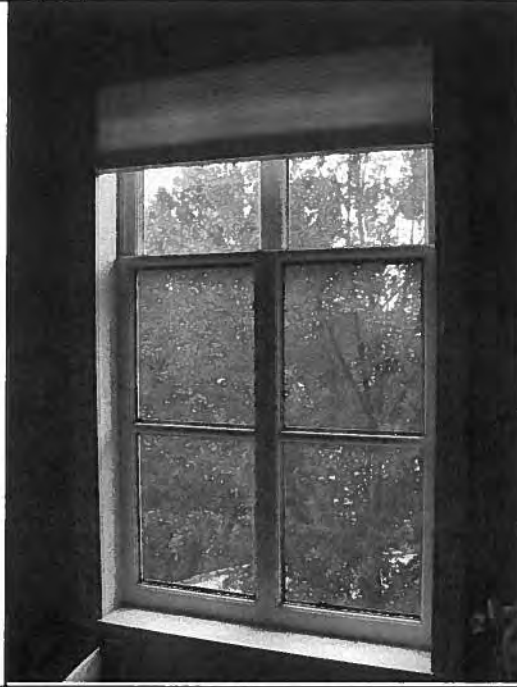
<p>88. Damaged finish of sill on Unit A2.</p>

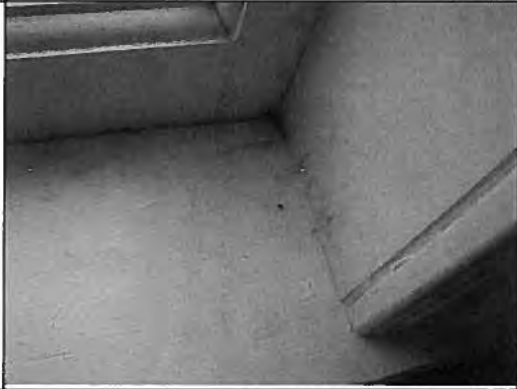
<p>89. Stain on frame at loose joint of Unit A2.</p>

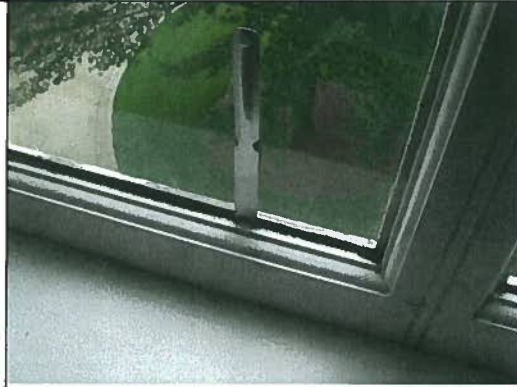
<p>92. Water stain on frame on Unit A2.</p>

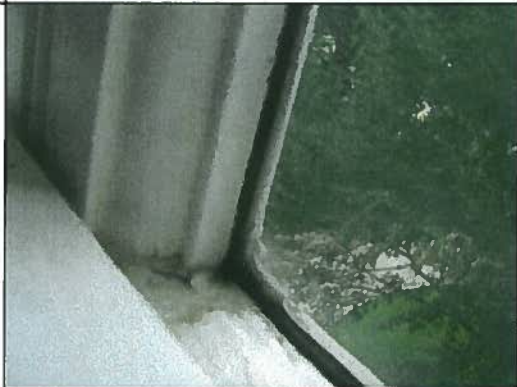
<p>93. Rust on exterior jamb at Unit A2.</p>

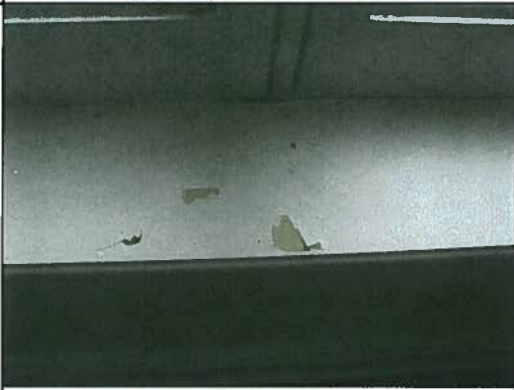
A photograph showing a white window unit with a six-pane grid. The window is set in a dark wall. A dark wooden chair is partially visible in the foreground.
<p>97. Damaged finish on sill of Unit C2.</p>

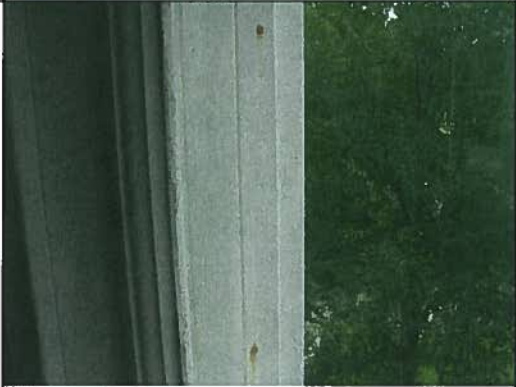
<p>101. Rust on exterior jamb of Unit D2.</p>

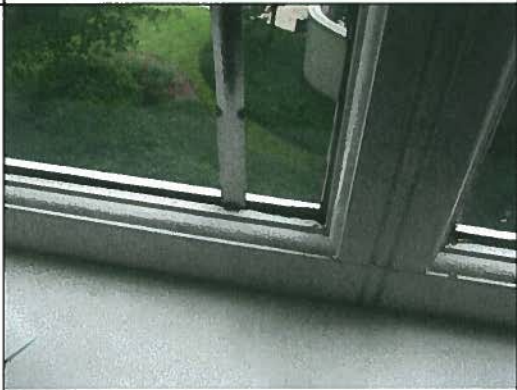
104. Loose seal at glass on Unit E2.

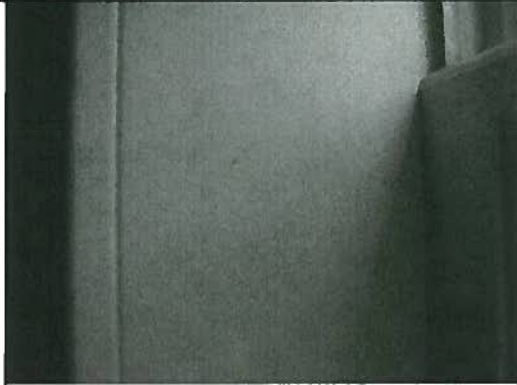
106. Water stain on jamb of Unit E2.

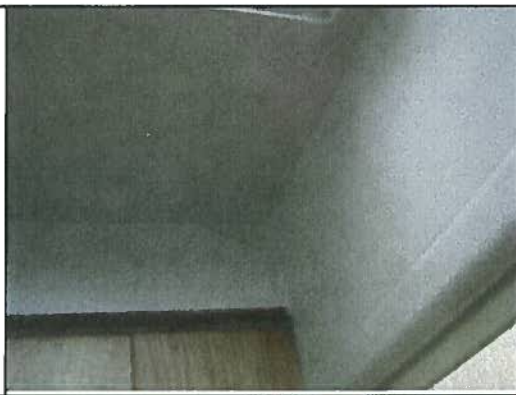
<p>111. Water stain on sill of Unit G.</p>

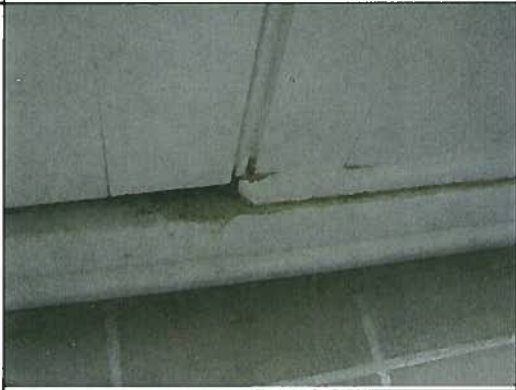
<p>113. Water stain on sill under door of Unit H.</p>

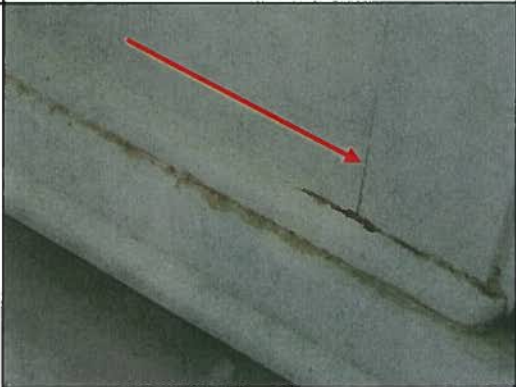
<p>114. Loose joint in frame of Unit H.</p>

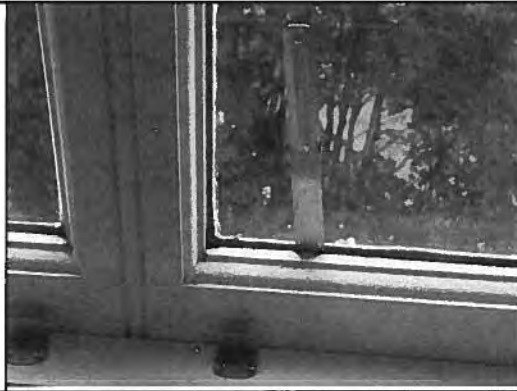
3. Loose seal at glass of Unit B3.

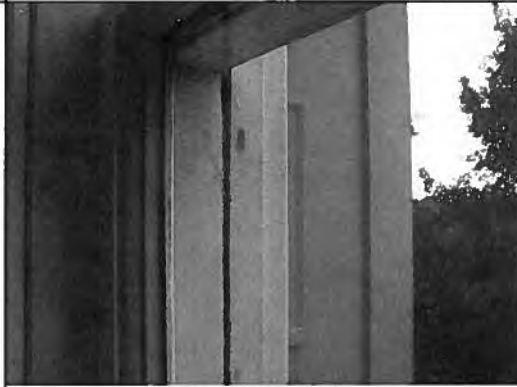
4. Rust on exterior jamb of Unit B3.

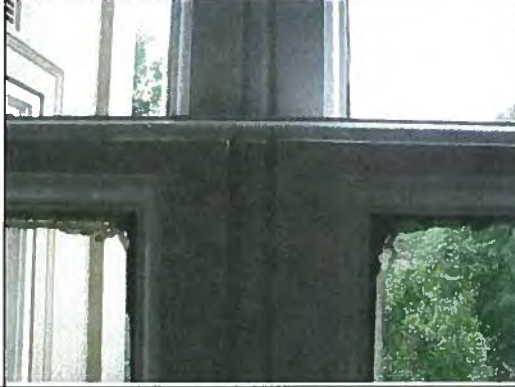
<p>6. Excessive exterior sealant on Unit C3.</p>

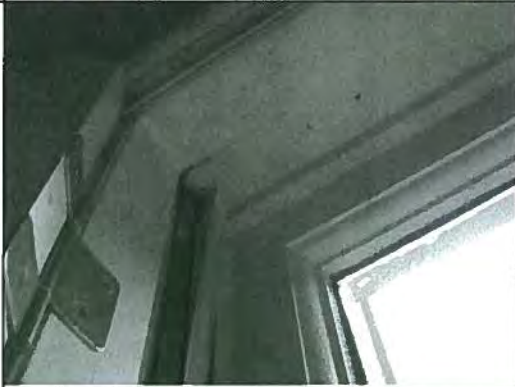
<p>7. Damaged slide on Unit C3.</p>

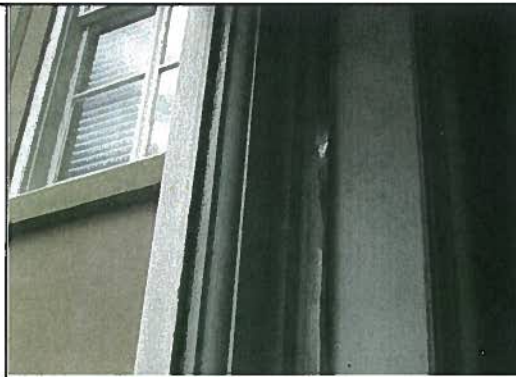
<p>9. Damaged slide on Unit D3.</p>

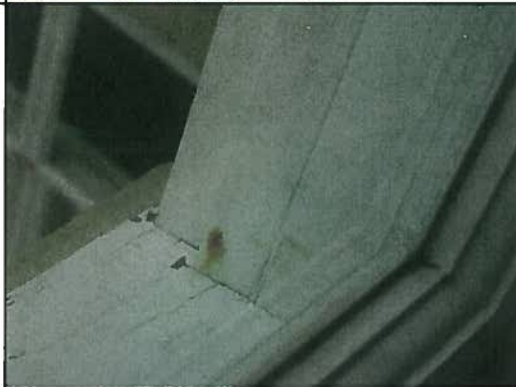
<p>10. Rust on exterior jamb of Unit D3.</p>

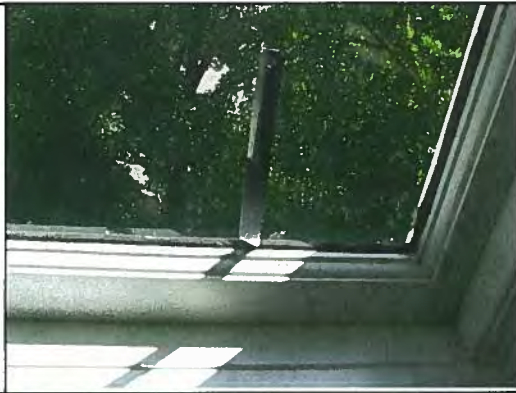
12. Loose seal at glass of Unit E3.

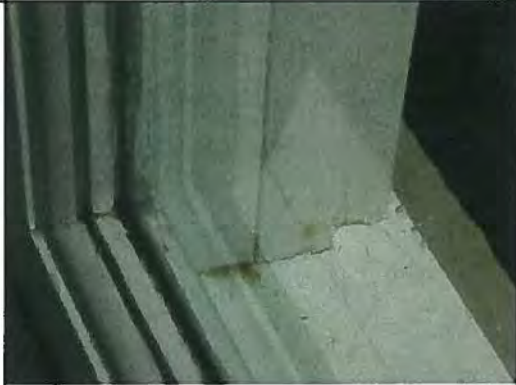
13. Rust on exterior jamb and sill of Unit E3.

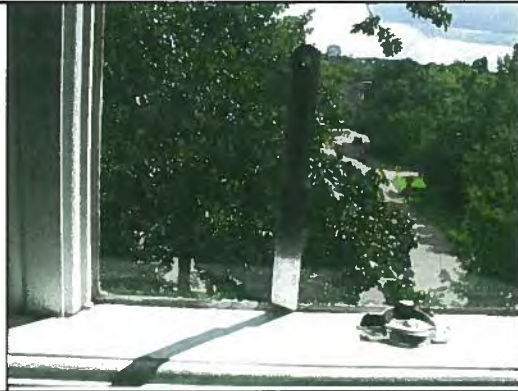
15. Loose seal at glass of Unit F3.

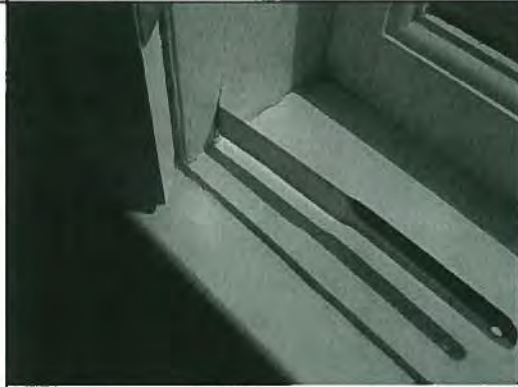
16. Split interior jamb of Unit F3.

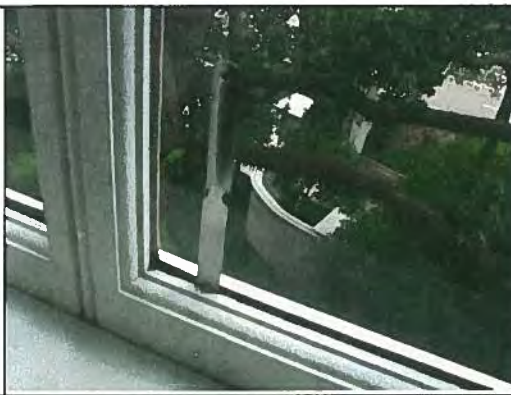
<p>18. Loose seal at glass of Unit G3.</p>

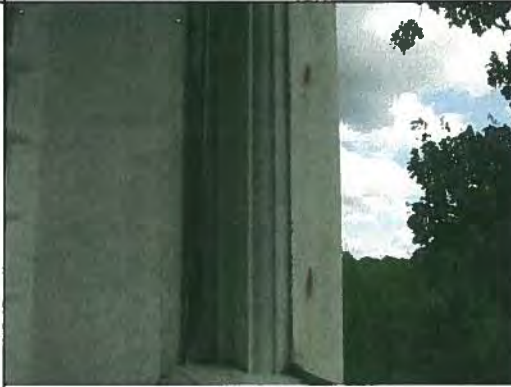
<p>19. Rust on exterior jamb of Unit G3.</p>

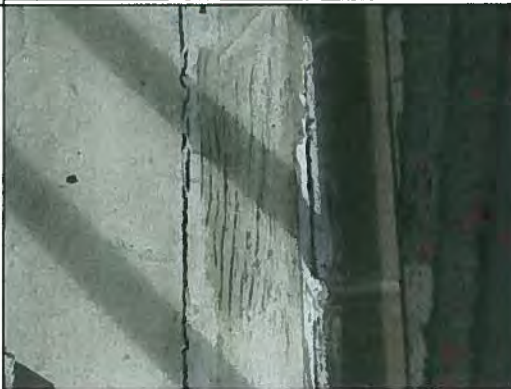
<p>21. Split exterior sill at Unit H.</p>

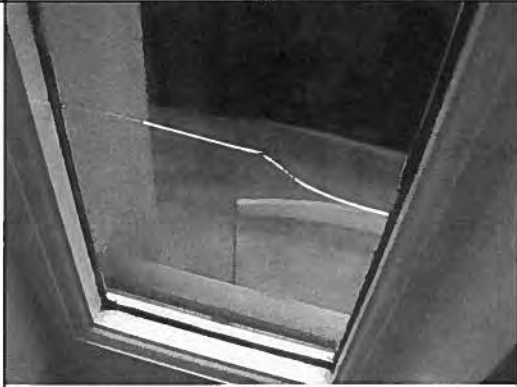
<p>23. Broken glass in Unit I.</p>

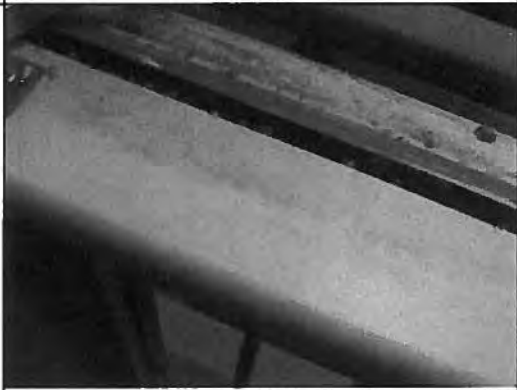
<p>24. Water stain on frame of Unit I.</p>

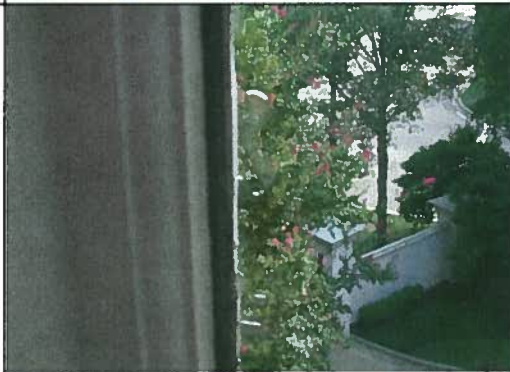
<p>26. Loose solar film on Unit J.</p>

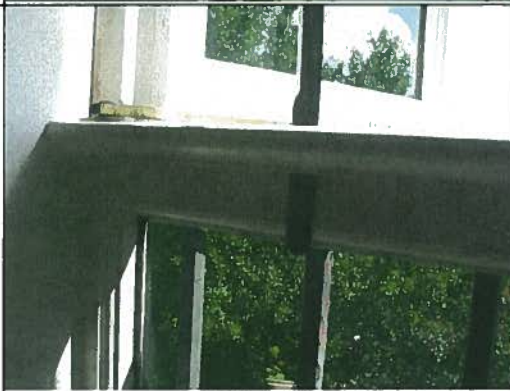
<p>27. Open joint from exterior to interior on Unit J.</p>

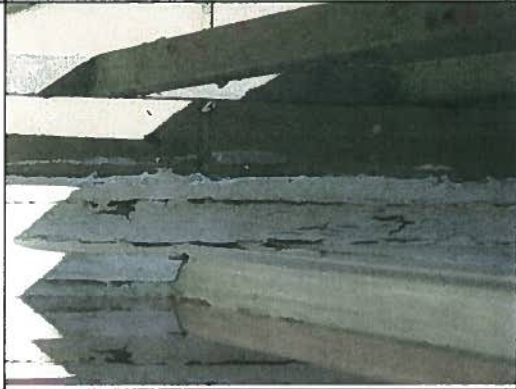
A close-up photograph of a window joint. A red arrow points to a dark, possibly metal or plastic, component that appears to be loose or misaligned within the window frame.
<p>29. Severely decayed wood at the exterior sill of Unit J.</p>

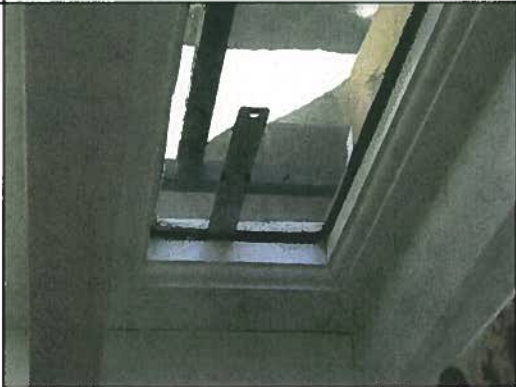
A close-up photograph of the seal between the glass and the window frame. The sealant is missing or has become loose, creating a gap between the glass and the frame.
<p>31. Loose seal at glass on Unit J.</p>

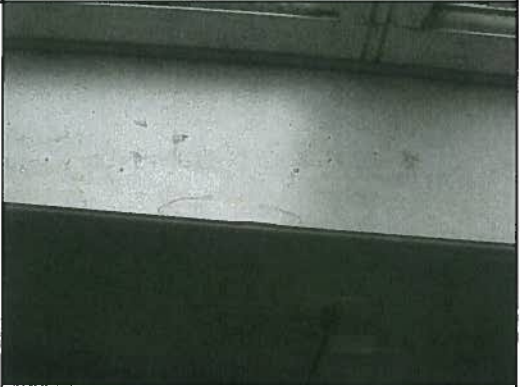
A photograph showing a window with white horizontal shutters. A lamp with a beige shade is positioned in front of the window. The room is dimly lit, with light coming from the window.
<p>36. Water stain on sill of Unit B2.</p>

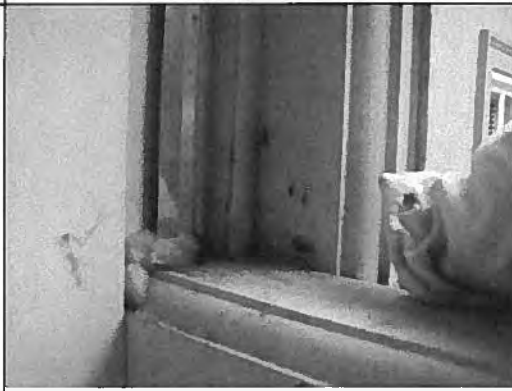
<p>39. Water stain with mildew on frame and jamb of Unit C2.</p>

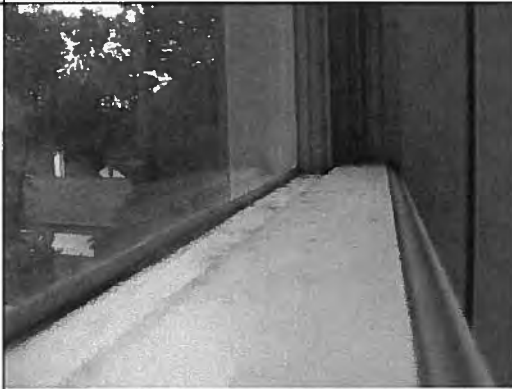
<p>40. Water stain on frame of Unit C2.</p>

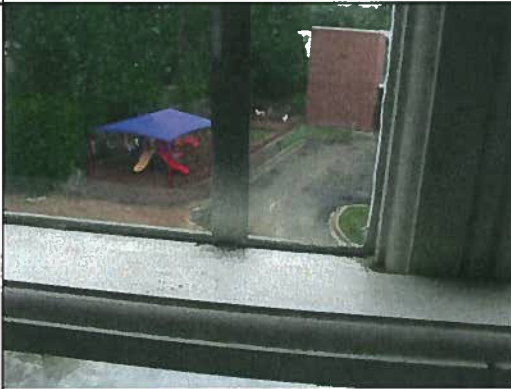
<p>43. Loose seal at glass on Unit D2.</p>

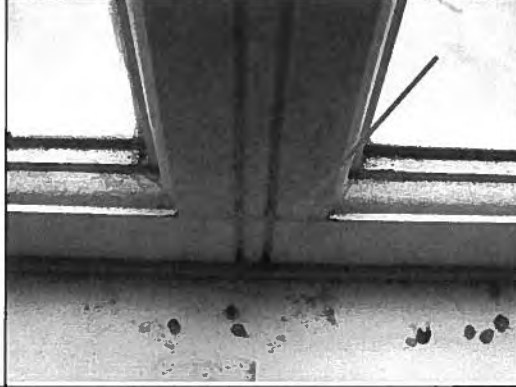
<p>44. Loose joint in frame of Unit D2.</p>

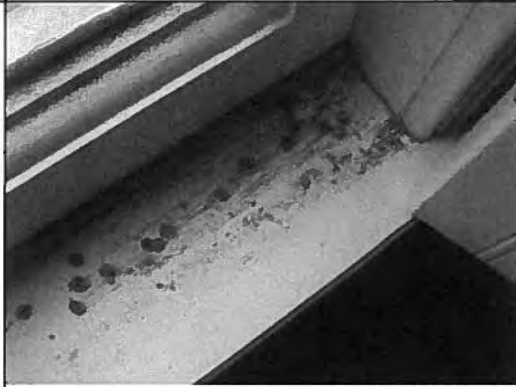
<p>45. Damaged finish on sill of Unit D2.</p>

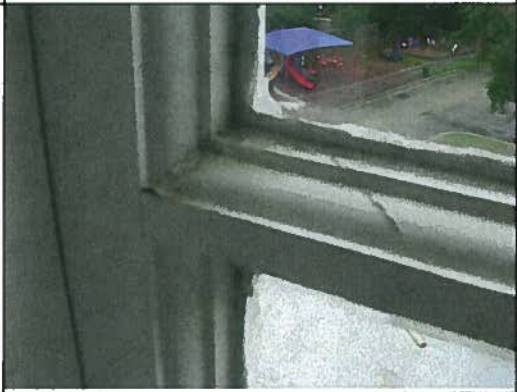
49. Water stain on frame of Unit E2.

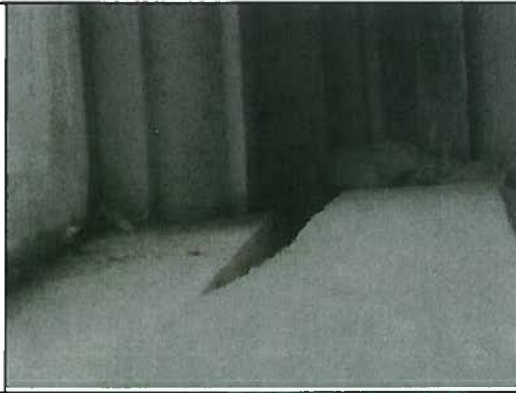
<p>50. Damaged frame of Unit E2.</p>

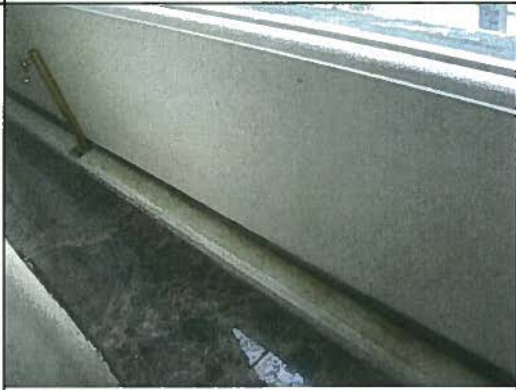
A photograph showing a view from a window in Unit F. The window is large and multi-paned, looking out onto a balcony with a metal railing. There are trees and a building visible in the background. The interior of the unit shows a white chair and a potted plant.
<p>52. Water stain on sill (threshold) of Unit F.</p>

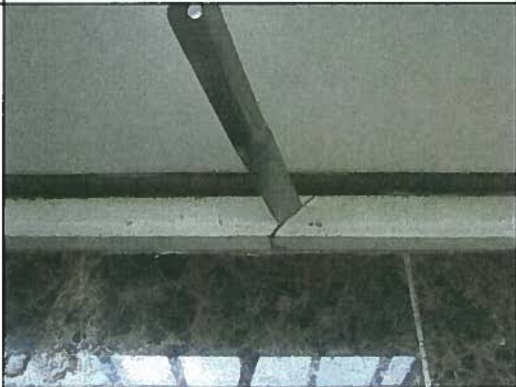
A close-up photograph of a window sill (threshold). The sill is made of a light-colored material, possibly concrete or stone, and shows a dark, irregular water stain. A wooden tool is visible in the background, leaning against the wall.
<p>53. Loose joint in sill of Unit F.</p>

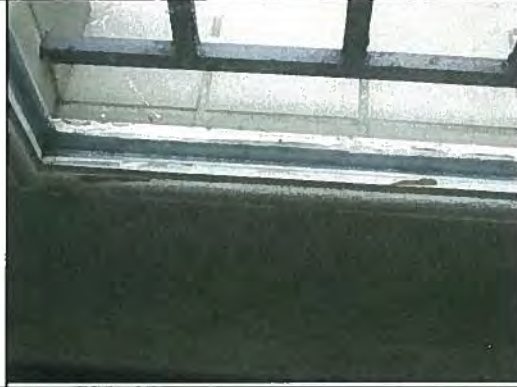
<p>54. Damaged finish on frame of Unit F.</p>

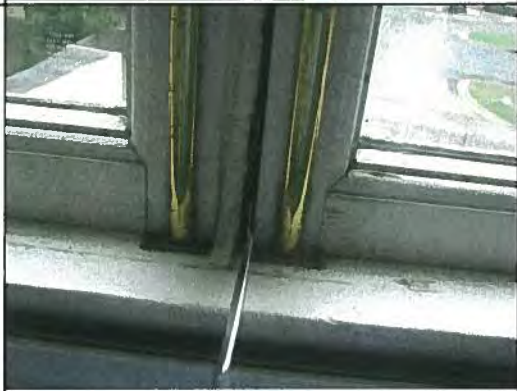
<p>56. Open joint at meeting casement leaves on Unit G.</p>

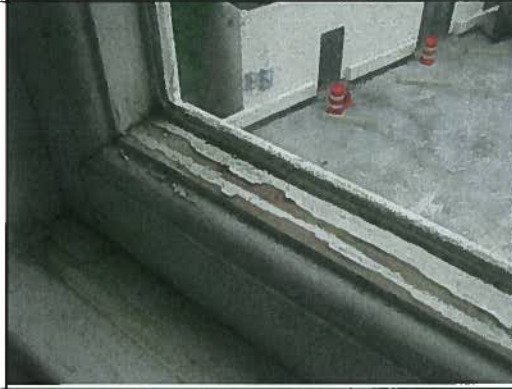
<p>58. Damaged finish on frame and sill of Unit G.</p>

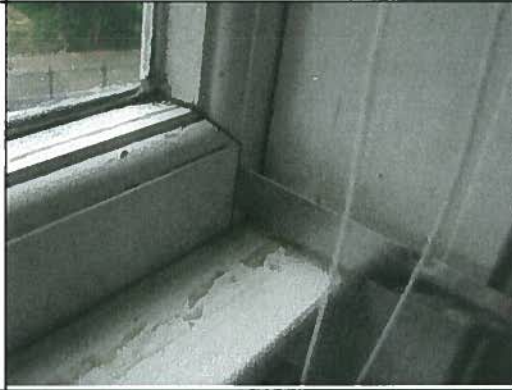
<p>59. Loose joint in frame of Unit G.</p>

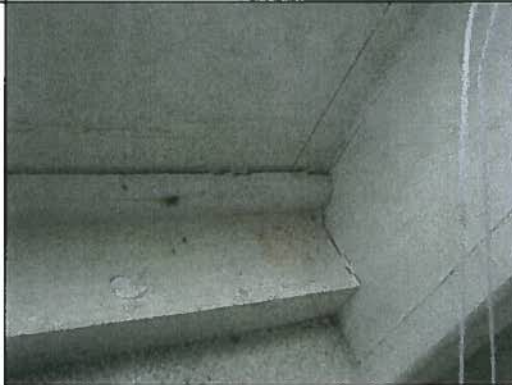
<p>60. Water stain on frame and sill of Unit G.</p>

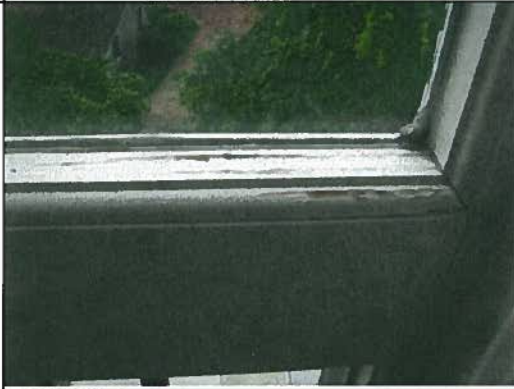
<p>62. Damaged finish on frame of Unit H.</p>

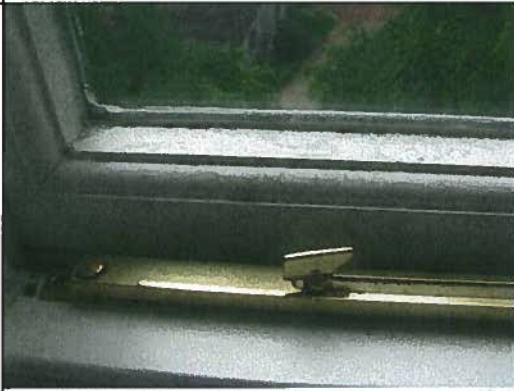
<p>63. Water stain on casement frame of Unit H.</p>

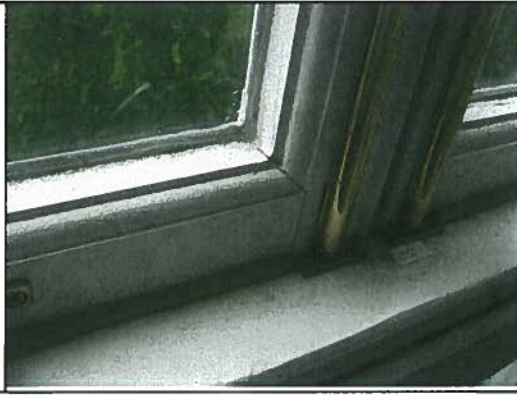
64. Loose joint in casement frame of
Unit H.

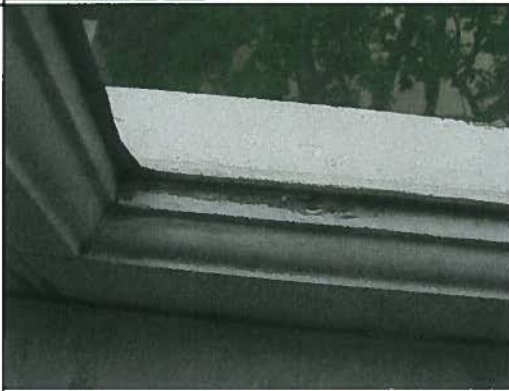
<p>67. Damaged finish on Unit A3.</p>

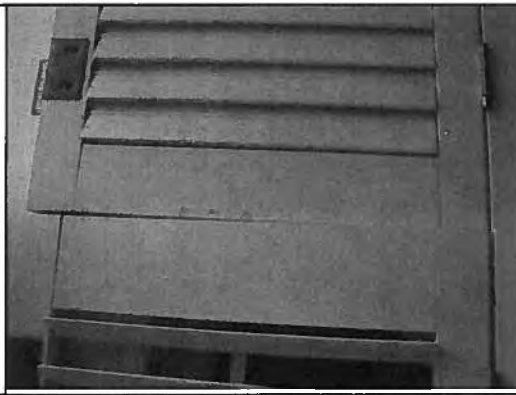
<p>68. Water stain on inside face of shutters on Unit A3.</p>

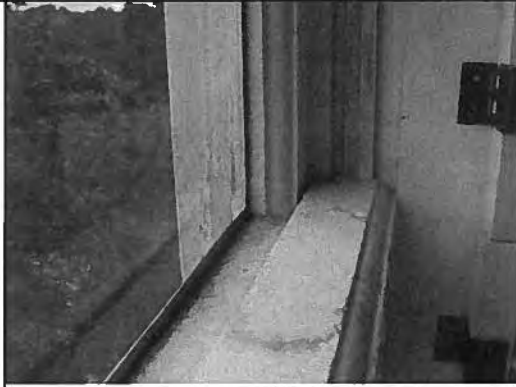
<p>69. Water stain on frame of Unit A3.</p>

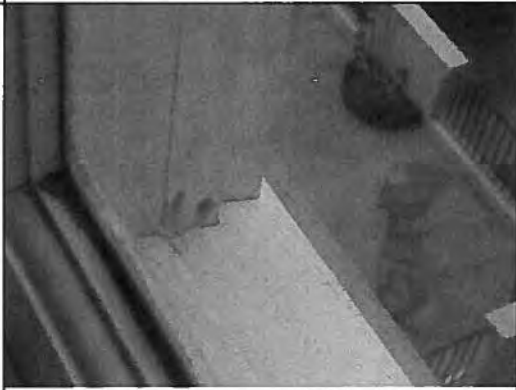
<p>70. Rust on exterior jamb of Unit A3.</p>

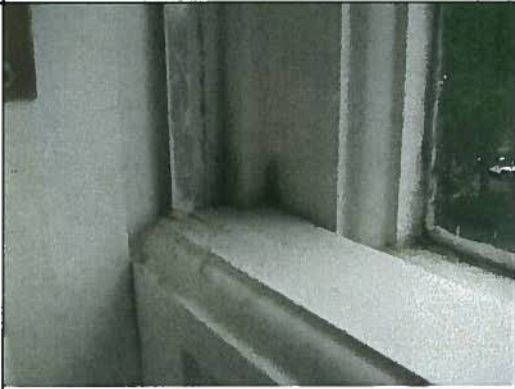
<p>72. Water stain on frame and jamb with mildew on Unit B3.</p>

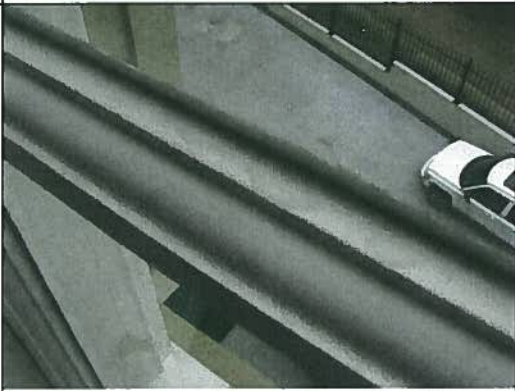
<p>73. Water stain on frame of Unit B3.</p>

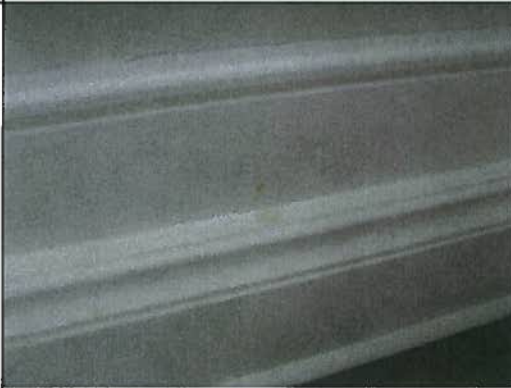
<p>80. Water stain on base board from Unit E3 above.</p>

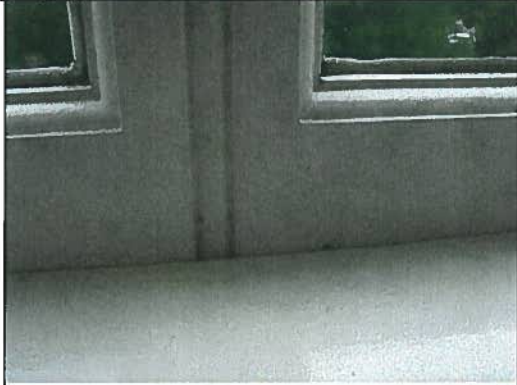
82. Water stain on frame of Unit E3.

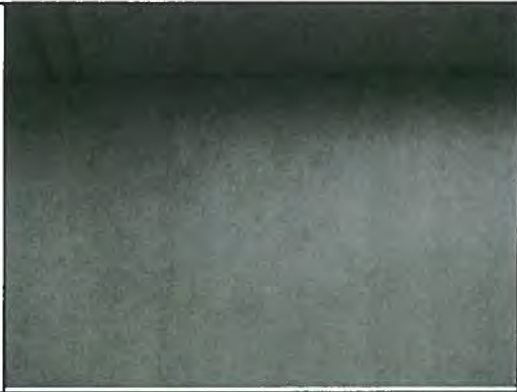
<p>84. Water stain on sill of Unit F3.</p>

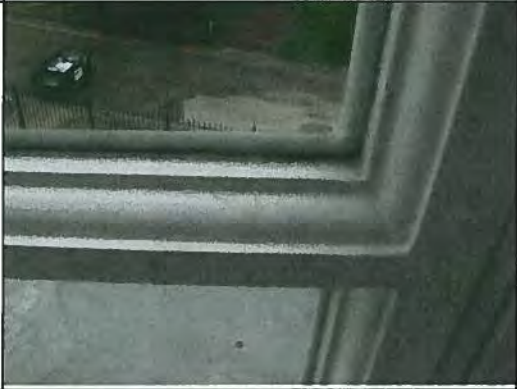
<p>85. Water stain on frame of Unit F3.</p>

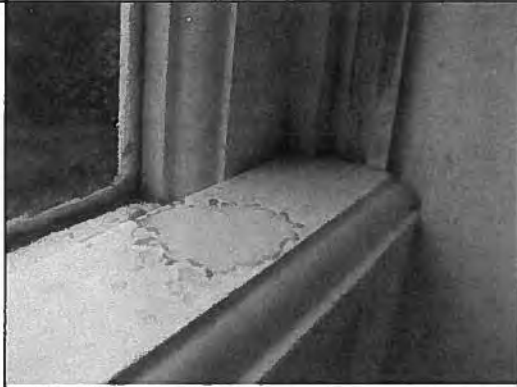
<p>88. Water stain on frame of Unit G3.</p>

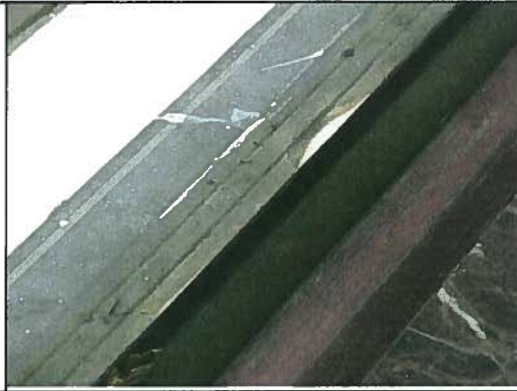
<p>91. Damaged finish on sill at threshold of Unit H.</p>

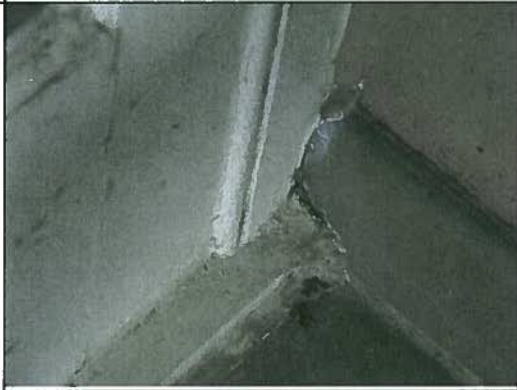
<p>93. Excessive sealant, failing, on Unit I.</p>

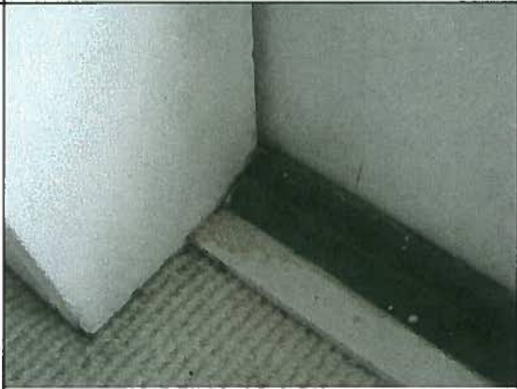
<p>94. Water stain on sill (threshold) of Unit I.</p>

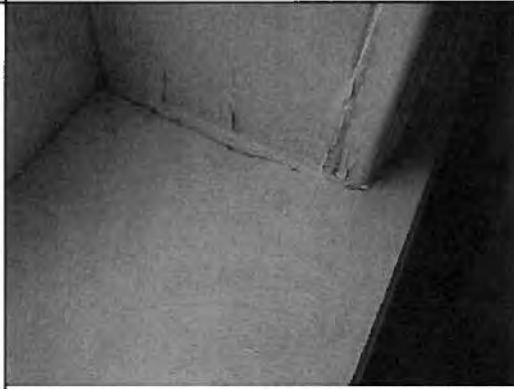
<p>97. Damaged finish on jamb of Unit A2.</p>

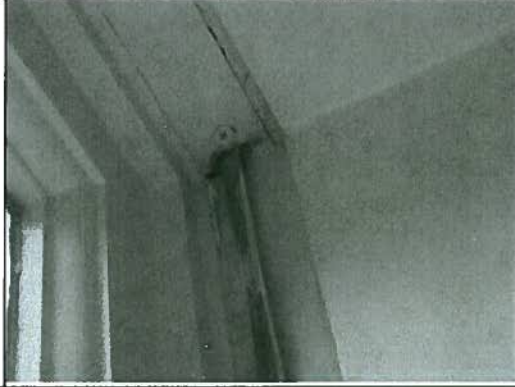
<p>99. Rust on slide cover with damaged slide of Unit A2.</p>

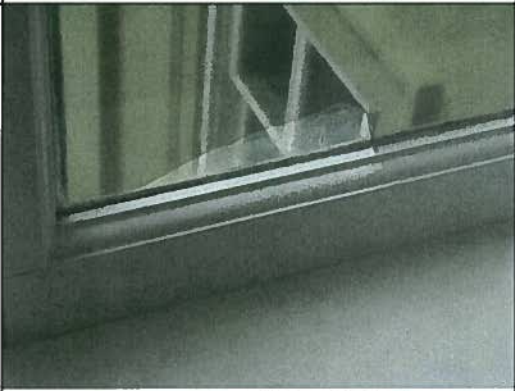
<p>101. Loose solar film on Unit B2.</p>

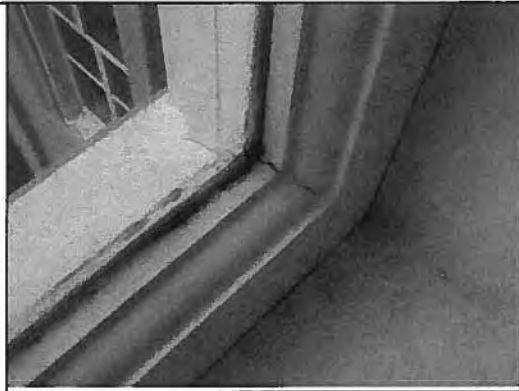
102. Loose joint in Unit B2.

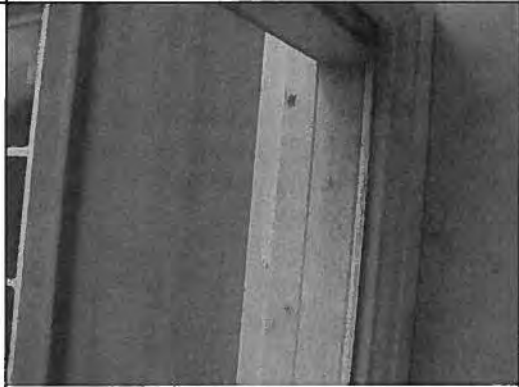
103. Rust on the exterior jamb of Unit B2.

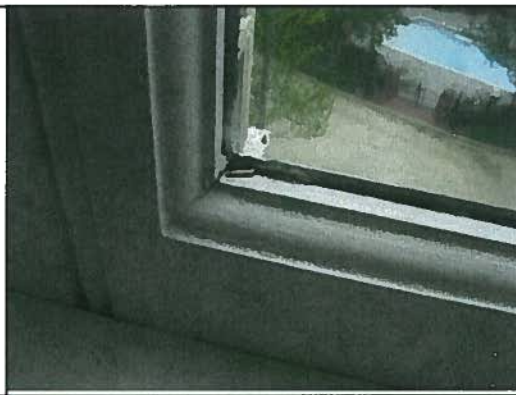
<p>105. Damaged finish on frame of Unit C2.</p>

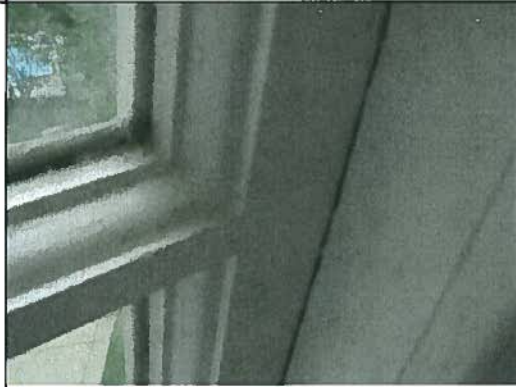
<p>106. Water stain on frame of Unit C2.</p>

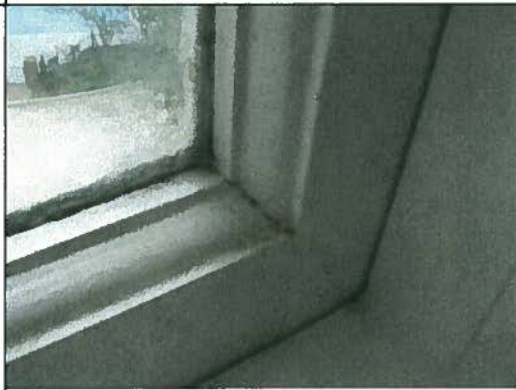
<p>107. Water stain on frame with loose joint on Unit C2.</p>

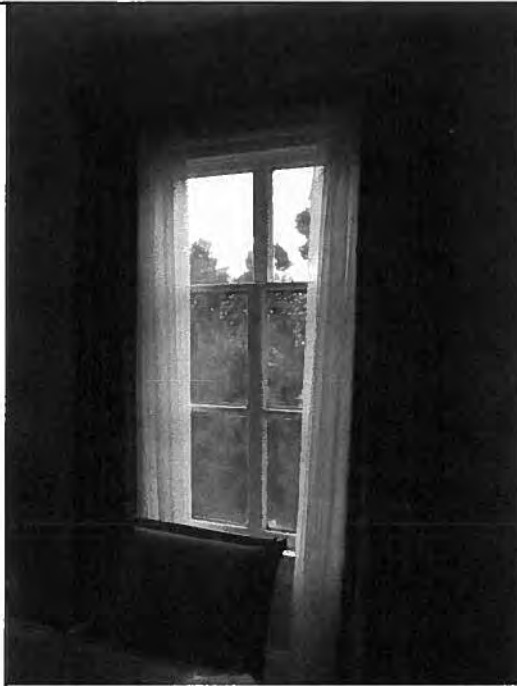
110. Loose joint in frame of Unit D2.

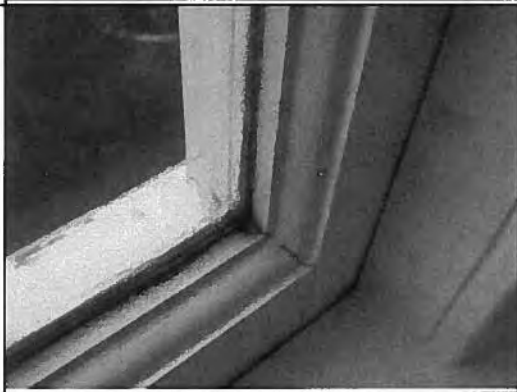
111. Loose solar film on Unit D2.

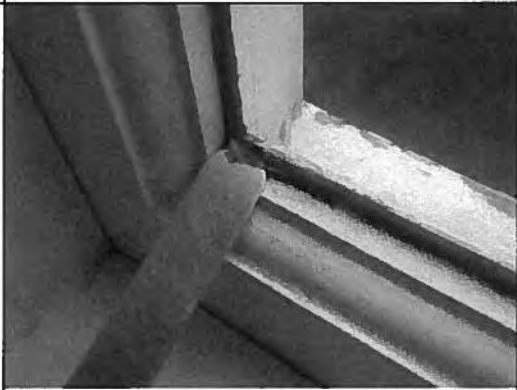
<p>112. Loose seal at glass of Unit D2.</p>

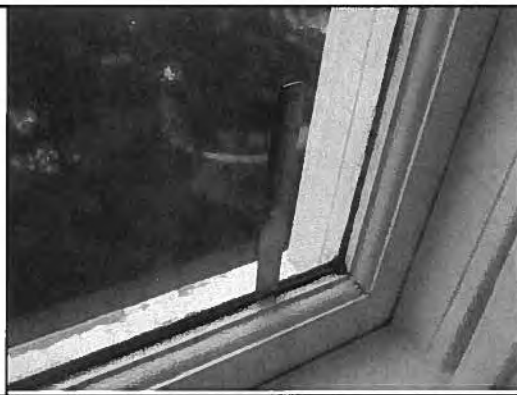
<p>113. Damaged slide on Unit D2.</p>

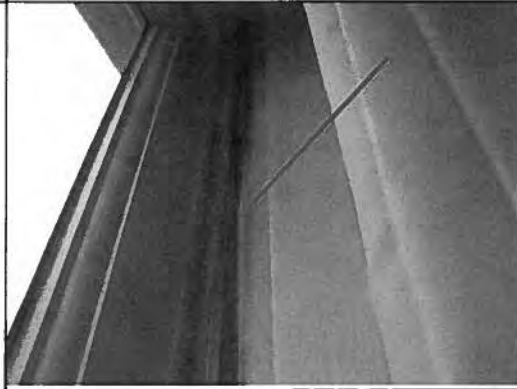
<p>114. Water stain and damaged finish on frame of Unit D2.</p>

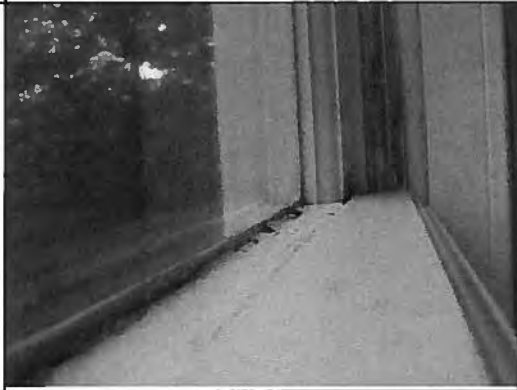
<p>115. Rust on exterior jamb of Unit D2.</p>

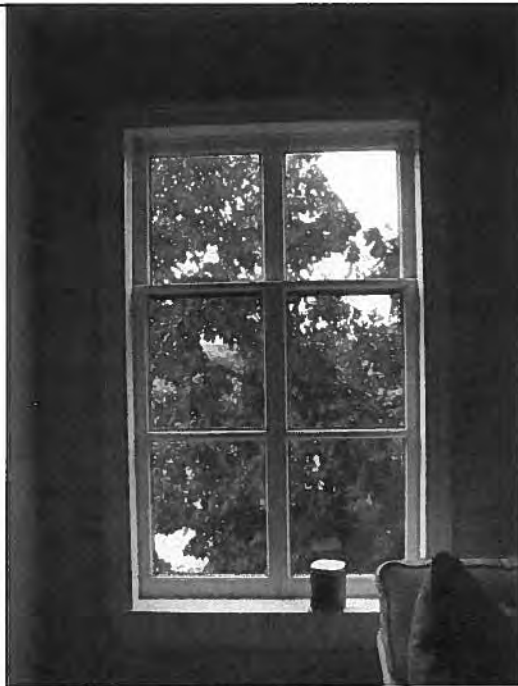
117. Water stain on frame of Unit E2.

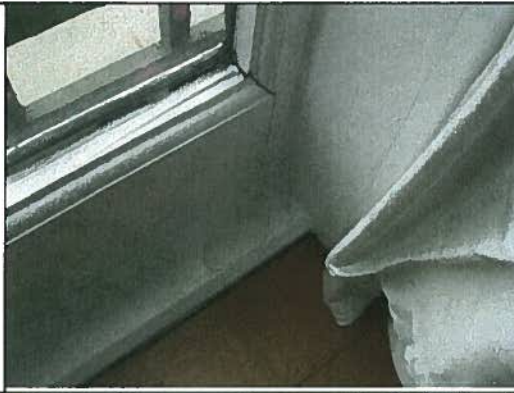
<p>123. Water stain on sill at loose joint on Unit F.</p>

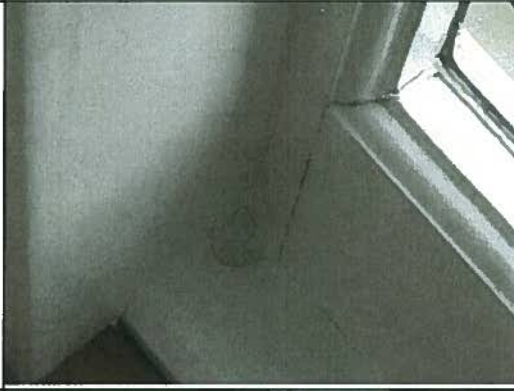
<p>124. Decayed exterior wood of Unit F.</p>

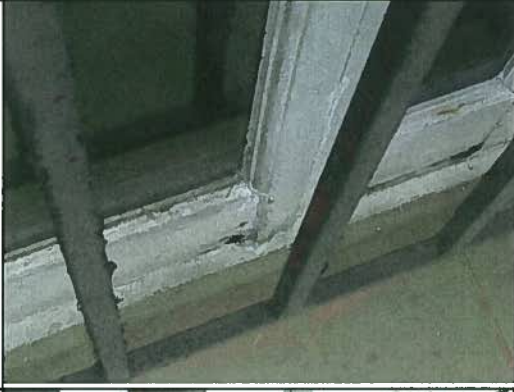
<p>125. Open joint from poor design at Unit F.</p>

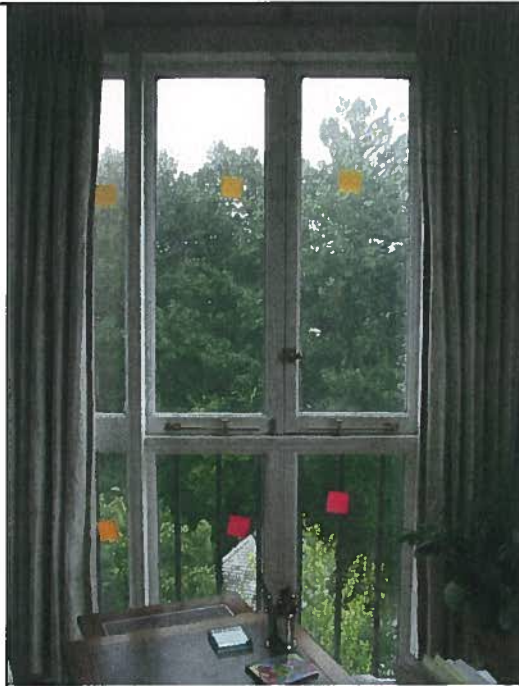
127. Water stain on sill with a loose joint at Unit G.

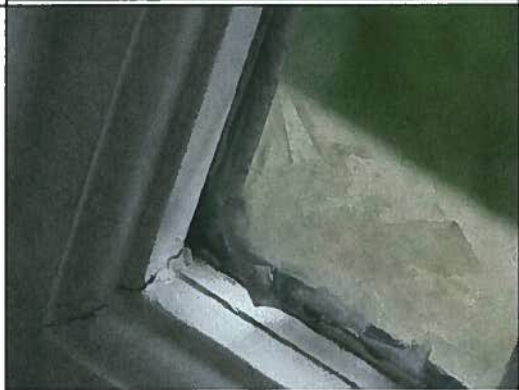
<p>129. Loose seal at glass on Unit G.</p>

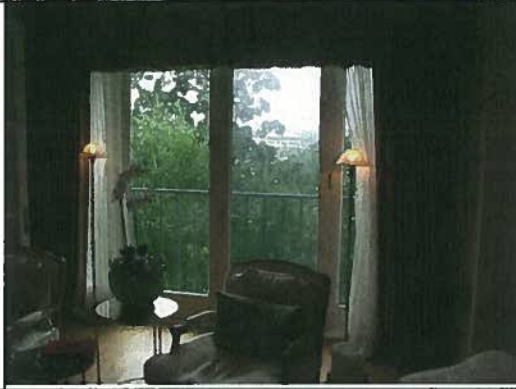
<p>131. Water stain on sill at threshold of Unit H.</p>

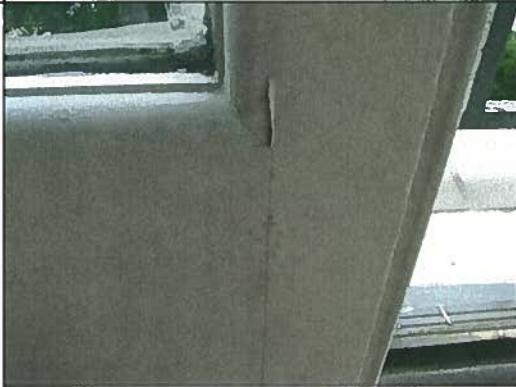
133. Water stain at threshold from under the door on Unit H.

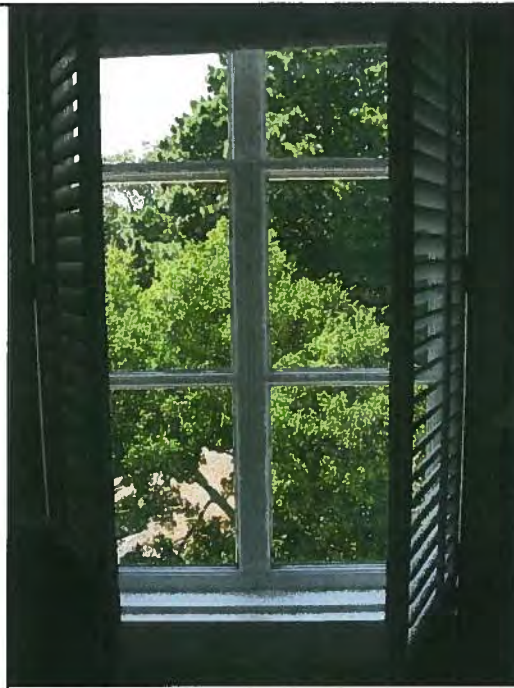
A photograph showing a white-framed window with four panes, viewed through dark green shutters. The window is set in a light-colored wall. The view outside shows lush green trees and a portion of a brown roof.
<p>2. Damaged finish, loose joint and loose seal at glass of Unit A3.</p>

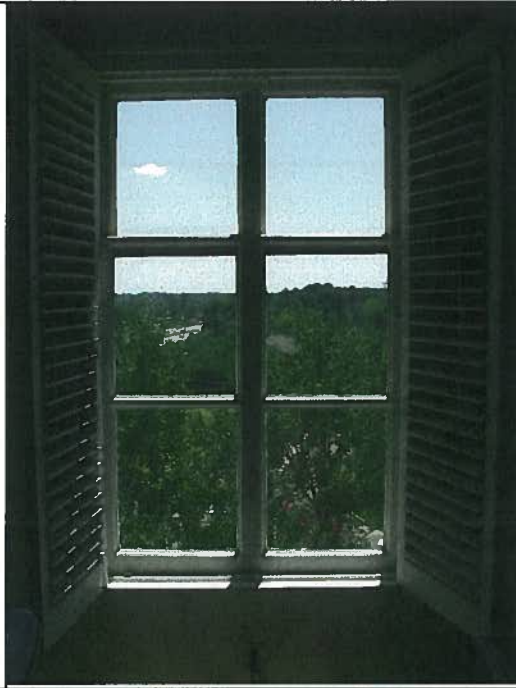
<p>5. Loose seal at glass of Unit B3.</p>

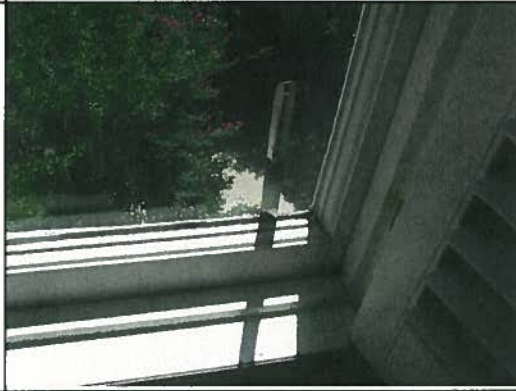
<p>6. Loose seal at glass and damaged finish of Unit B3.</p>

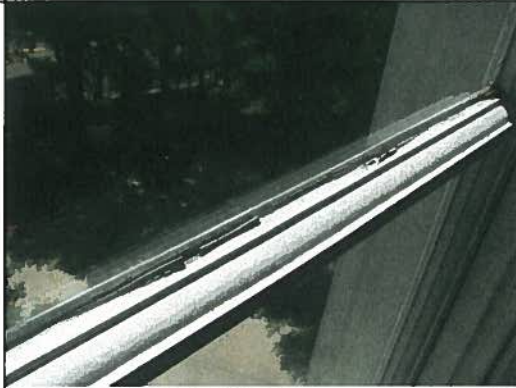
<p>7. Rust on exterior jamb of Unit B3.</p>
