DOCUMENT 009113 - ADDENDA

- A. Addendum No. 002.

- A. Project Name: The Barrington Exterior Refinishing
- B. Owner: The Barrington Condominium Association, Inc.
- C. Architect: Purser & Company, PA.
- D. Architect Project Number: 20230809001.
- E. Date of Addendum: 6/18/24.

Between August 12 and September 2, 2020 Dennis Walters, CSI, CDT, CCCA, Principal, Central Building Consultants, LLC visited the building and through Ms. Beth Hartness' introductions to the unit owners, observed the existing interior conditions of the windows and terrace enclosures of each of the four units on floors 3 through 9.

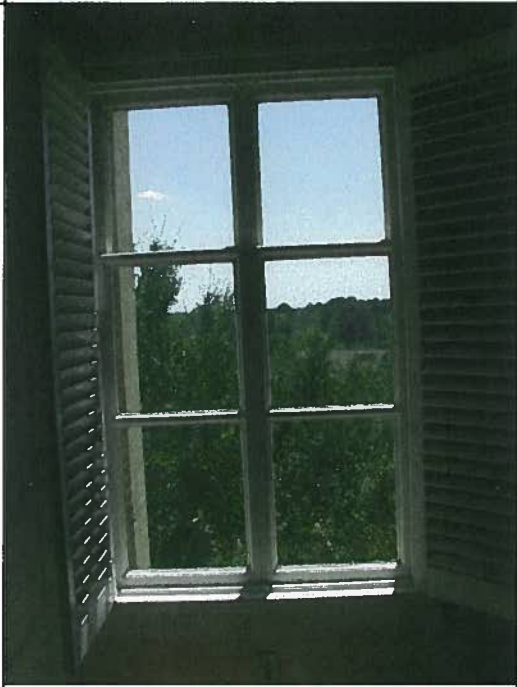
<p>9. Loose joint of Unit C3.</p>

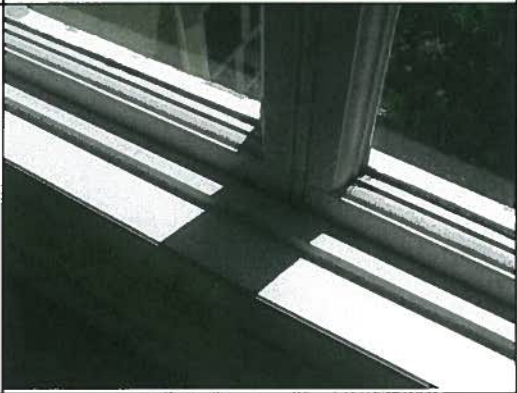
10. Loose seal at glass of Unit C3.

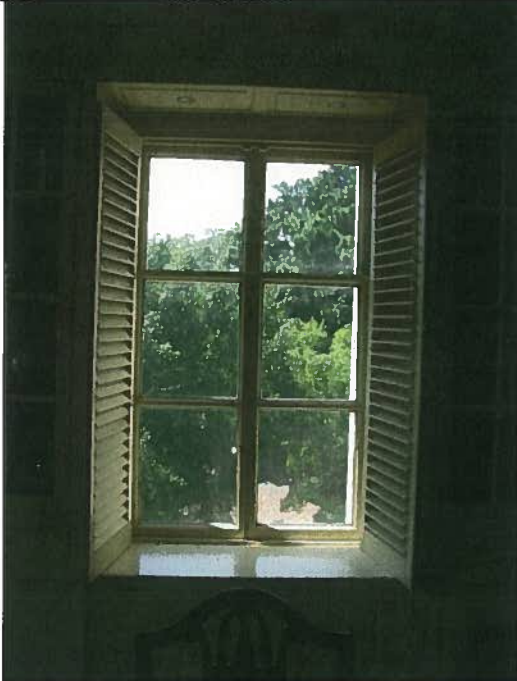
12. Water stain with mildew on frame and jamb of Unit D3.

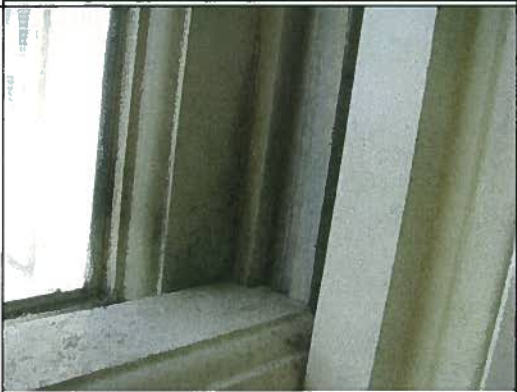
13. Water stain on frame of Unit D3.

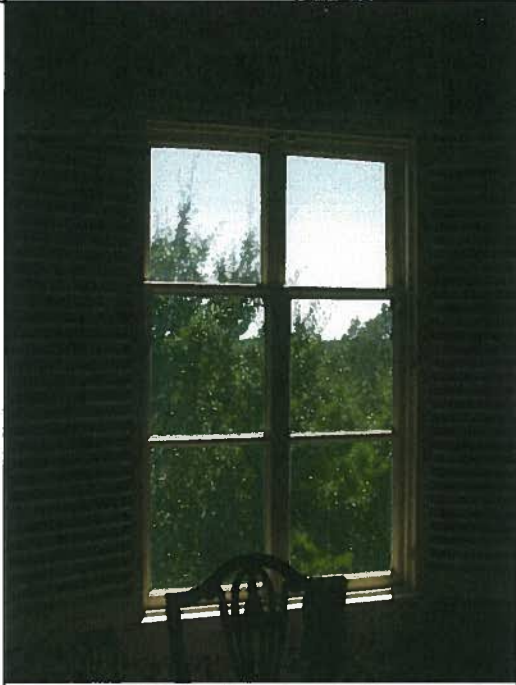
15. Loose seal at glass of Unit E3.

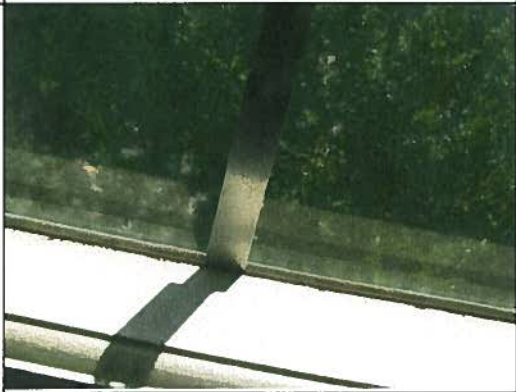
<p>16. Damaged finish on frame of Unit E3.</p>

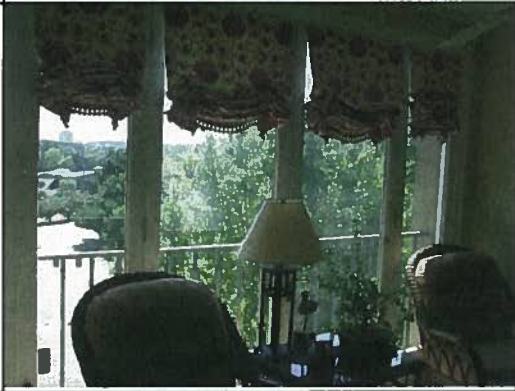
<p>21. Decayed wood at Unit H.</p>

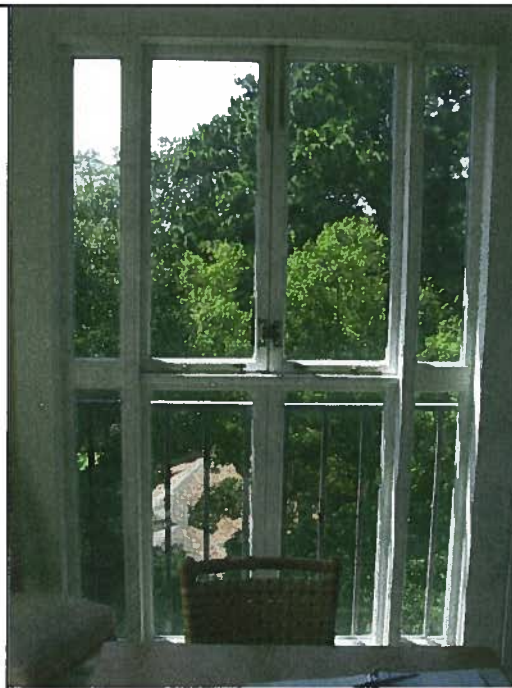
<p>23. Owner imposed inoperable casements of Unit I.</p>

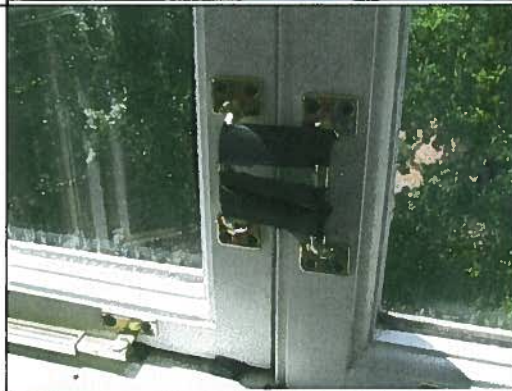
<p>24. Loose joint on Unit I.</p>

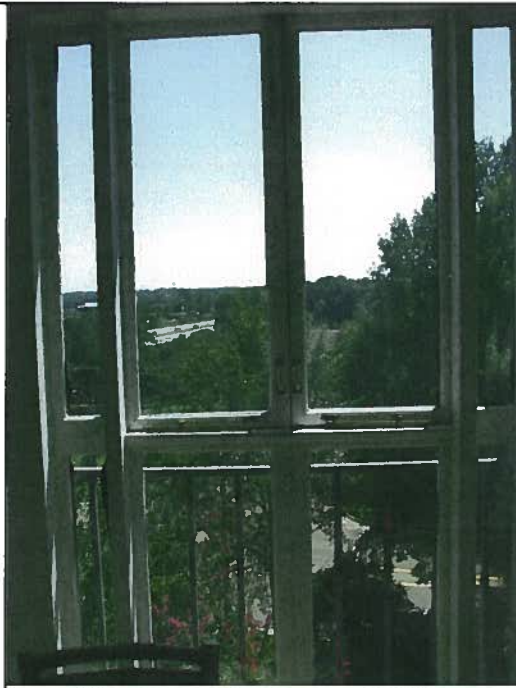
<p>26. Failing insulated glass gasket in Unit J.</p>

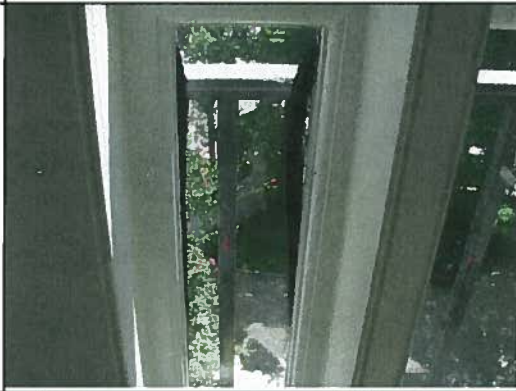
<p>27. Open joint on Unit J.</p>

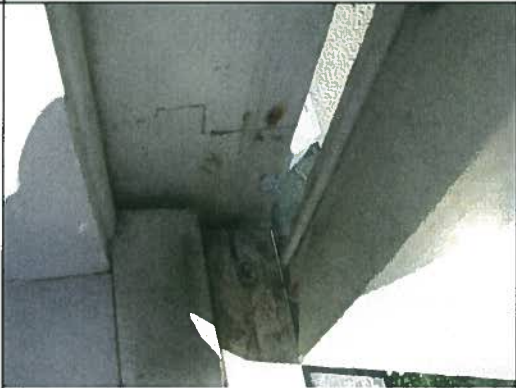
28. Severely decayed exterior wood sill of Unit J.

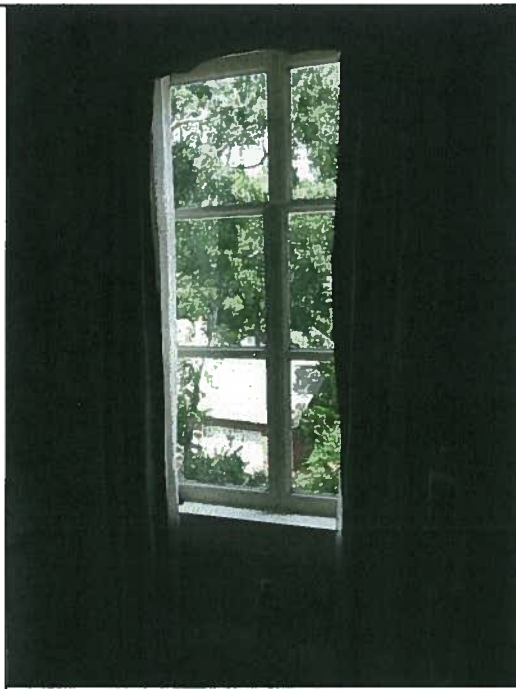
<p>30. Water stain on frame of Unit A2.</p>

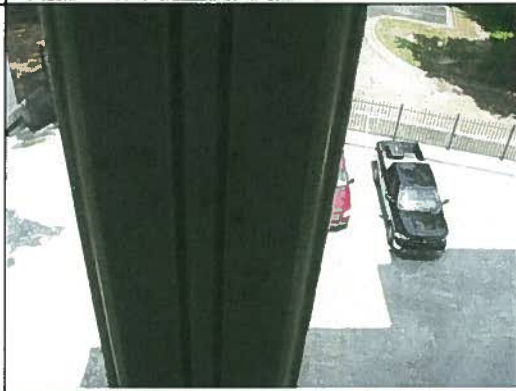
<p>31. Loose seal at glass and damaged finish on Unit A2.</p>

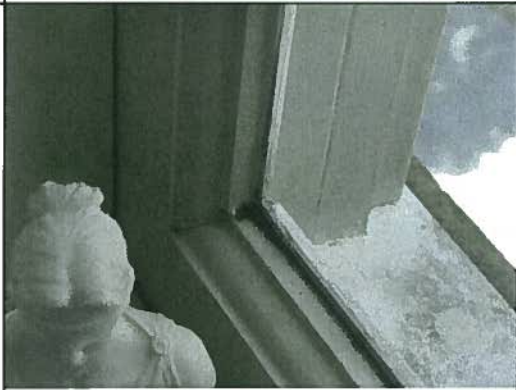
<p>32. Water stain on frame of Unit A2.</p>

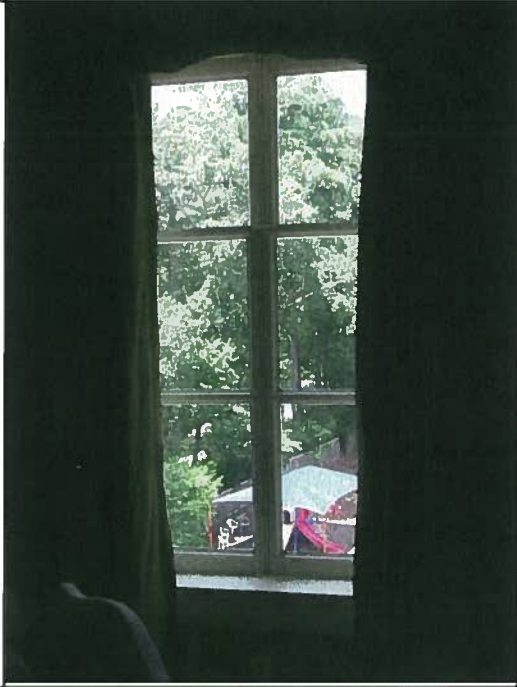
<p>34. Water stain and damaged finish on Unit B2.</p>

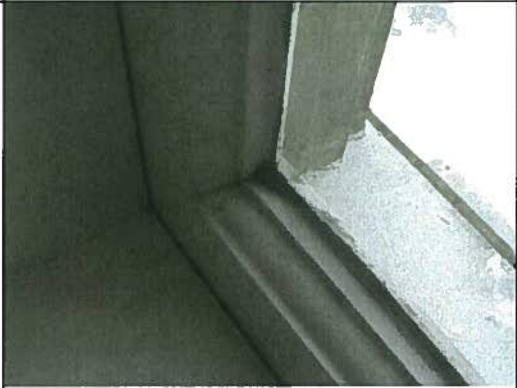
<p>35. Water stain on frame of Unit B2.</p>

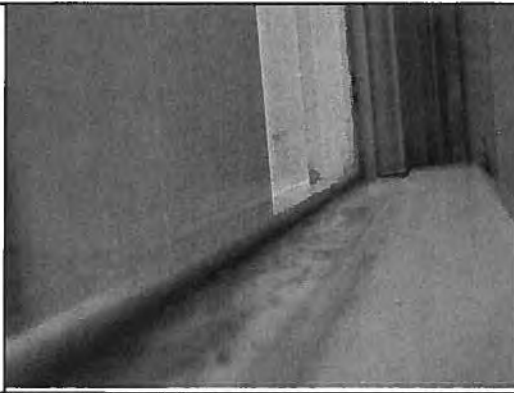
<p>36. Damaged slide on Unit B2.</p>

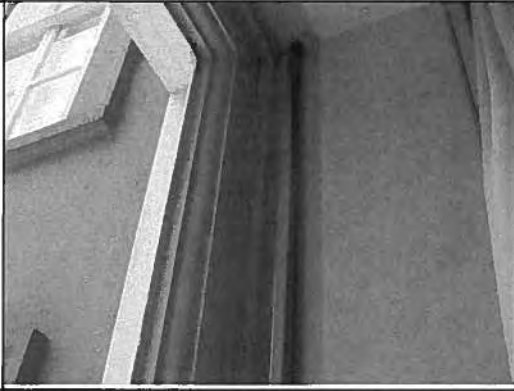
<p>37. Water stain on slide cover of Unit B2.</p>

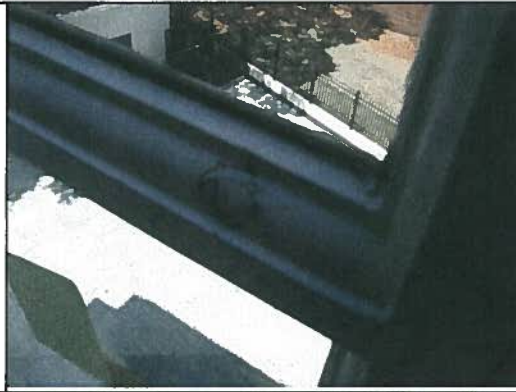
<p>41. Water stain on jamb of Unit D2.</p>

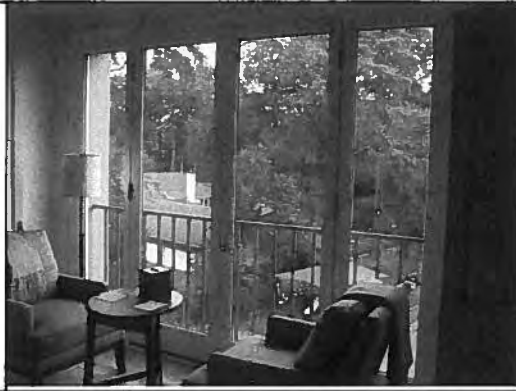
44. Loose joint with water stain on sill
of Unit F.

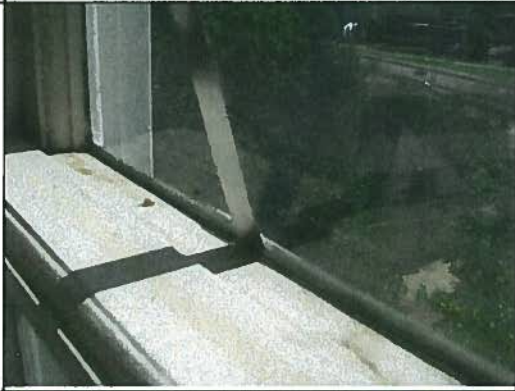
<p>47. Loose joint in frame of Unit A3.</p>

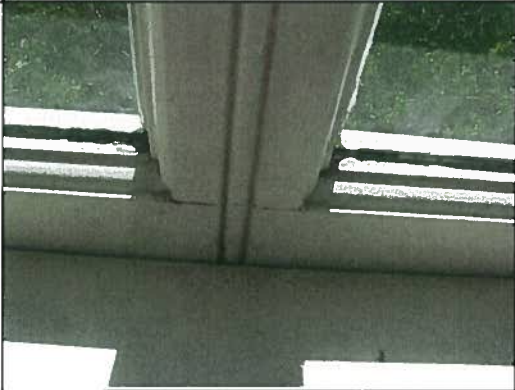
<p>48. Water stains on jamb and sill of Unit A3.</p>

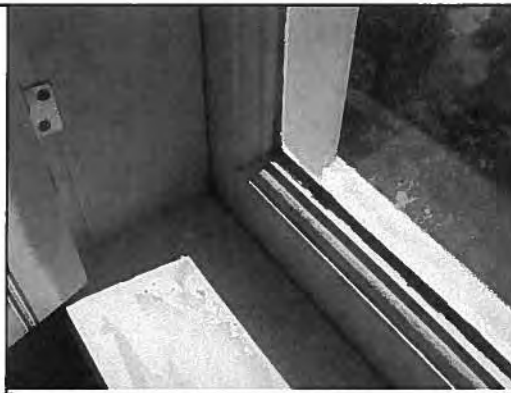
<p>49. Damaged finish on frame of Unit A3.</p>

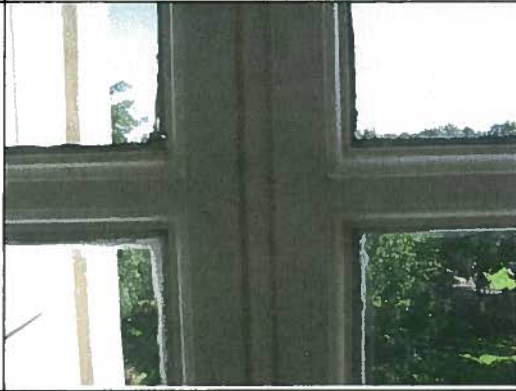
<p>53. Water stain with mildew on jamb of Unit C3.</p>

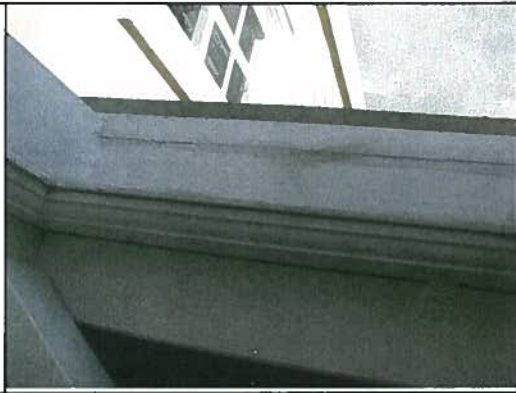
54. Split exterior sill of Unit C3.

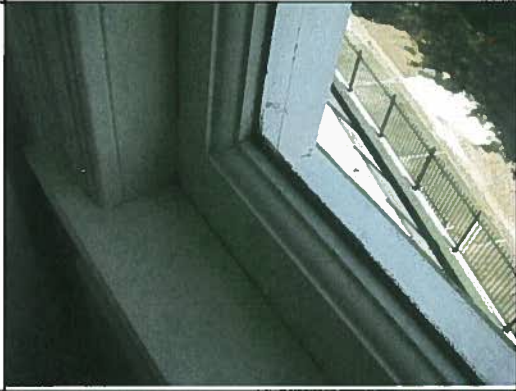
A photograph showing an interior view of a window in Unit E3. The window is dark-framed and looks out onto a bright, green outdoor area. The room is dimly lit.
<p>57. Loose joint in frame of Unit E3.</p>

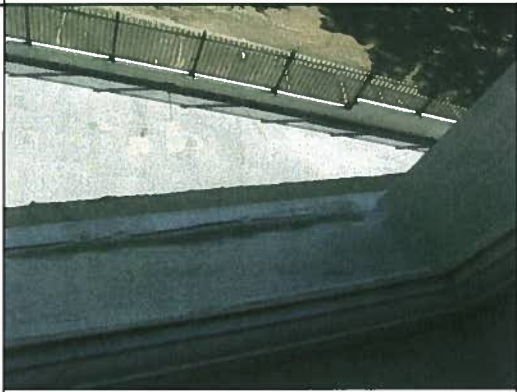
61. Split exterior sill of Unit F3.

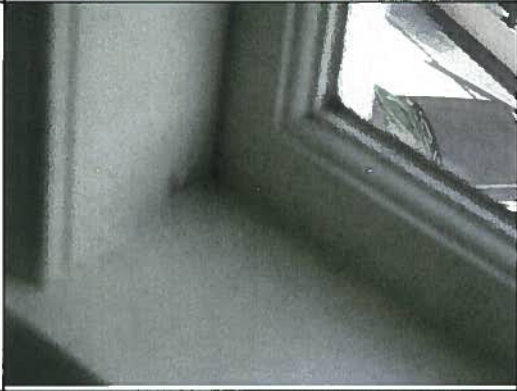
<p>63. Damaged finish on sill and jamb on Unit G3.</p>

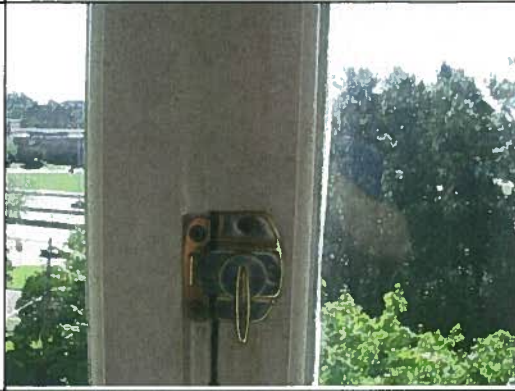
<p>66. Tape applied to joint at meeting of casement leaves of Unit H.</p>

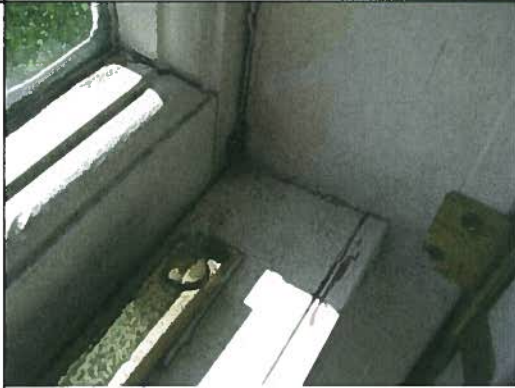
<p>67. Water stain on jamb, loose joint and damaged finish on Unit H.</p>

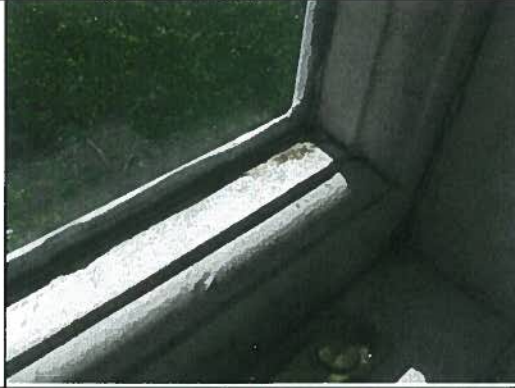
<p>68. Water stain on frame of Unit H.</p>

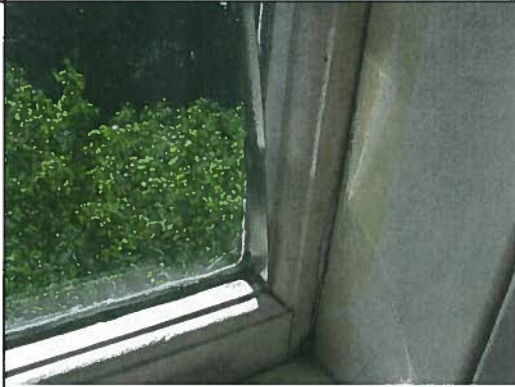
<p>69. Loose joint of frame of Unit H.</p>

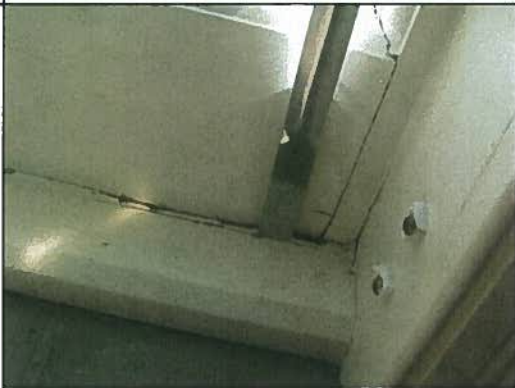
<p>70. Decayed wood at sill of Unit H.</p>

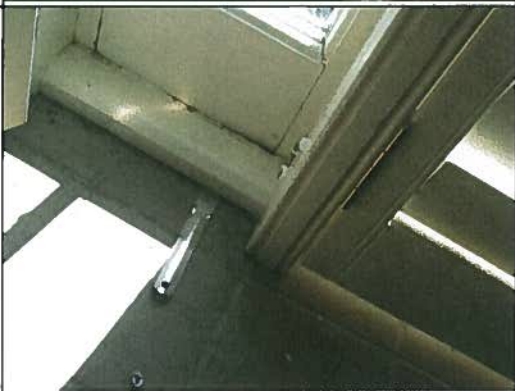
<p>71. Poor seal at sill/floor of Unit H.</p>

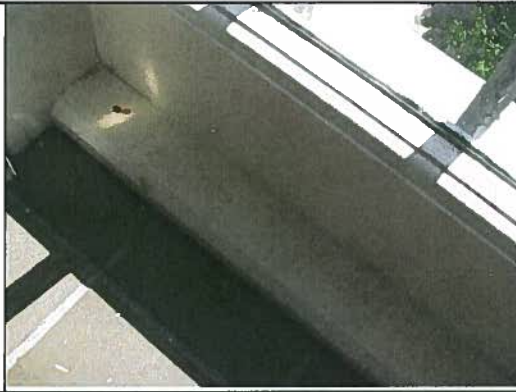
<p>72. Water stain on sill of Unit H.</p>

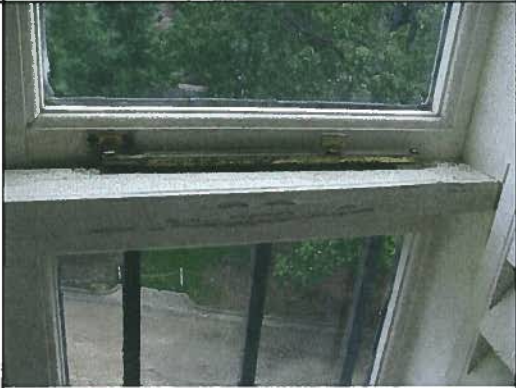
<p>74. Damaged finish on casement sill of Unit I.</p>

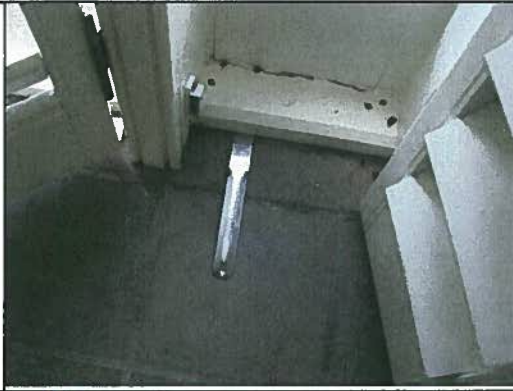
<p>75. Poor seal at sill/floor of Unit I.</p>

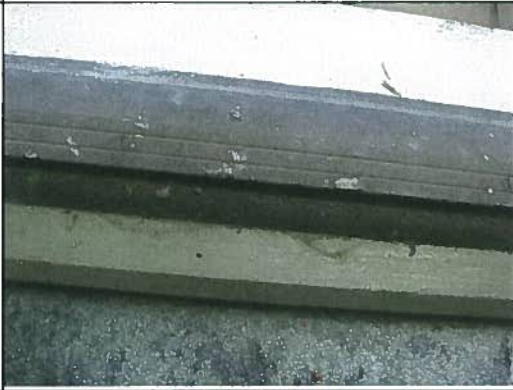
<p>77. Water stain on sill from under metal threshold of Unit J.</p>

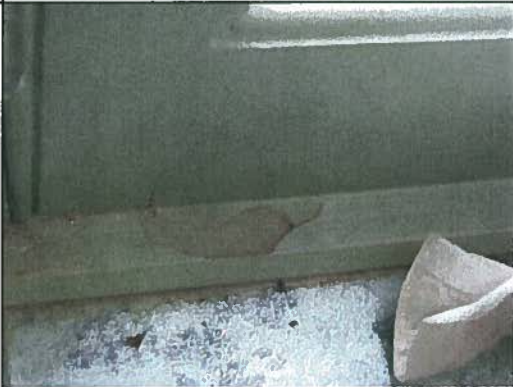
<p>78. Water stain on frame and sill of Unit J.</p>

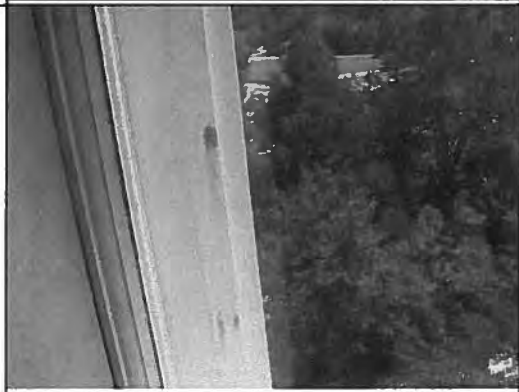
80. Rust on exterior jamb of Unit A2.

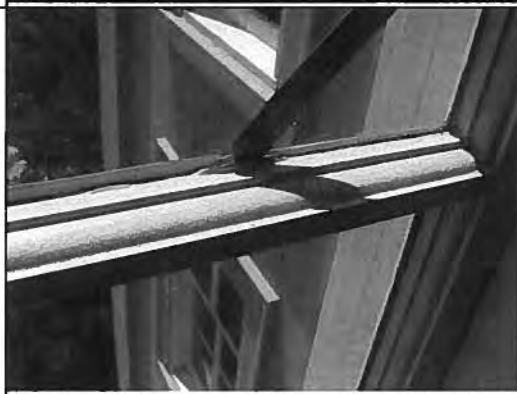
82. Loose seal at glass of Unit B2.

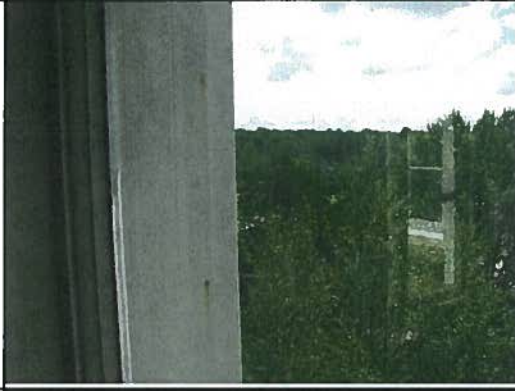
<p>86. Rust on exterior jamb of Unit D2.</p>

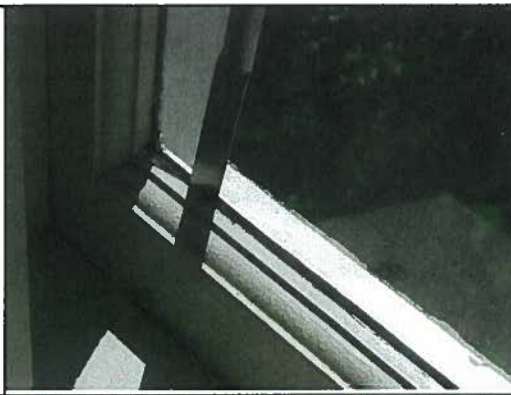
<p>88. Loose seal at glass of Unit E2.</p>

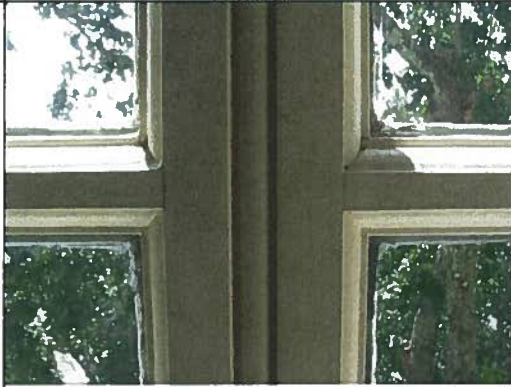
<p>89. Loose joint on Unit E2.</p>

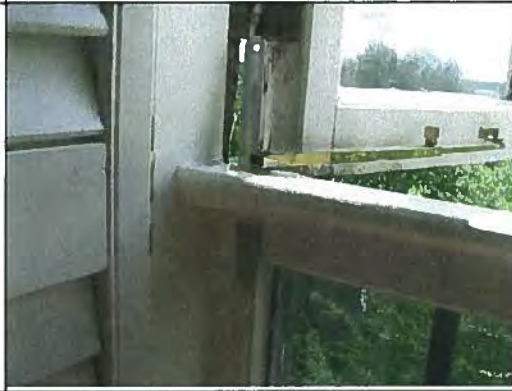
<p>92. Open joint below casement leaf to interior below on Unit F.</p>

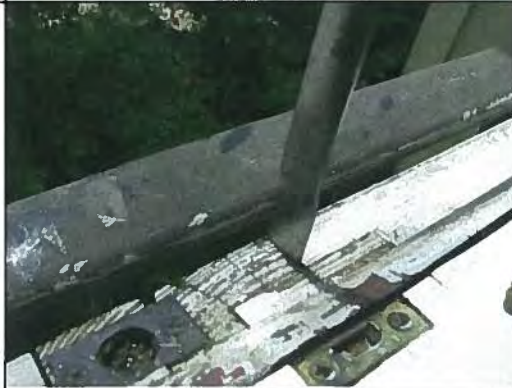
<p>93. Loose joint in lower frame of Unit F.</p>

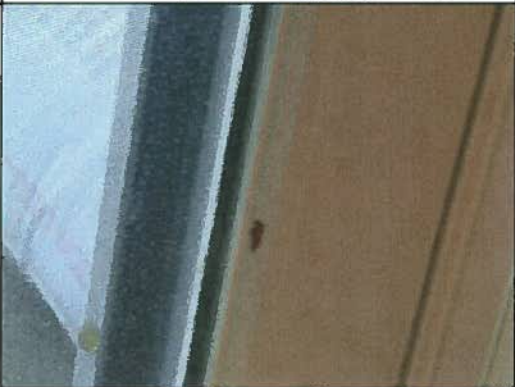
<p>32. Damaged finish on frame of Unit I.</p>

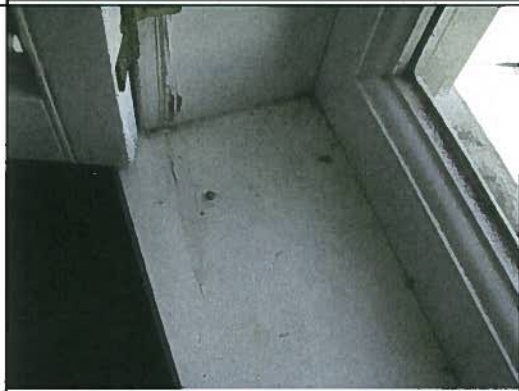
<p>34. Damaged finish on sill of Unit A2.</p>

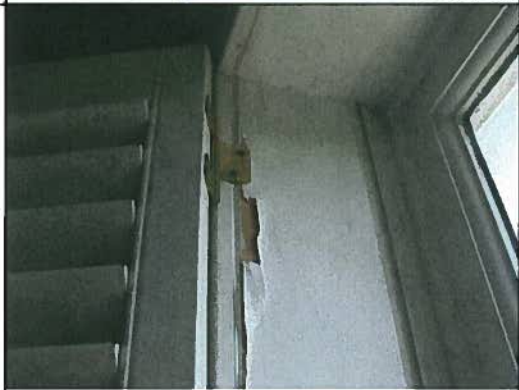
<p>35. Damaged finish on jamb of Unit A2.</p>

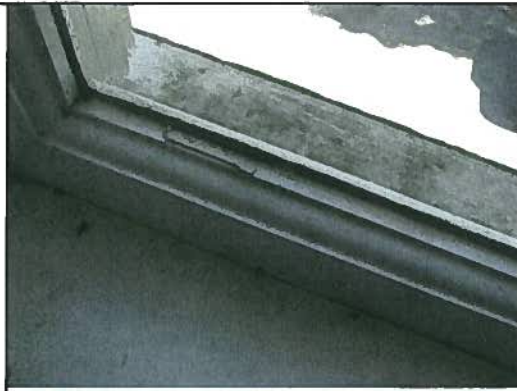
<p>36. Loose seal at glass of Unit A2.</p>

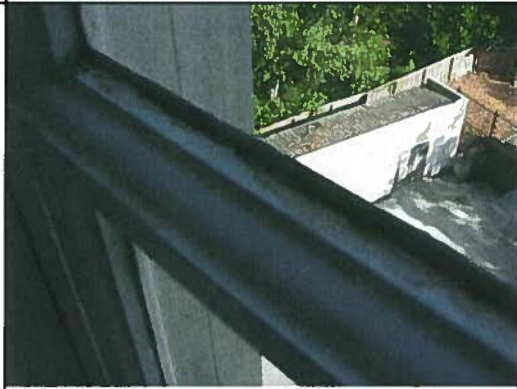
<p>37. Water stain on frame of Unit A2.</p>

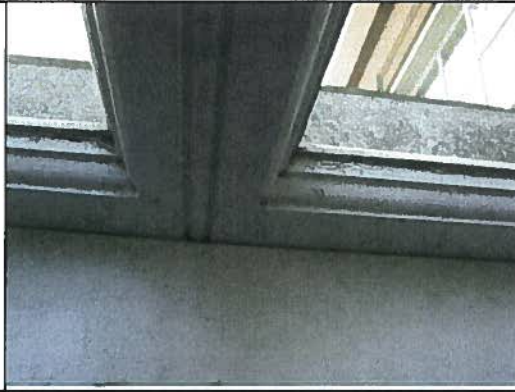
<p>39. Damaged finish and water stain on frame of Unit B2.</p>

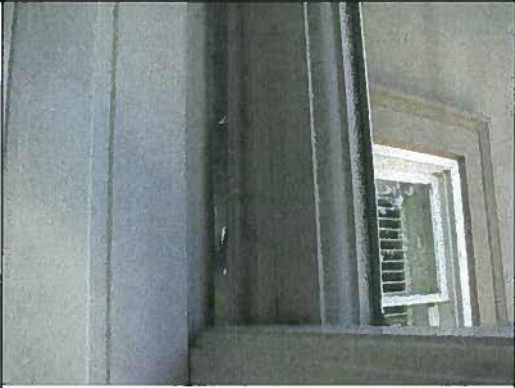
<p>41. Damaged slide of Unit C2.</p>

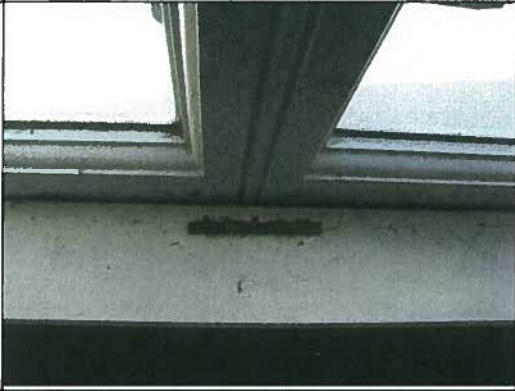
<p>43. Water stain on sill of Unit D2.</p>

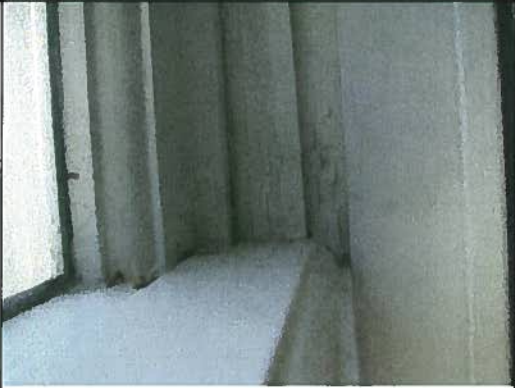
<p>44. Damaged finish on jamb of Unit D2.</p>

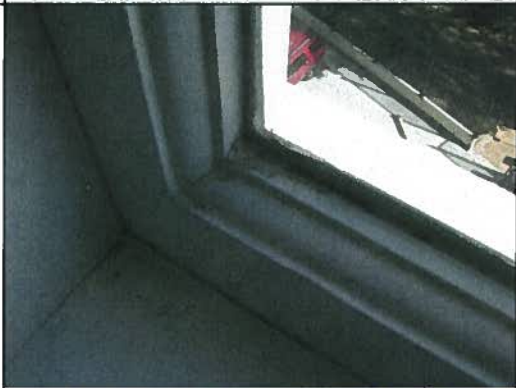
46. Water stain on frame of Unit E2.

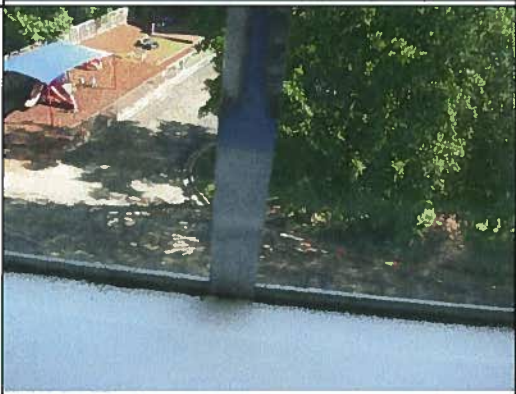
47. Loose seal at glass on Unit E2.

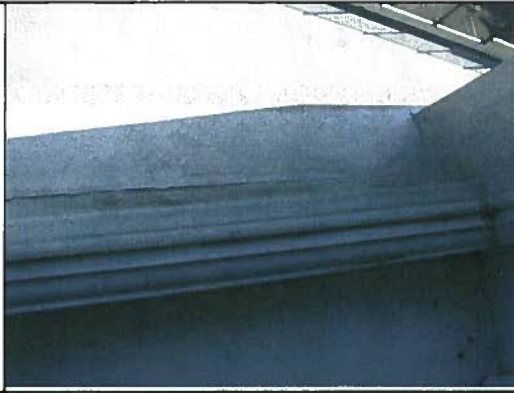
<p>48. Split exterior sill at Unit E2.</p>

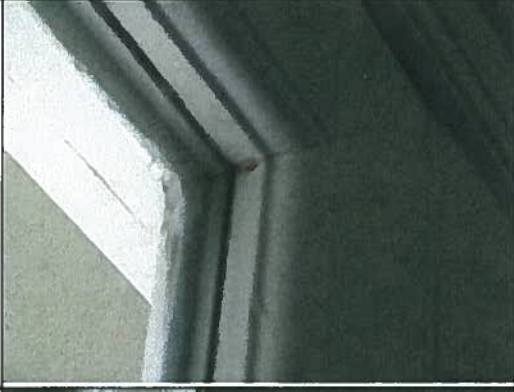
An interior view of a window in Unit F. The window has a dark frame and is looking out onto a balcony with a metal railing and lush green trees. The room is dimly lit, with light coming from the window.
<p>50. Water stain at loose joint in frame of Unit F.</p>

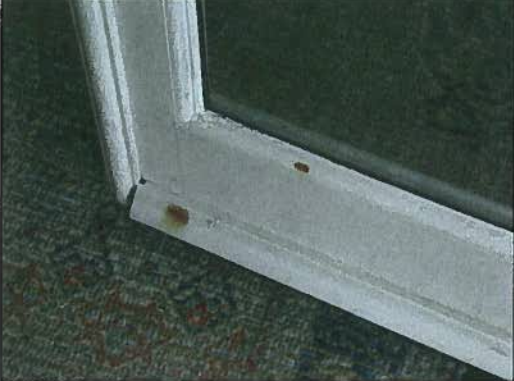
A close-up photograph of the corner joint of a window frame. The frame is white and appears to be made of wood or a composite material. There is a visible water stain on the wall adjacent to the joint, indicating a leak or moisture intrusion.
<p>51. Rust on exterior of frame of Unit F.</p>

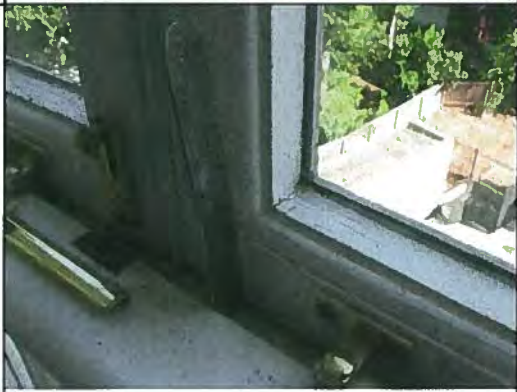
54. Loose joint in frame of Unit G.

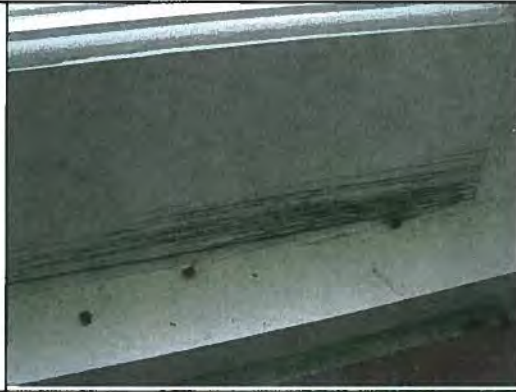
<p>55. Damaged finish on Unit G.</p>

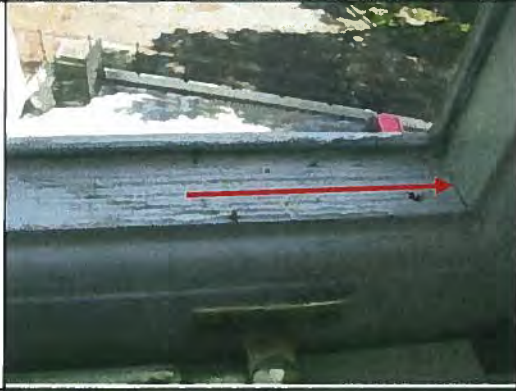
<p>56. Loose joint of frame of Unit G.</p>

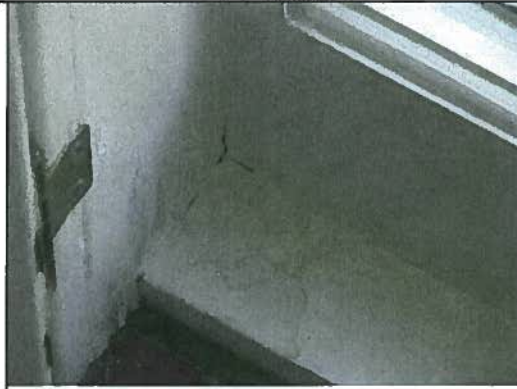
<p>58. Water stain on sill of Unit H.</p>

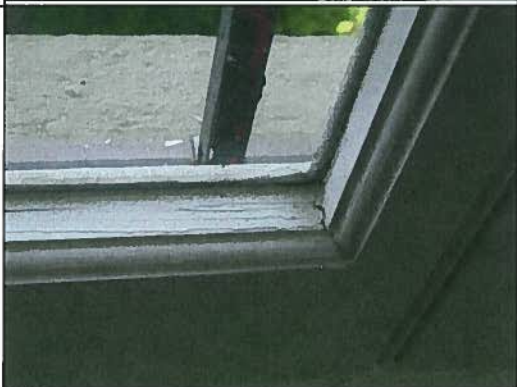
<p>60. Loose joint in frame of Unit H.</p>

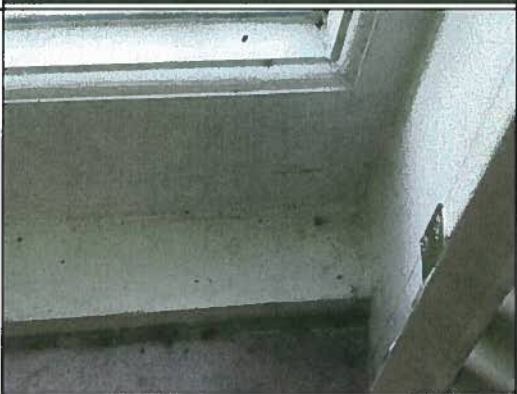
<p>61. Water stain on sill of Unit H.</p>

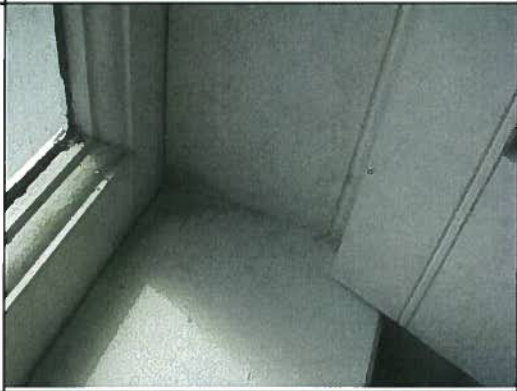
A photograph showing the interior of Unit A3. A window with white shutters is open, looking out onto a green landscape. A small table with a red top is visible near the window.
<p>63. Water stain on sill of Unit A3.</p>

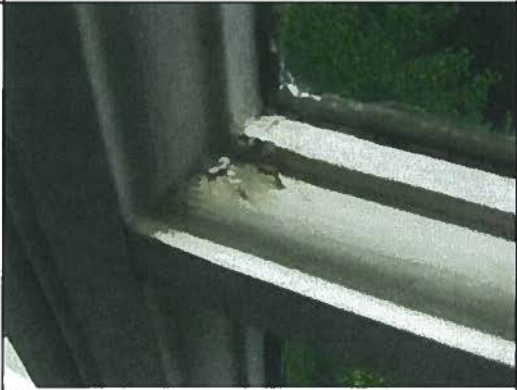
A close-up photograph of the window sill in Unit A3, showing a distinct water stain on the white surface.
<p>64. Water stain of frame of Unit A3.</p>

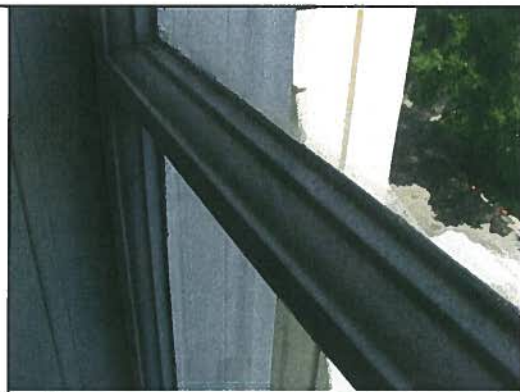
<p>68. Water stain on frame of Unit B3.</p>

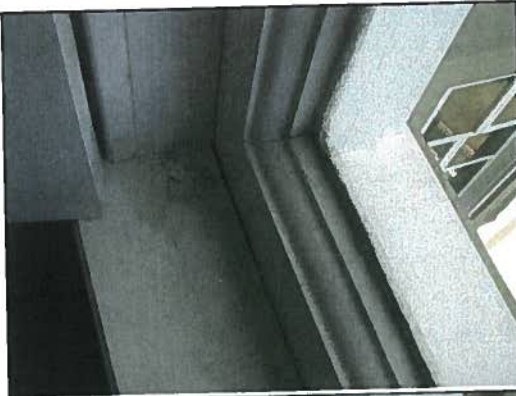
71. Water stain on sill and jamb at loose joint of Unit C3.

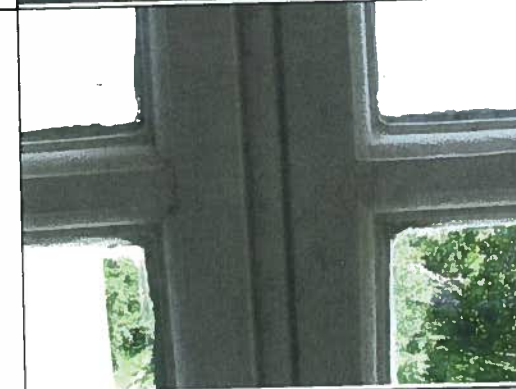
73. Excessive exterior sealant and water stain at loose joint on frame of Unit C3.

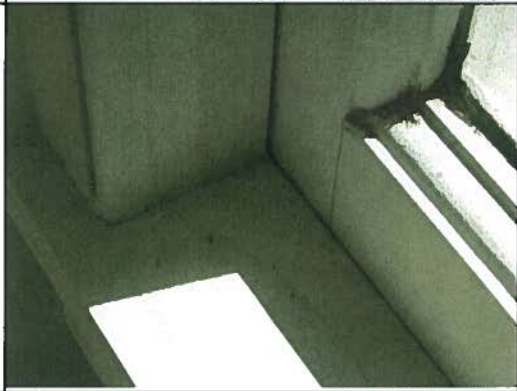
75. Water stain on sill, jamb and frame
at loose joint in frame of Unit D3.

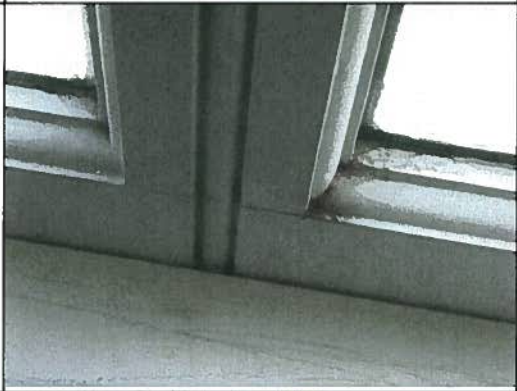
A photograph showing the interior of a room with a window. The window has a dark frame and is partially covered by dark curtains. The room is dimly lit, with light coming from the window.
<p>77. Water stain on frame at loose joint of Unit E3.</p>

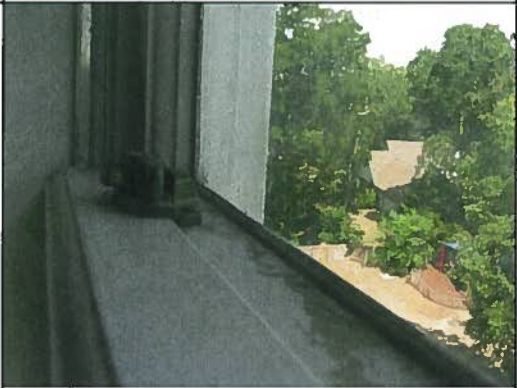
A close-up photograph of a window frame. The frame is white and shows a dark, irregular water stain. The stain is located at a joint where the frame meets the wall.
<p>78. Water stain on frame of Unit E3.</p>

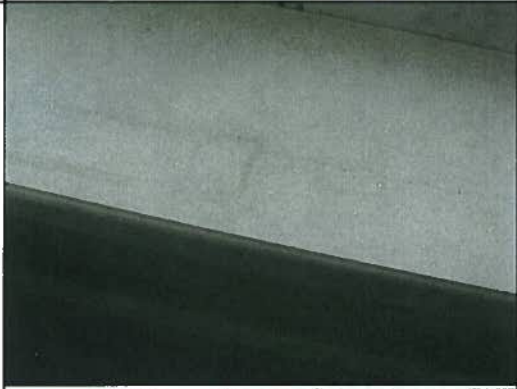
A photograph showing a window with white shutters and dark curtains. A desk with a laptop and framed photos is visible in the foreground.
<p>80. Water stain on sill of Unit F3.</p>

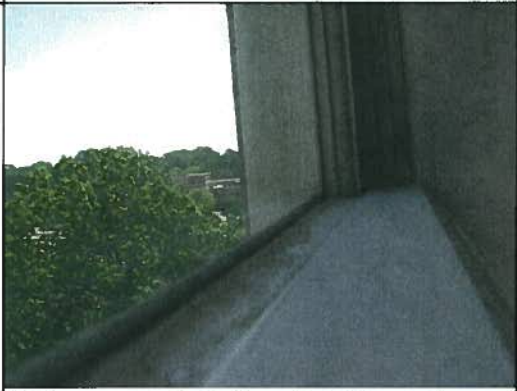
A close-up photograph of a window sill showing a dark, irregular water stain on the light-colored surface.
<p>81. Water stain on frame of Unit F3.</p>

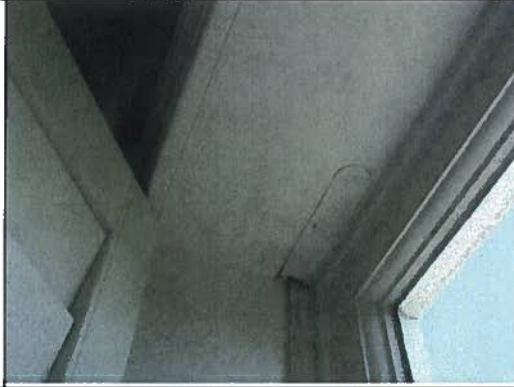
<p>82. Water stain on head of Unit F3.</p>

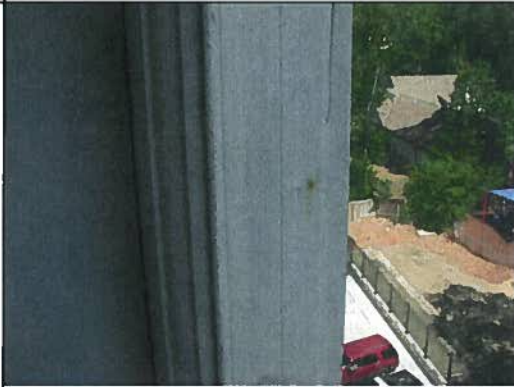
<p>83. Rust on exterior jamb of Unit F3.</p>

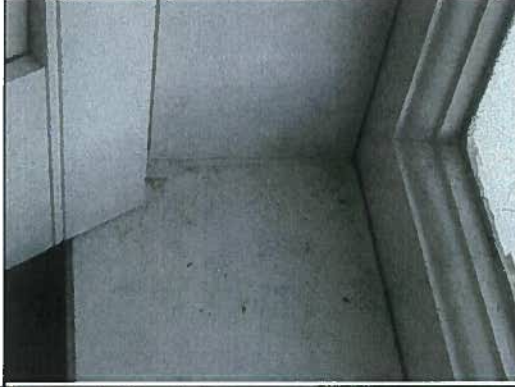
<p>85. Water stain on sill and frame of Unit G3.</p>

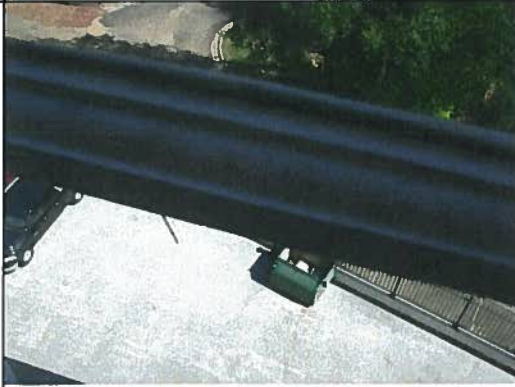
<p>86. Water stain on frame of Unit G3.</p>

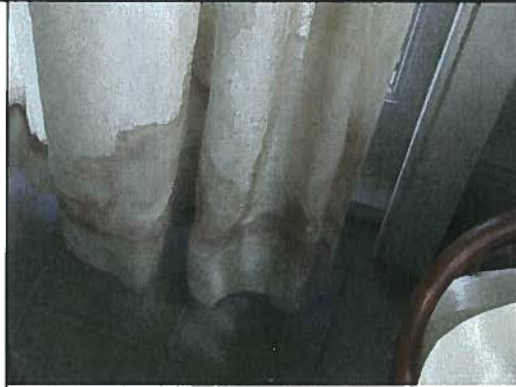
<p>88. Water stained draperies over Unit H.</p>

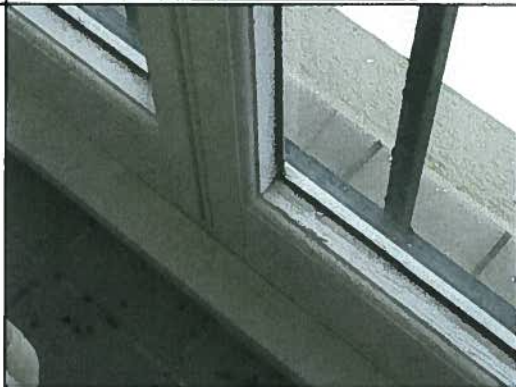
<p>89. Damaged finish on Unit H.</p>

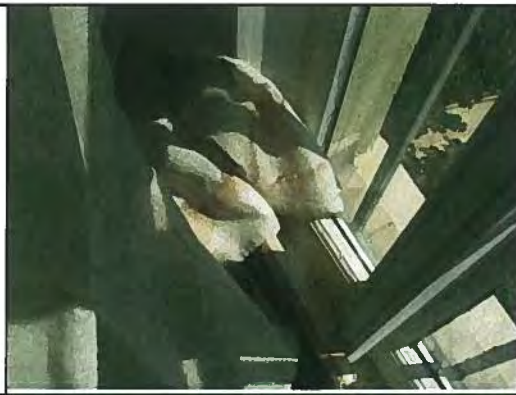
<p>91. Water stained draperies over Unit I.</p>

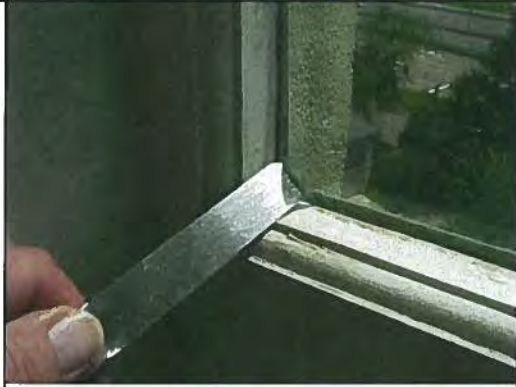
<p>92. Loose solar film on Unit I.</p>

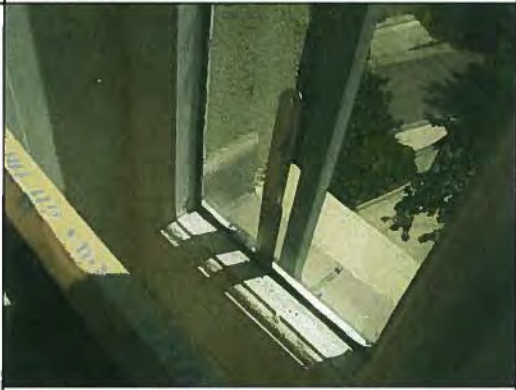
<p>93. Loose seal at glass of Unit I.</p>

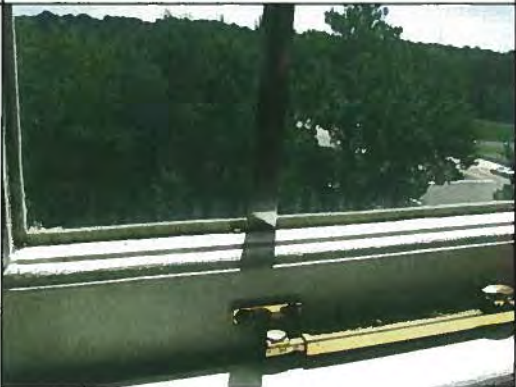
<p>94. Loose seal at glass of Unit I.</p>

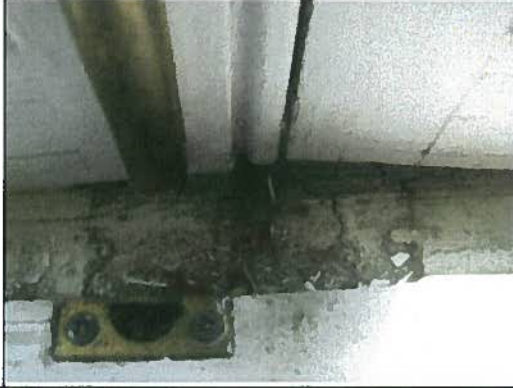
<p>95. Casement leaves will not close likely because of swollen wood frame of Unit I.</p>

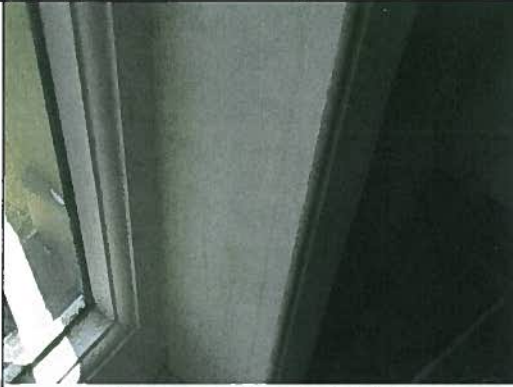
<p>96. Water stain on jamb of Unit I.</p>

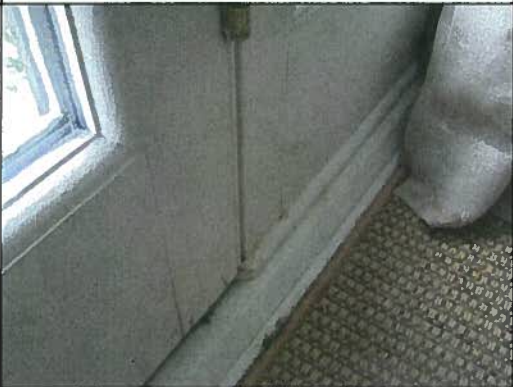
<p>98. Water stain on sill of Unit J.</p>

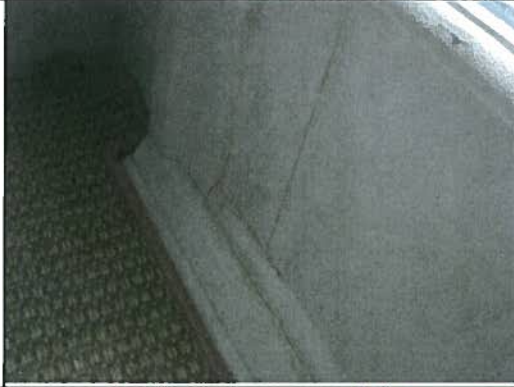
<p>99. Water stain on sill and frame at loose joint of Unit J.</p>

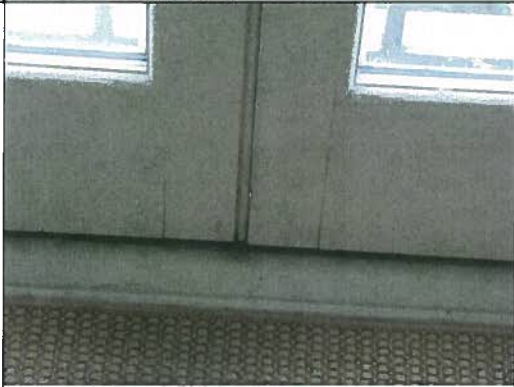
<p>100. Open joint to exterior when doors are closed and the frames have loose joints on Unit J.</p>

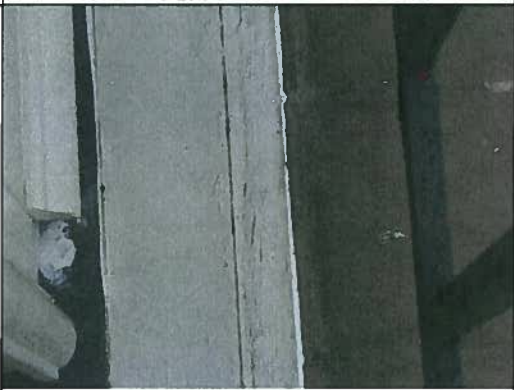
<p>101. Split exterior sill of Unit J.</p>

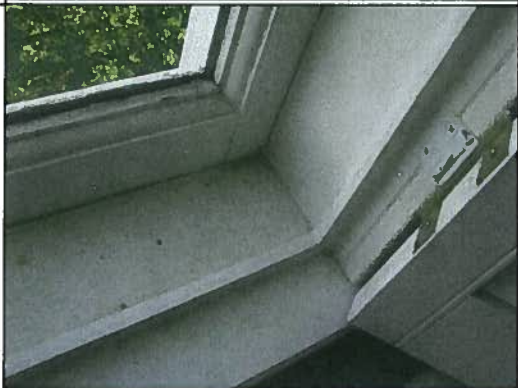
103. Water stain and damaged finish on
frame and sill of Unit A2.

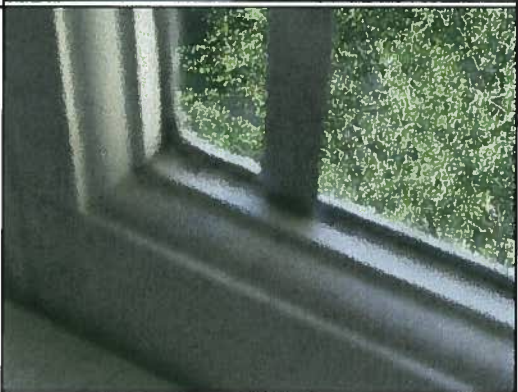
104. Loose seal at glass on Unit A2.

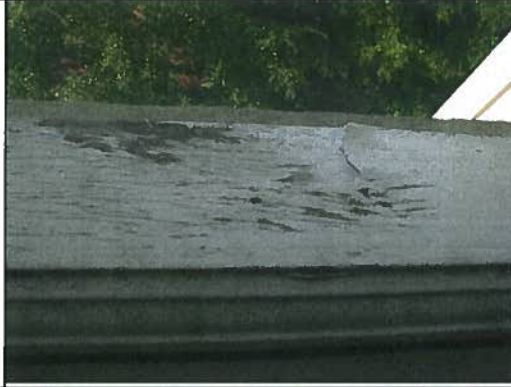
<p>105. Split exterior sill of Unit A2.</p>

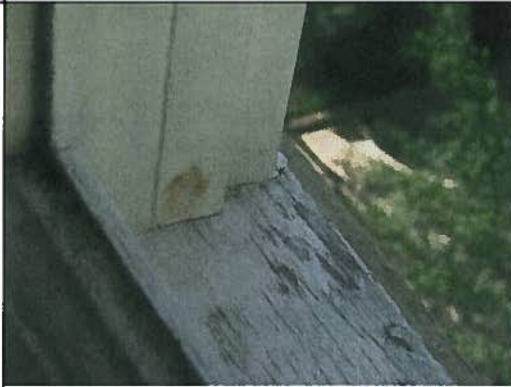
A close-up photograph showing a horizontal exterior sill of a window. The sill is made of a light-colored material, possibly concrete or stone, and exhibits significant cracking and splitting along its length. The background shows green foliage.
<p>106. Rust on exterior jamb of Unit A2.</p>

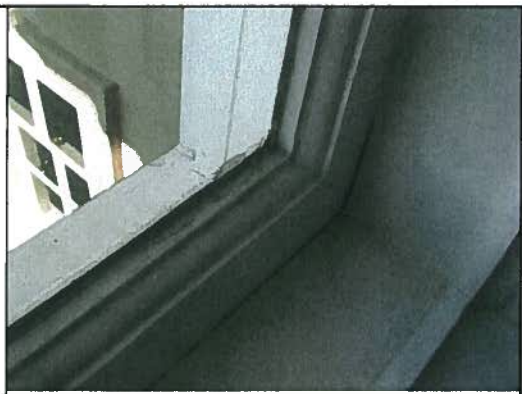
<p>108. Water stain on frame of Unit B2.</p>

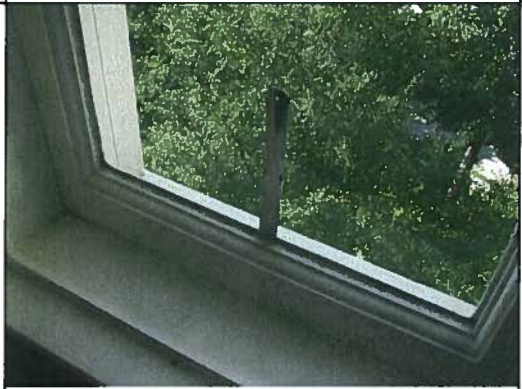
<p>109. Loose seal at glass of Unit B2.</p>

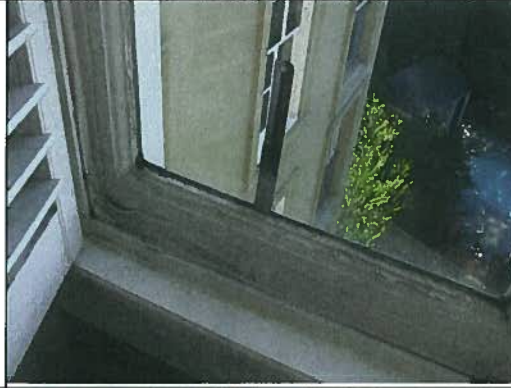
<p>111. Loose seal at glass of Unit C2.</p>
