DOCUMENT 009113 - ADDENDA

- A. Addendum No. 002.

- A. Project Name: The Barrington Exterior Refinishing
- B. Owner: The Barrington Condominium Association, Inc.
- C. Architect: Purser & Company, PA.
- D. Architect Project Number: 20230809001.
- E. Date of Addendum: 6/18/24.

Between August 12 and September 2, 2020 Dennis Walters, CSI, CDT, CCCA, Principal, Central Building Consultants, LLC visited the building and through Ms. Beth Hartness' introductions to the unit owners, observed the existing interior conditions of the windows and terrace enclosures of each of the four units on floors 3 through 9.

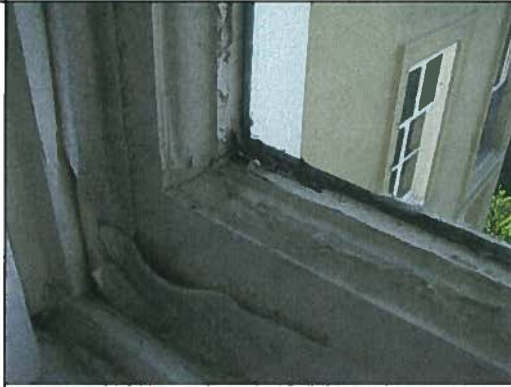
<p>112. Damaged finish and tape on sill of Unit C2.</p>

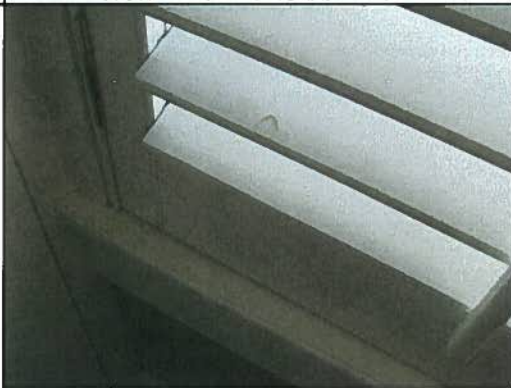
<p>113. Water stain on shutter of Unit C2.</p>

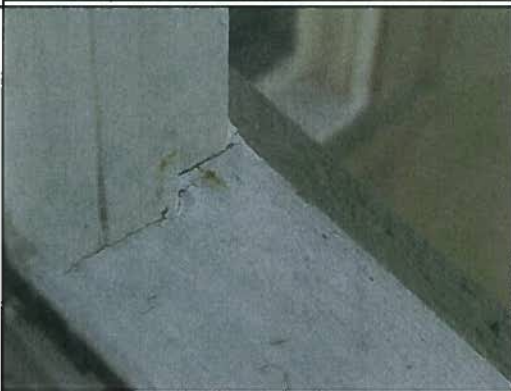
<p>114. Rust on exterior sill and jamb of Unit C2.</p>

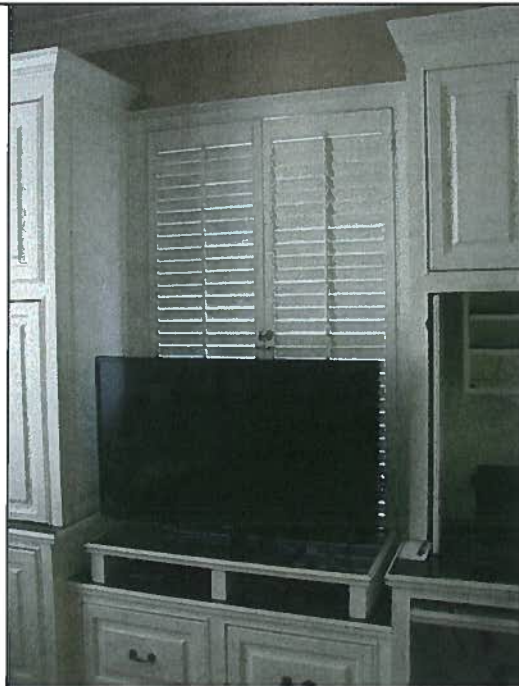
116. Damaged finish on frame of Unit D2.

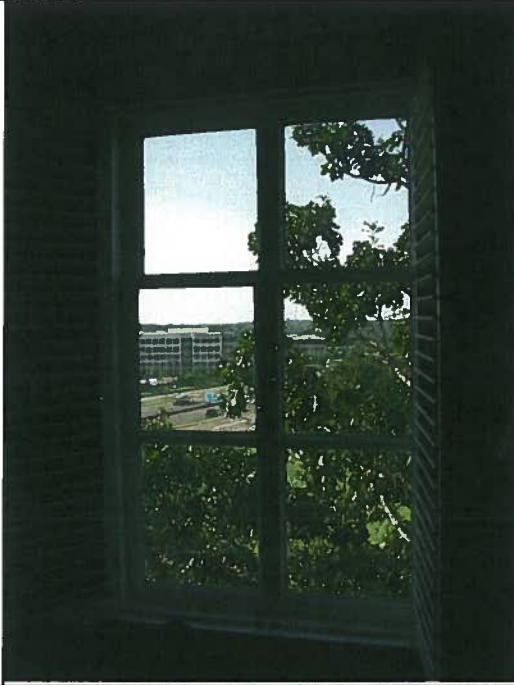
<p>118. Damaged slide of Unit E2.</p>

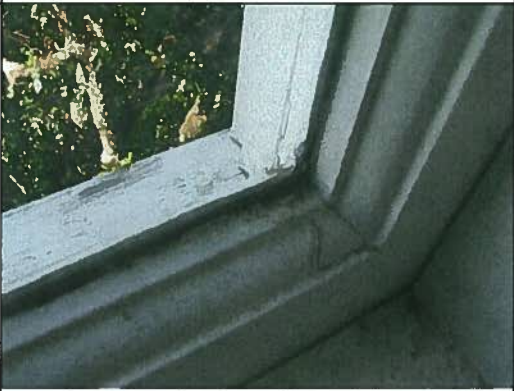
<p>120. Split exterior sill of Unit E2.</p>

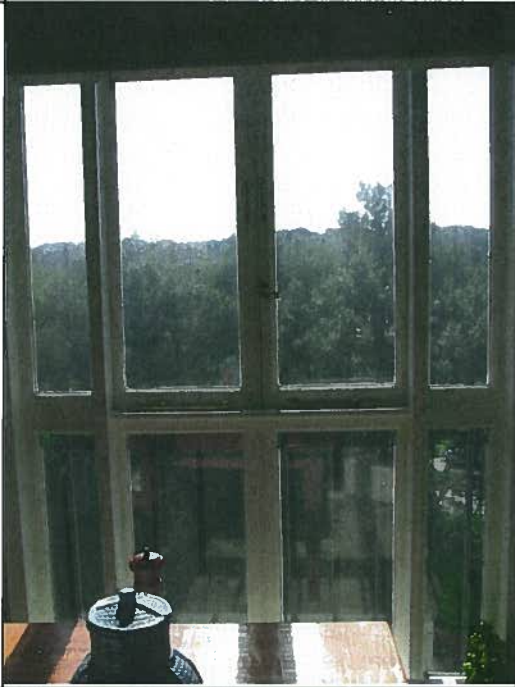
<p>125. Open joint when casement leaves are closed on Unit G, probe passes from interior to exterior.</p>

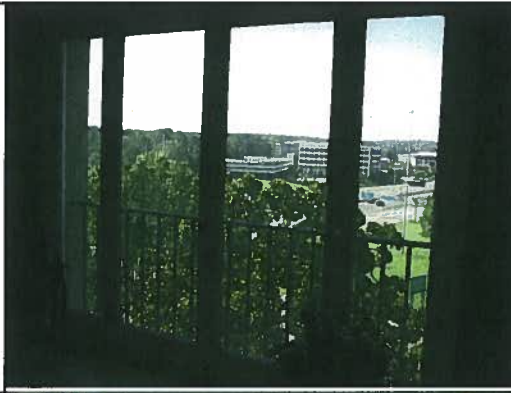
<p>127. Decayed wood in Unit H.</p>

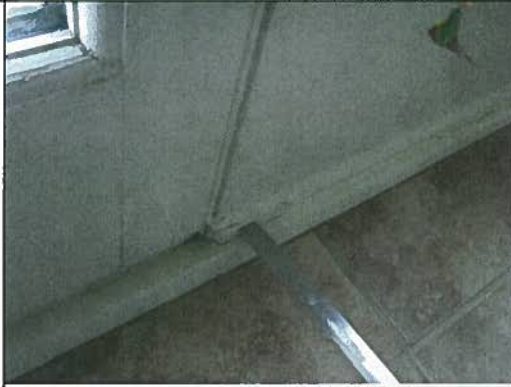
<p>128. Decayed wood in Unit H.</p>

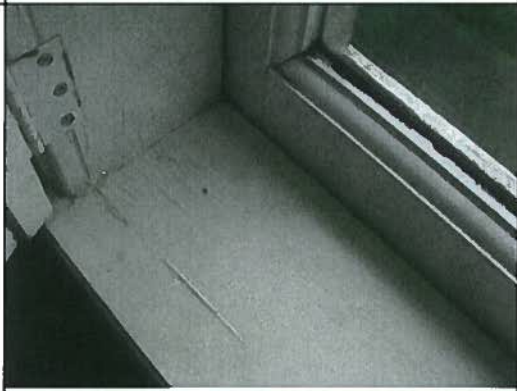
<p>3. Loose seal at glass of Unit A3.</p>

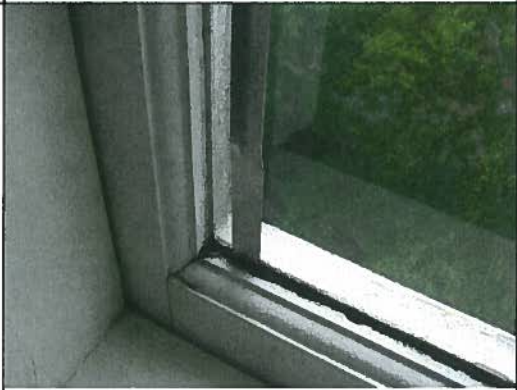
<p>4. Split exterior sill of Unit A3.</p>

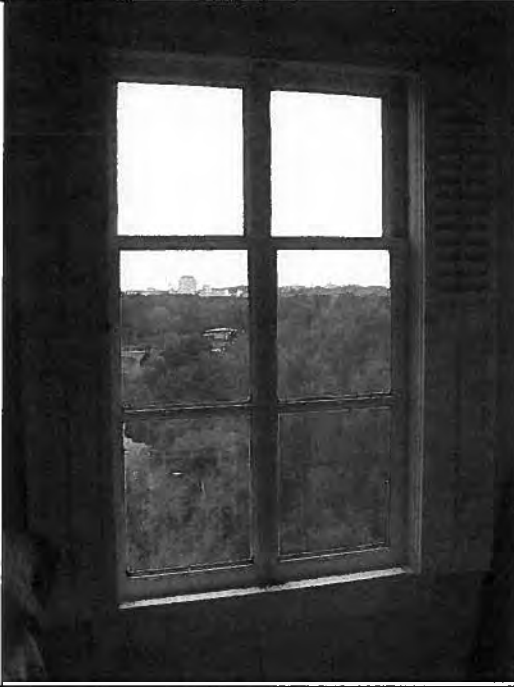
<p>6. Loose seal at glass of Unit B3.</p>

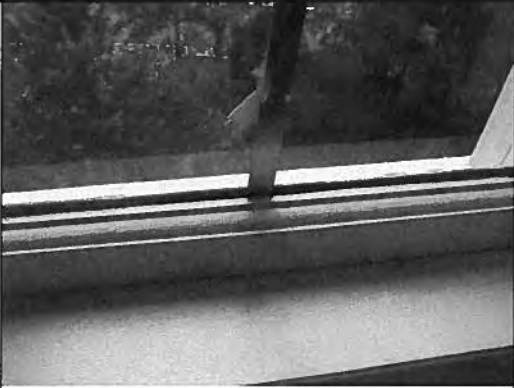
<p>7. Rust on exterior jamb of Unit B3.</p>

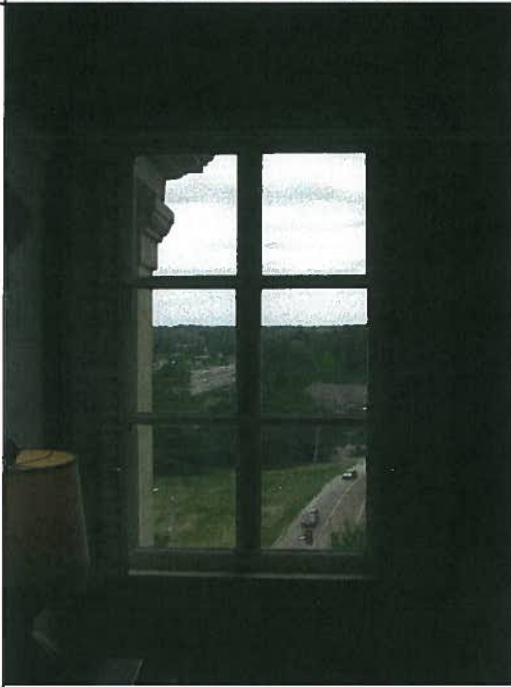
<p>9. Damaged finish on sill of Unit C3.</p>

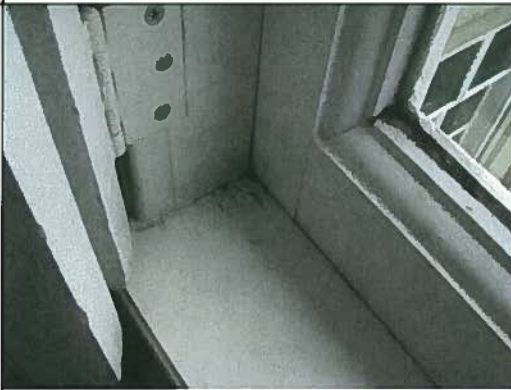
10. Rust stain on slide cover at head of Unit C3.

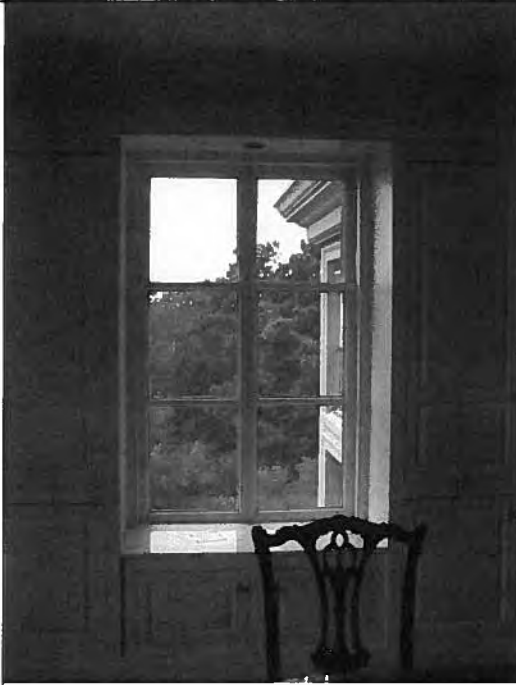
12. Loose seal at glass of Unit D3.

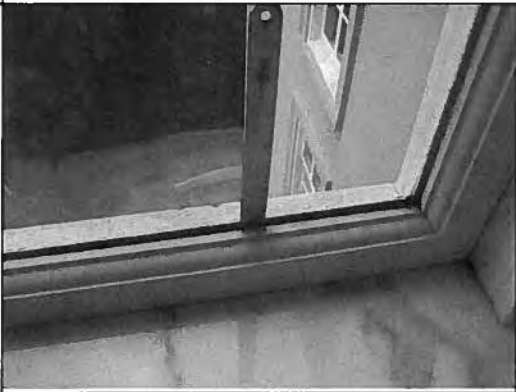
<p>13. Water stain on frame and jamb of Unit D3.</p>

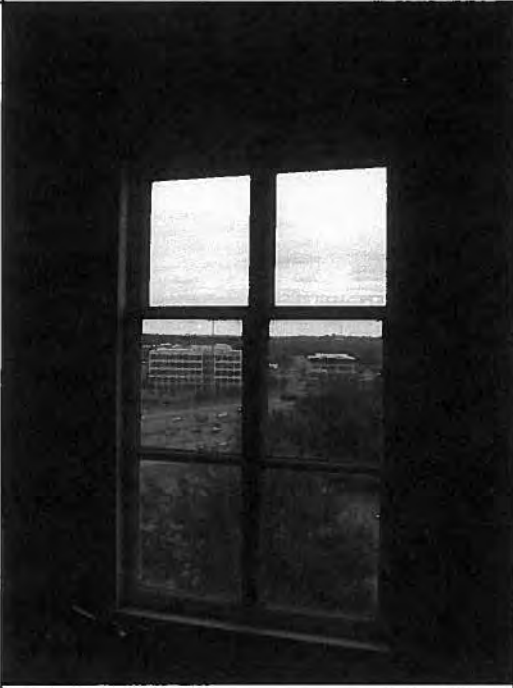
<p>16. Water damaged finish on crown molding above Unit E3.</p>

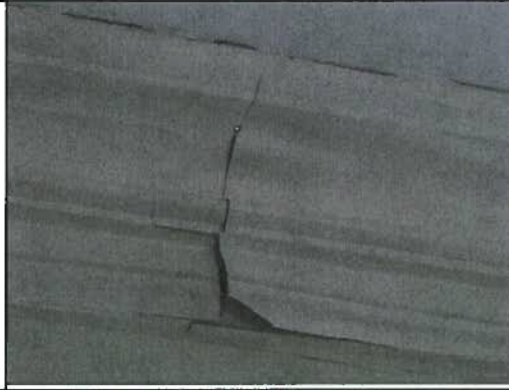
<p>17. Loose seal at glass on Unit E3.</p>

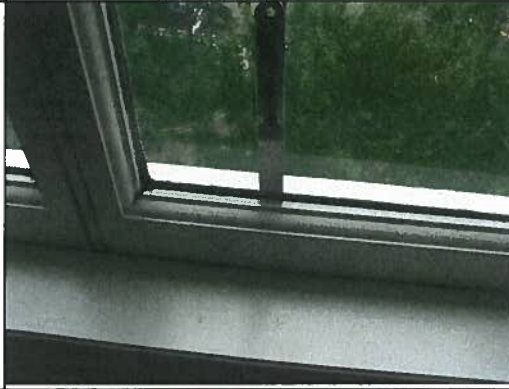
<p>18. Water stain on frame of Unit E3.</p>

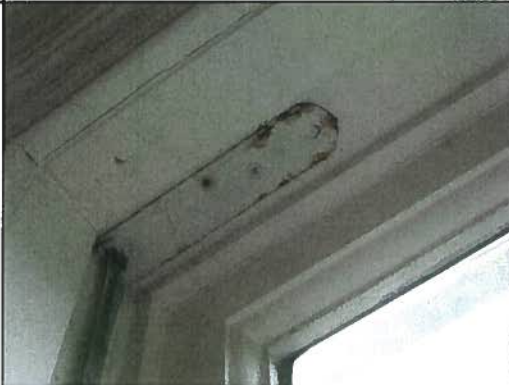
<p>20. Rust on exterior jamb and sill of Unit E3.</p>

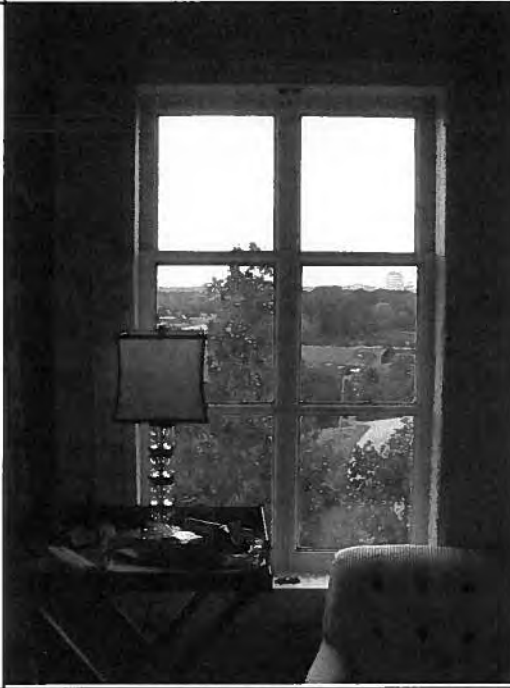
<p>22. Damaged finish on sill of Unit F3.</p>

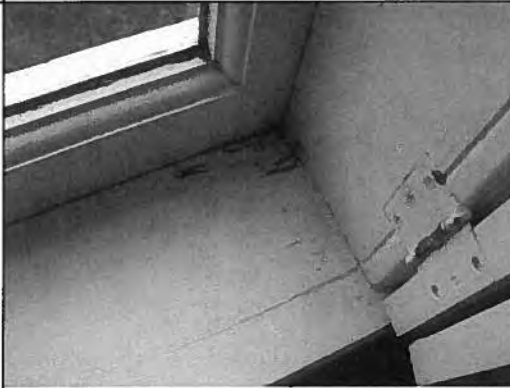
<p>23. Loose seal at glass of Unit F3.</p>

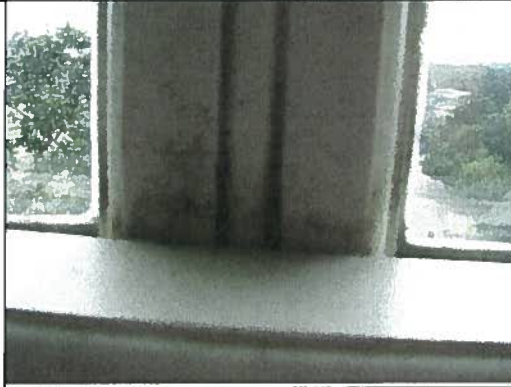
<p>25. Water damaged finish on crown molding above Unit F3.</p>

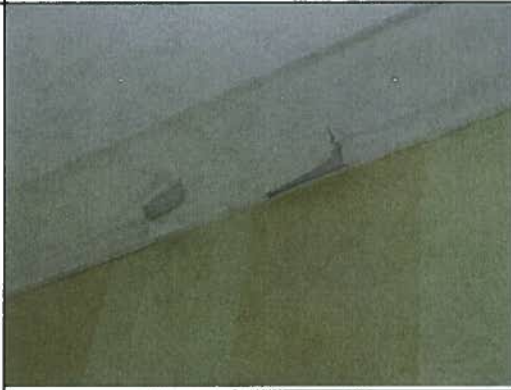
<p>26. Loose joint in frame of Unit F3.</p>

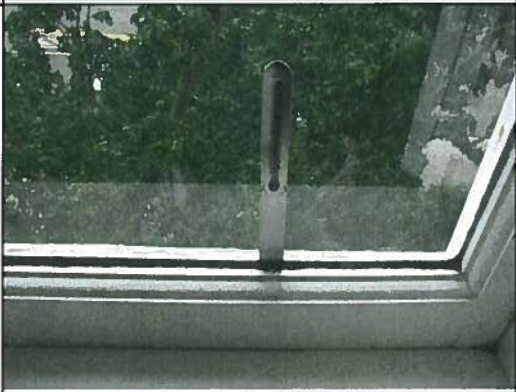
29. Loose seal at glass of Unit G3.

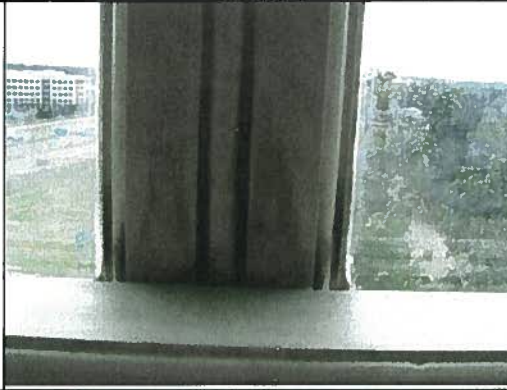
<p>30. Water stain on frame of Unit G3.</p>

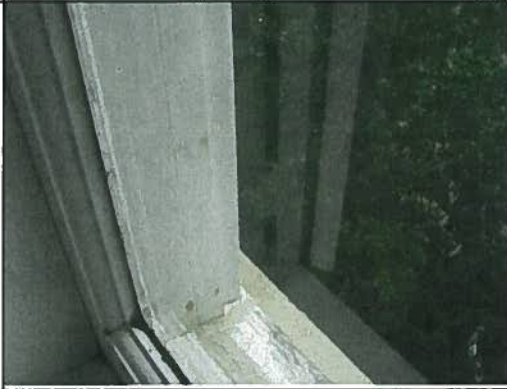
<p>31. Rust on exterior jamb of Unit G3.</p>

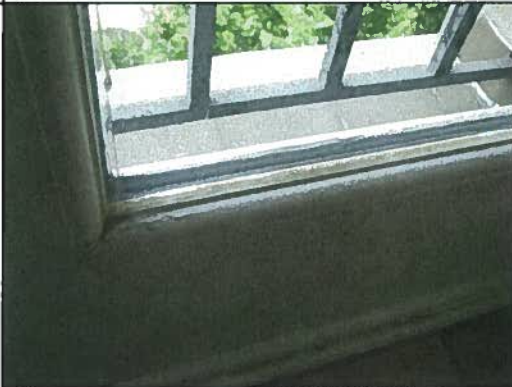
A close-up photograph of a window sill. The sill is made of a light-colored material, possibly concrete or stone, and shows a prominent, irregular water stain.
<p>37. Water stain on frame of Unit H.</p>

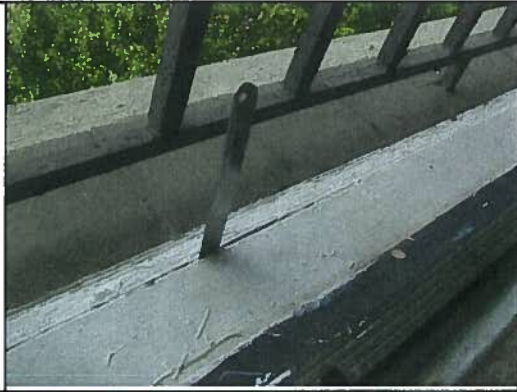
38. Split exterior sill of Unit H.

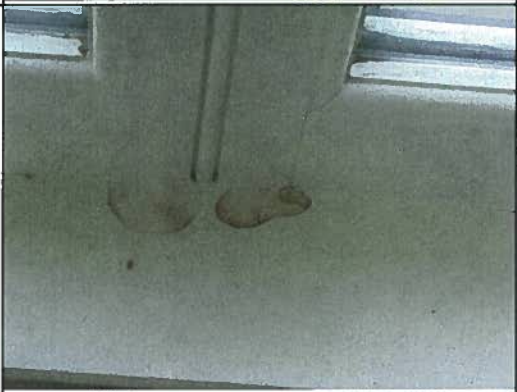
40. Water stain at sill of Unit I.

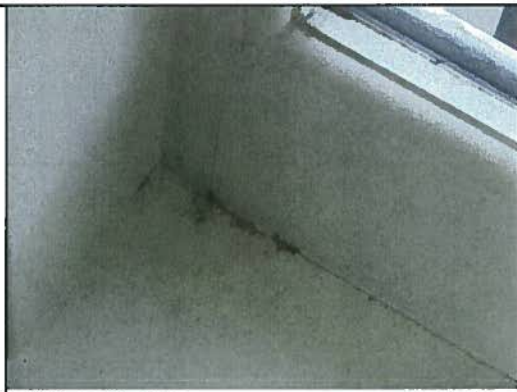
<p>41. Water stain at sill with loose joint in Unit I.</p>

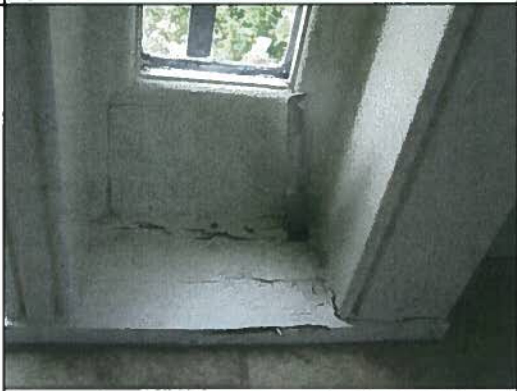
<p>43. Severely decayed wood at sill of Unit J.</p>

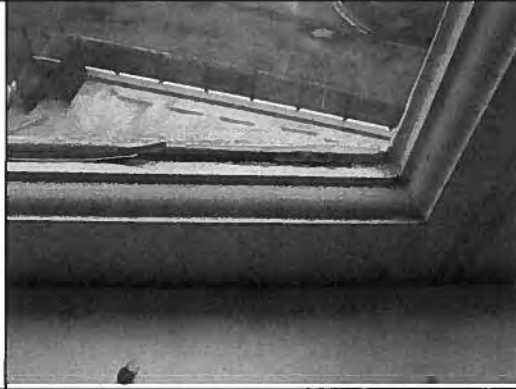
<p>47. Loose seal at glass of Unit A2.</p>

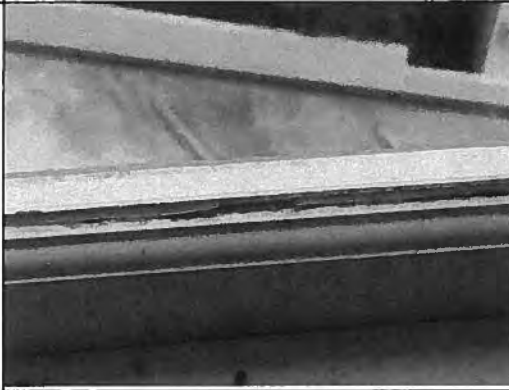
<p>52. Loose seal at glass of Unit C2.</p>

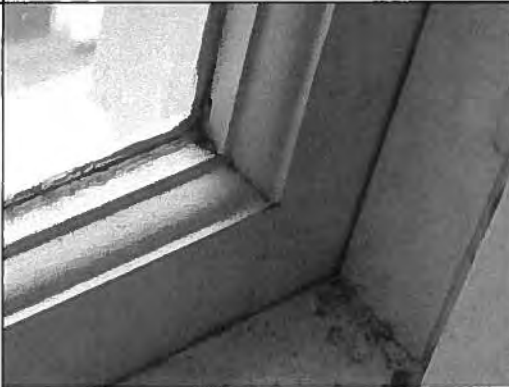
<p>53. Water stain on sill at loose joint in frame of Unit C2.</p>

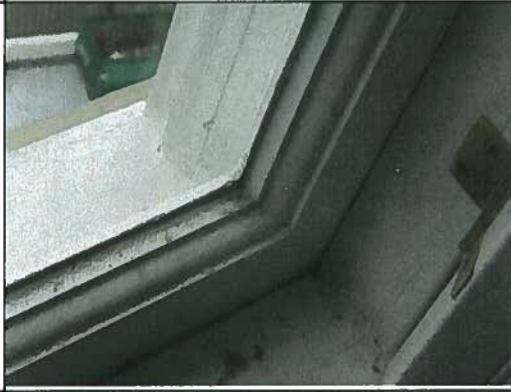
A photograph showing the interior of a room with a window. The window has dark shutters on both sides. The view through the window shows a green landscape with trees and a building in the distance.
<p>55. Water stain on frame and sill of Unit D2.</p>

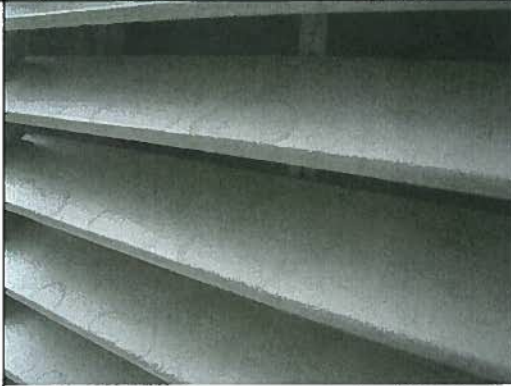
A close-up photograph of the window frame and sill. There is a visible water stain on the white frame and sill area.
<p>56. Water stains on shutter of Unit D2.</p>

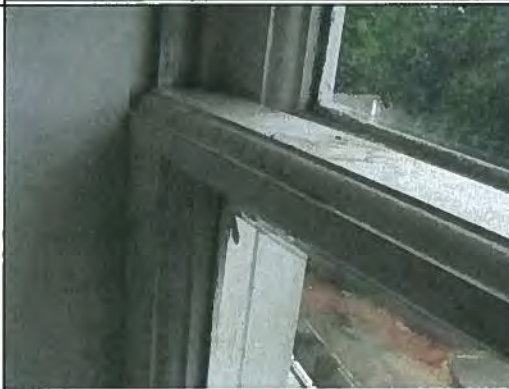
A photograph showing a window with white horizontal blinds. The blinds are partially open, revealing a view of greenery and a building outside. The window frame is dark.
<p>58. Water stain on frame of Unit E2.</p>

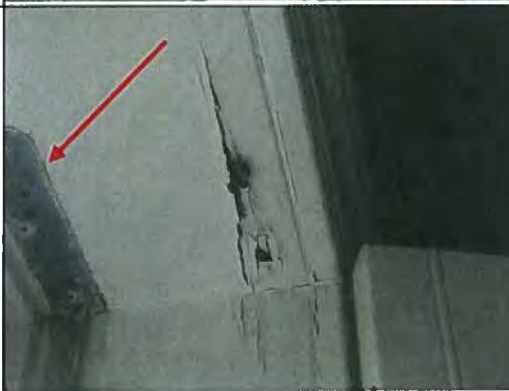
A close-up photograph of the window frame. The frame is dark and shows a significant water stain, appearing as a reddish-brown discoloration on the surface.
<p>59. Damaged finish and wood with organic growth and rust stain on side cover of Unit E2.</p>

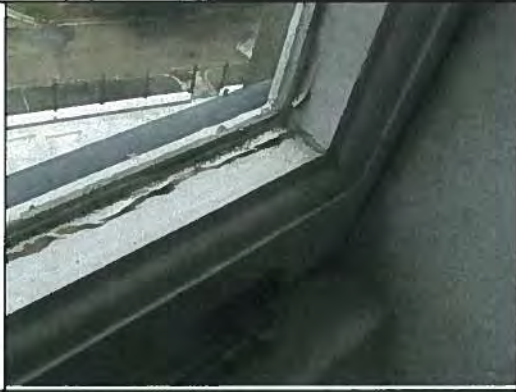
63. Water stain and damaged finish on frame of Unit G.

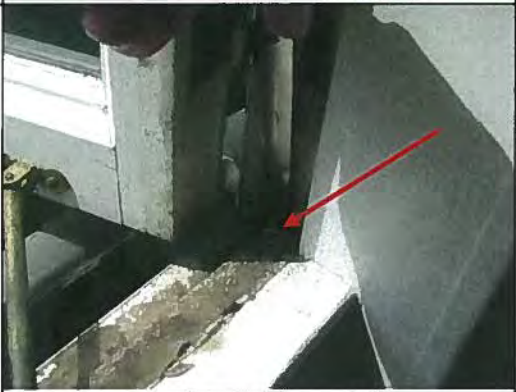
65. Open joint in frame of Unit H.

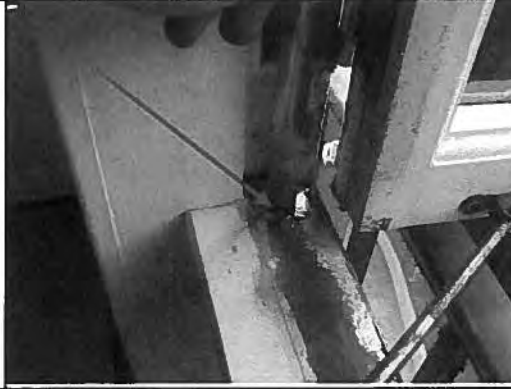
<p>66. Decayed wood in frame of Unit H.</p>

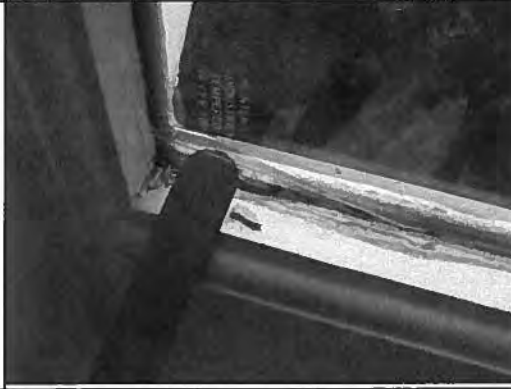
<p>67. Loose solar film on Unit H.</p>

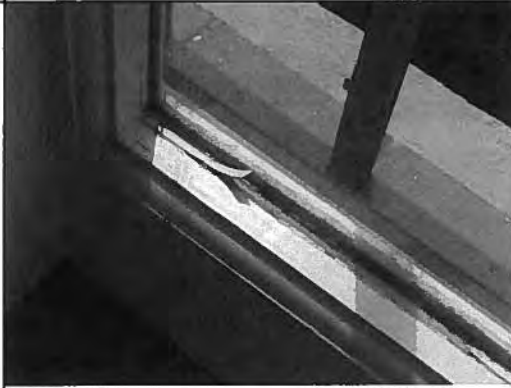
<p>68. Loose seal at glass of Unit H.</p>

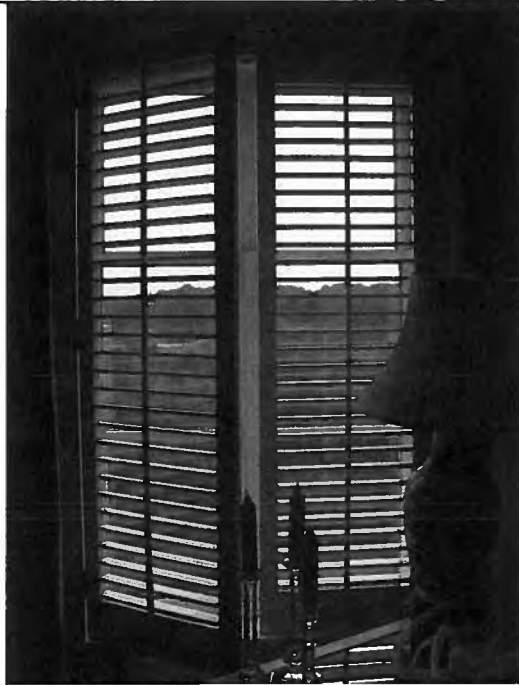
69. Unit A3.

Window units are identified as A3 through G3 plus the Living Room terrace (Terrace 1) and the Master Bedroom terrace (Terrace 2). Common deficiencies include loose seals at the glass, decayed wood, water stains at heads, frames, jambs and sills, loose joints and damaged finishes. In general, the windows of this unit are in mostly poor condition.

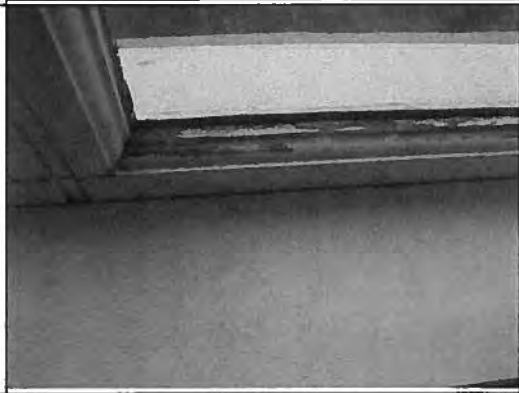
70. Damaged finish and loose seal at glass of Unit A3.

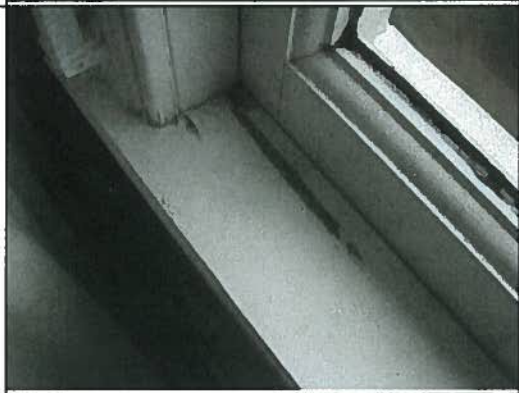
72. Damaged finish on sill of Unit B3.

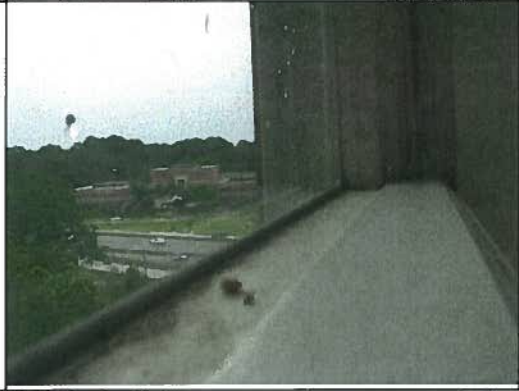
74. Water stain on frame of Unit C3.

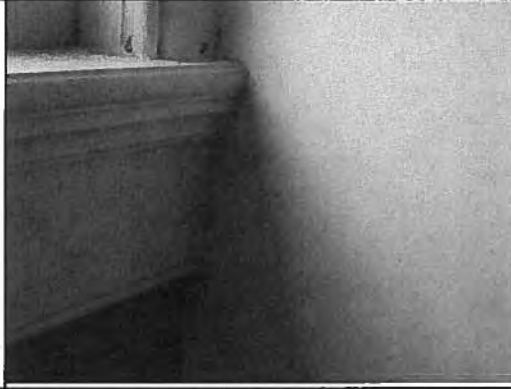
<p>78. Water stain on sill of Unit D3.</p>

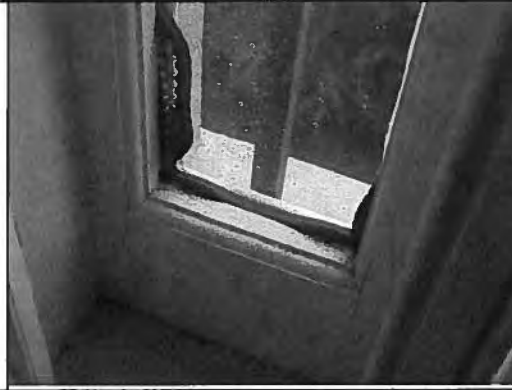
<p>86. Failing insulated glass gasket on Unit H.</p>

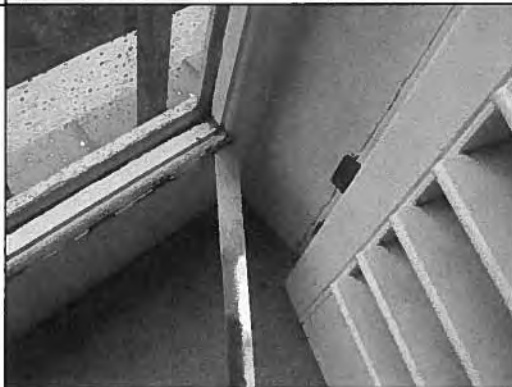
<p>89. Decayed wood of frame of Unit H.</p>

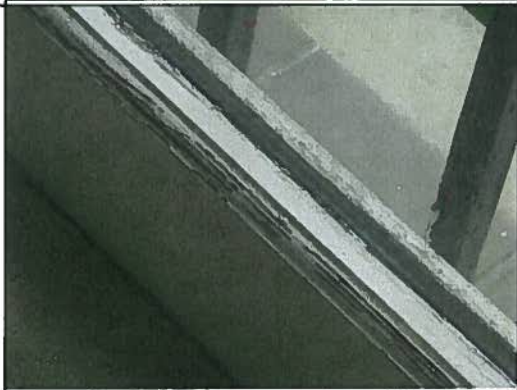
91. Damaged finish on Unit I.

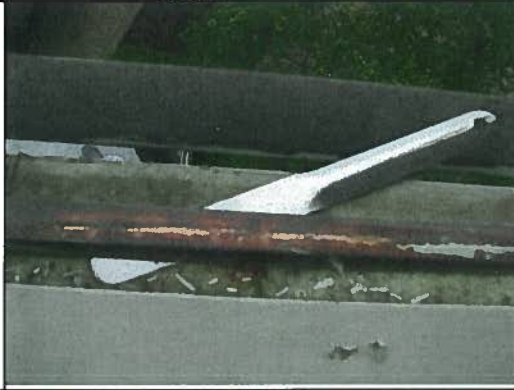
<p>93. No mastic bed below copper weather stripping on Unit I.</p>

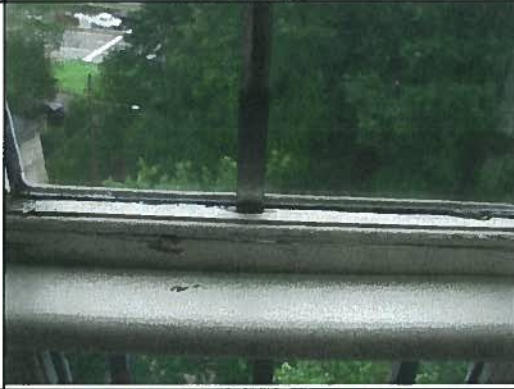
<p>94. Loose seal at glass on Unit I.</p>

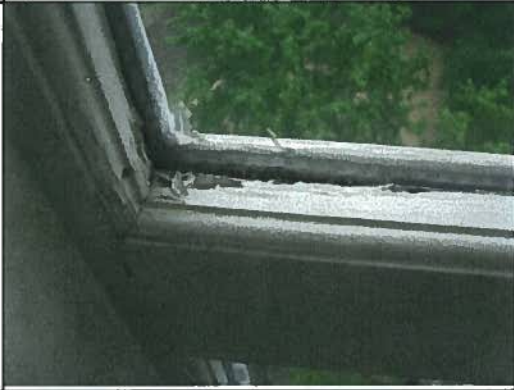
<p>95. Decayed wood in frame of Unit I.</p>

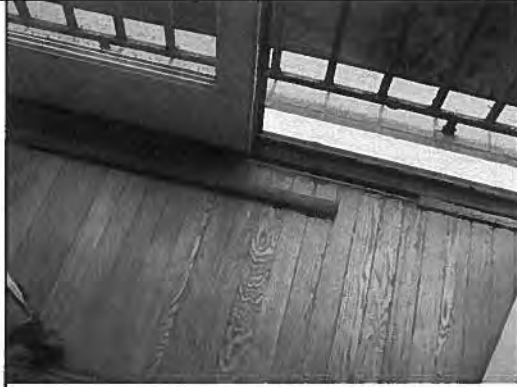
<p>97. Loose floor trim at threshold of Unit J.</p>

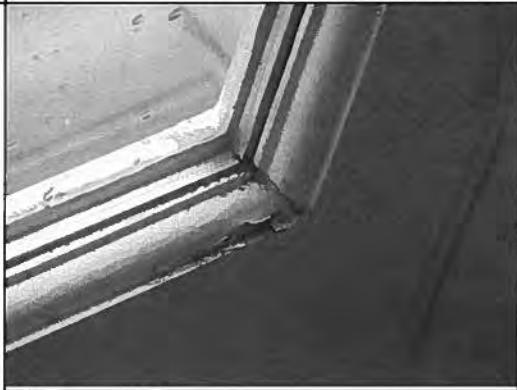
<p>98. Damaged finish and water stain on frame of Unit J.</p>

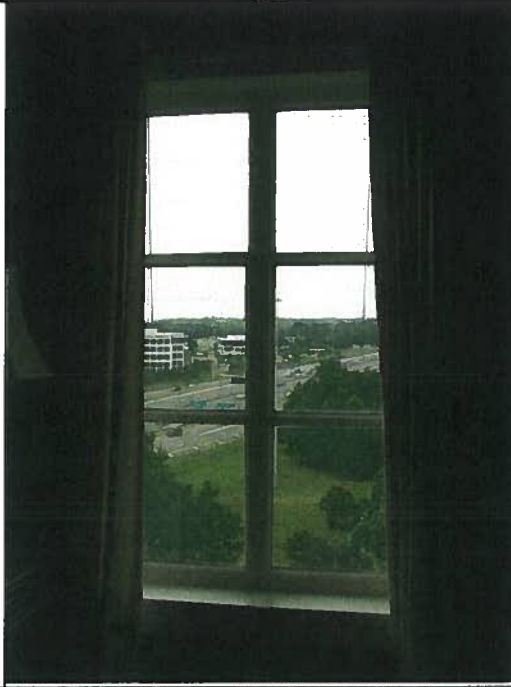
<p>99. Unit A2.</p>

Window units are identified as A2 through E2 plus the Living Room terrace (Terrace 1) and the Master Bedroom terrace (Terrace 2). Common deficiencies include water stains on the heads, jambs, sills and frames and damaged finishes. In general, the windows of this unit are in poor to fair condition.

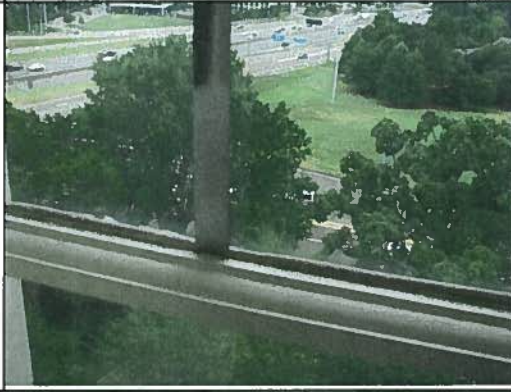
<p>100. Loose seal at glass in Unit A2.</p>

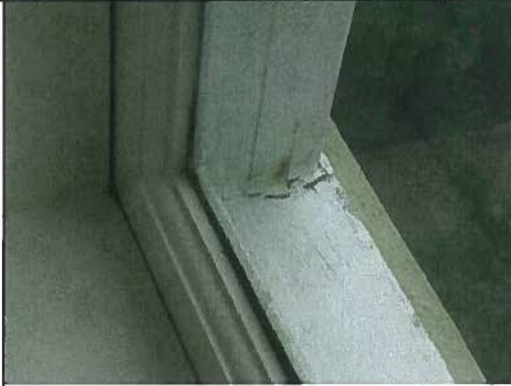
<p>101. Rust on exterior jamb on Unit A2.</p>

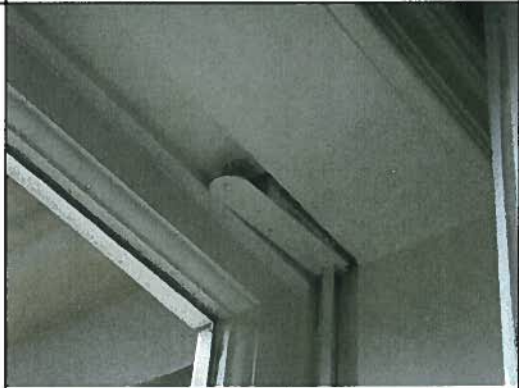
103. Loose slide cover on Unit B2.

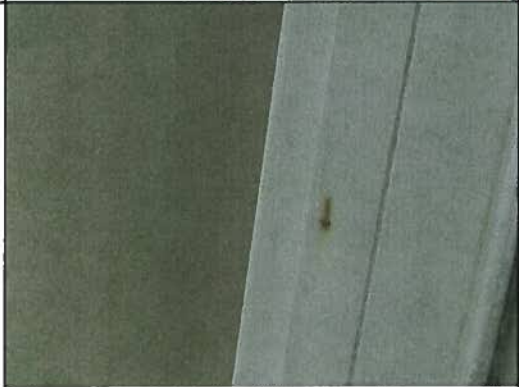
104. Rust on exterior jamb of Unit B2.

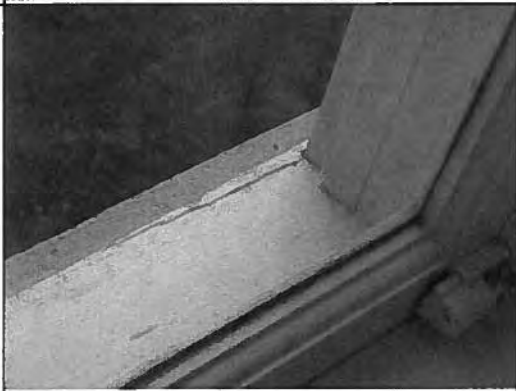
<p>107. Split exterior sill of Unit C2.</p>

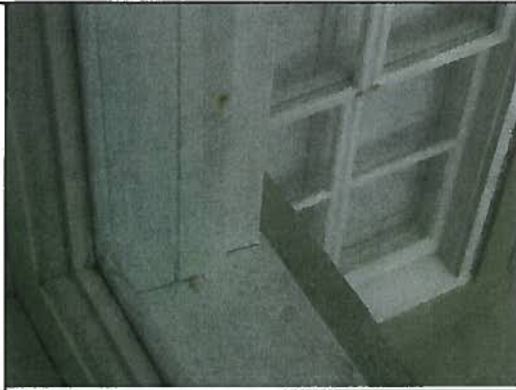
108. Rust on exterior jamb of Unit C2.

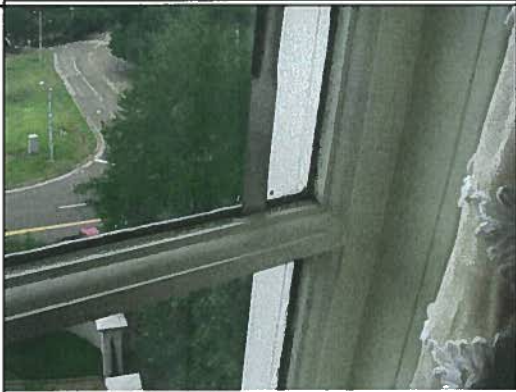
110. Loose seal at glass of Unit D2.

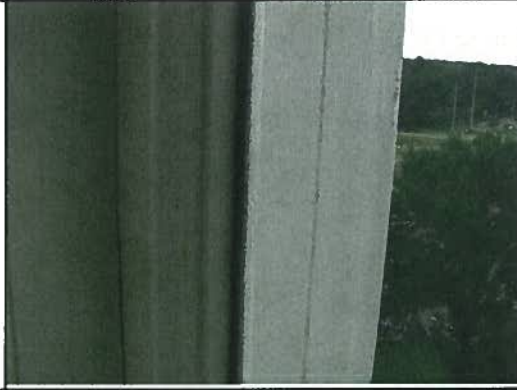
<p>111. Water stain on jamb of Unit D2.</p>

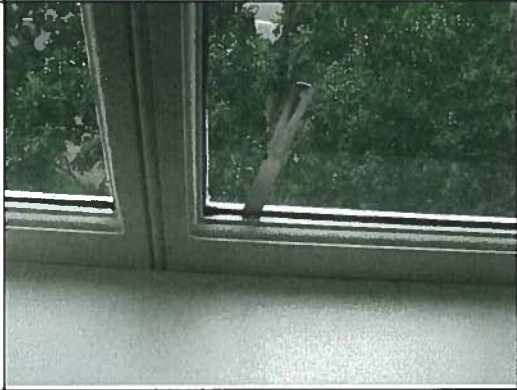
<p>113. Loose seal at glass of Unit E2.</p>

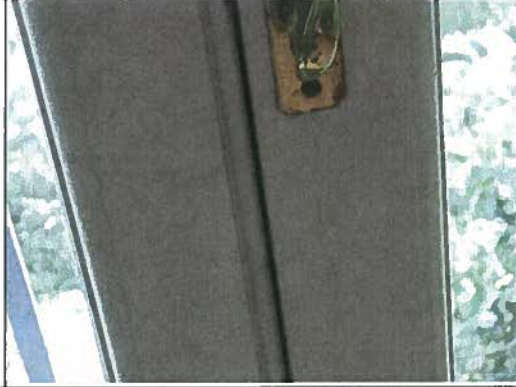
<p>115. Water stain on frame of Unit F.</p>

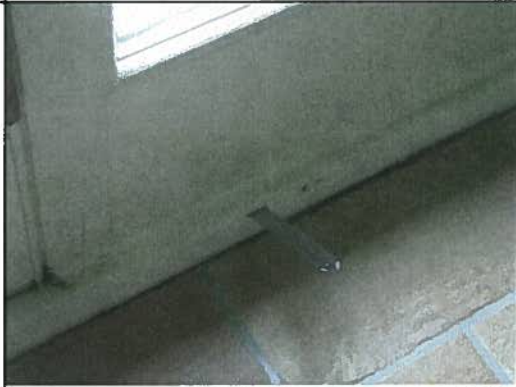
<p>116. Decayed wood at sill of Unit F.</p>

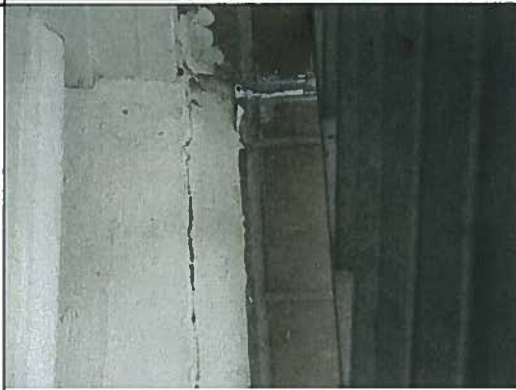
<p>117. Split exterior sill at Unit F.</p>

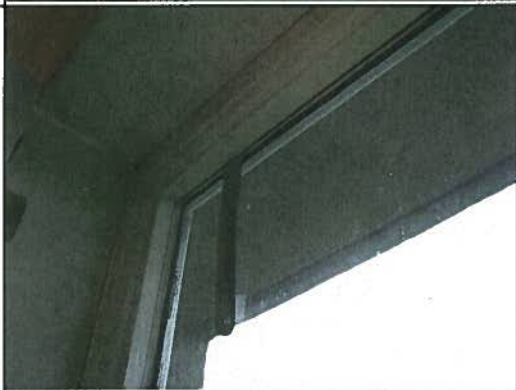
119. Loose seal at glass of Unit G.

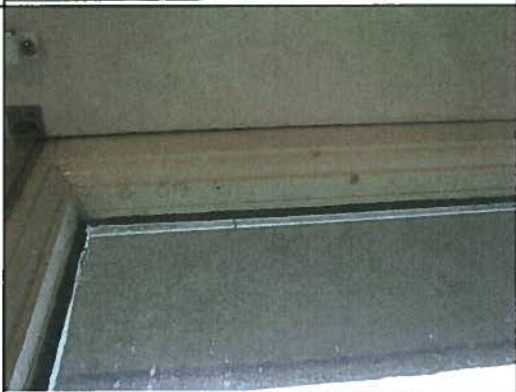
120. Water stain on head frame of Unit G.

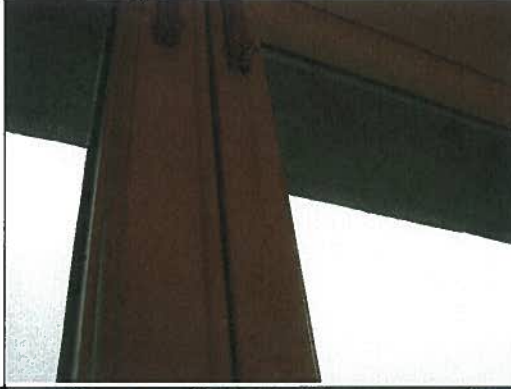
<p>124. Water stain on frame of Unit H.</p>

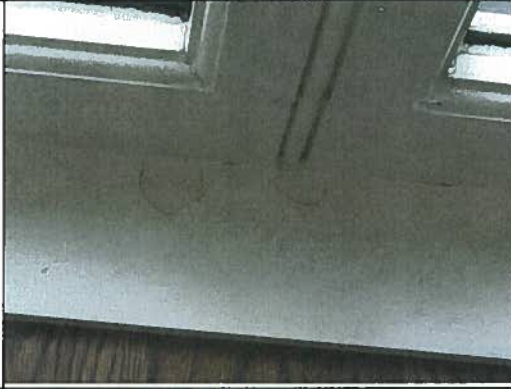
<p>125. Water stain on sill of Unit H.</p>

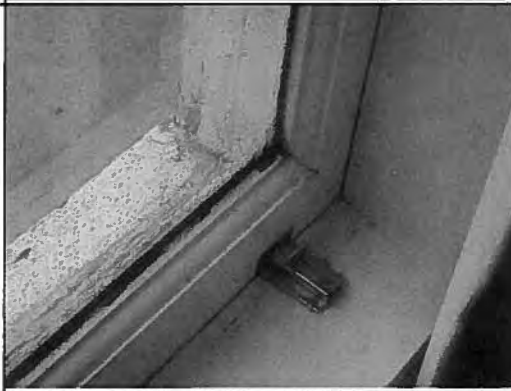
A black and white photograph showing an interior view of a window. The window has a dark frame and is partially covered by horizontal blinds. The view through the window shows an outdoor area with trees and a fence.
<p>2. Damaged finish on sill of Unit A3.</p>

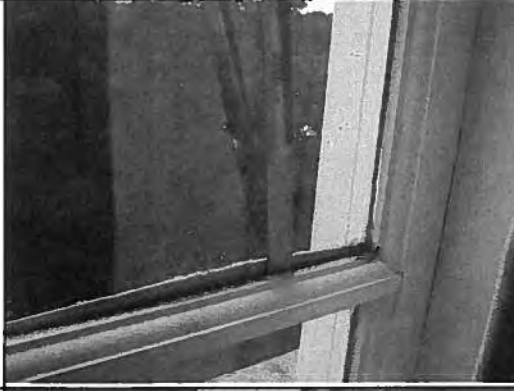
<p>4. Loose seal at glass in Unit A3.</p>

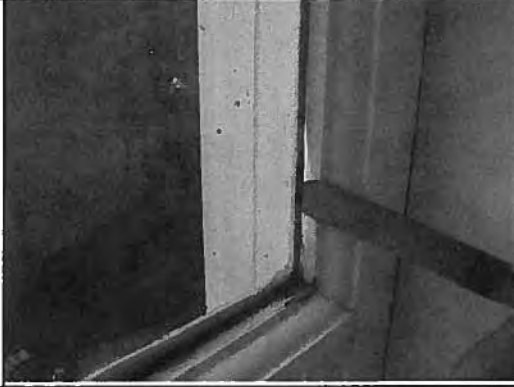
<p>5. Loose solar film on Unit A3.</p>

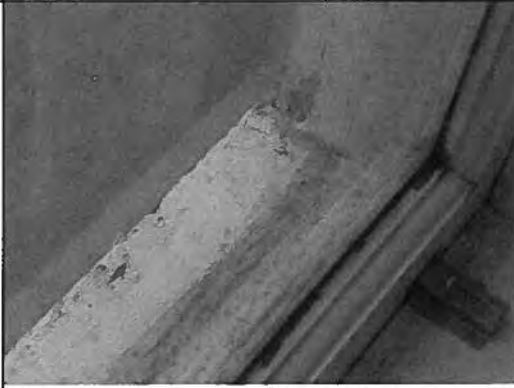
<p>6. Split exterior sill of Unit A3.</p>

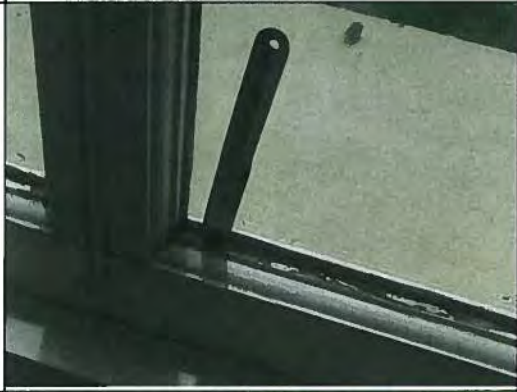
A photograph showing a window unit with horizontal blinds. The blinds are partially open, revealing a view of the outdoors. A dark object, possibly a chair or table, is visible in the foreground.
<p>8. Loose seal at glass on Unit B3.</p>

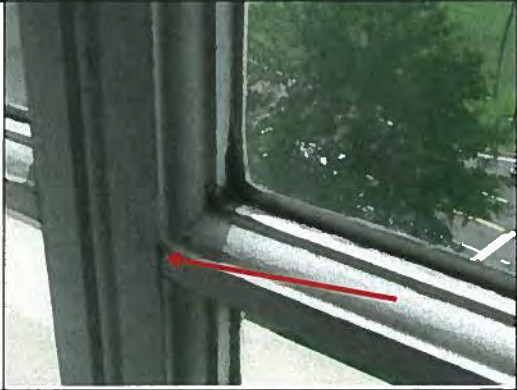
A close-up photograph of the window frame and glass. A black seal is visible, and a black tool is being used to pry it away from the frame, demonstrating a loose seal.
<p>9. Loose joint in frame of Unit B3.</p>

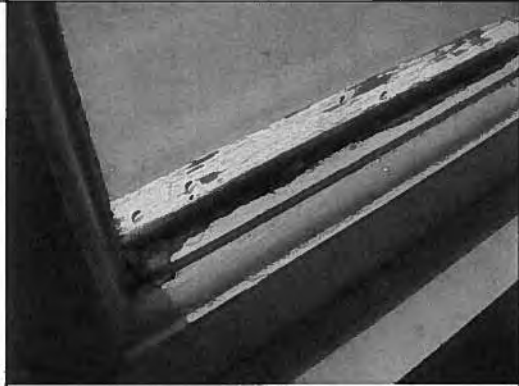
11. Loose seal at glass and damaged finish on frame of Unit C3.

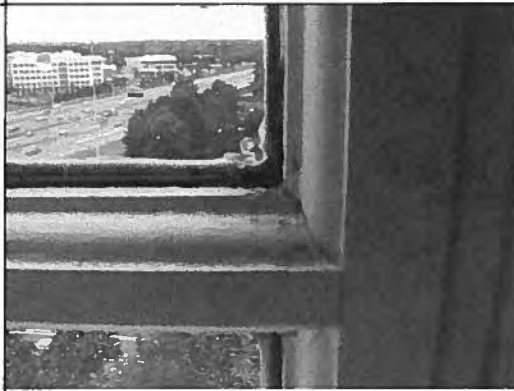
A close-up black and white photograph of a window frame. A dark, irregular stain is visible on the frame, indicating water damage.
<p>15. Loose joint in frame of Unit D3.</p>

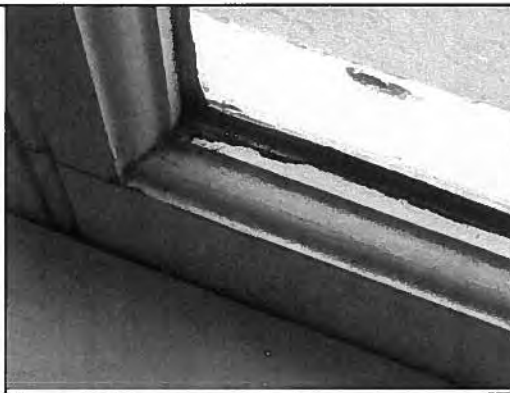
<p>16. Damaged finish loose seal at glass on Unit D3.</p>

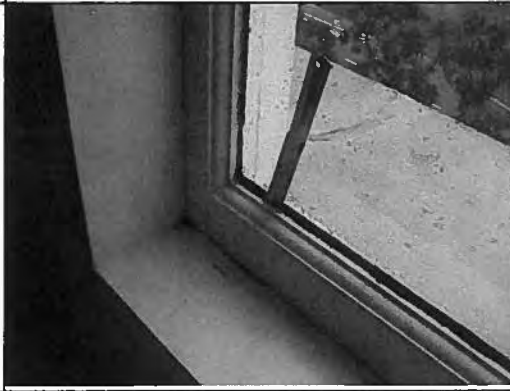
<p>17. Loose seal at glass on Unit D3.</p>

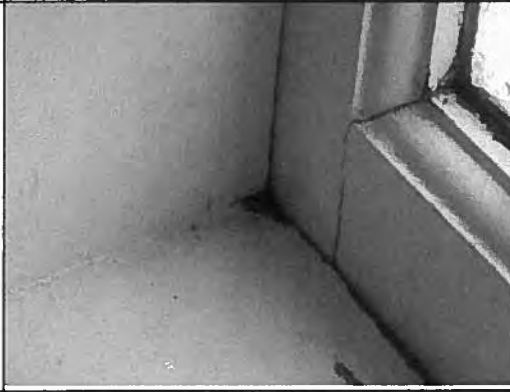
<p>18. Loose joint in frame of Unit D3.</p>

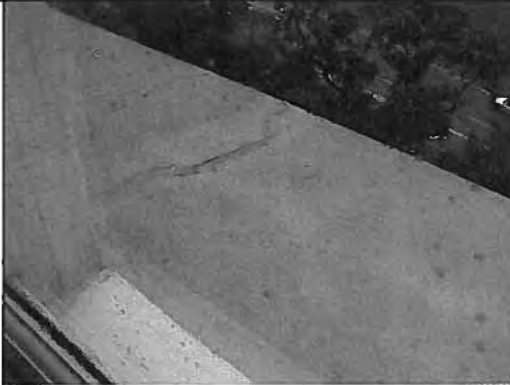
<p>19. Improper repair of EIFA damage at Unit D3.</p>

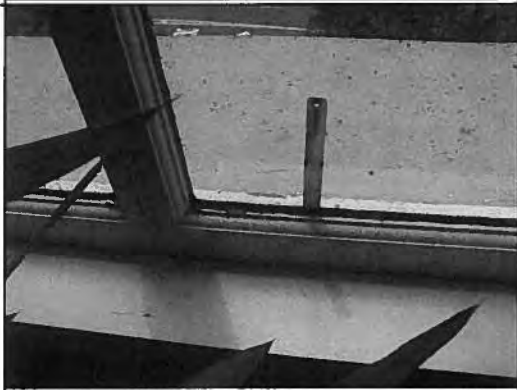
21. Loose seal at glass in Unit E3.

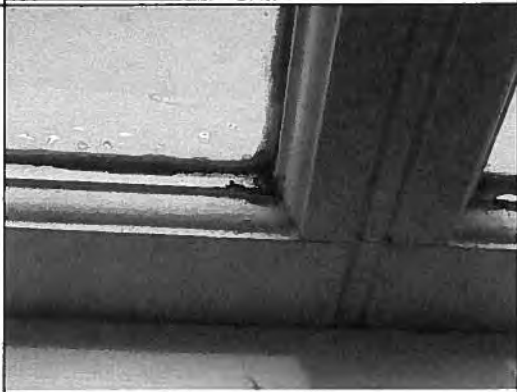
22. Decayed wood at loose joint in frame of Unit E3.

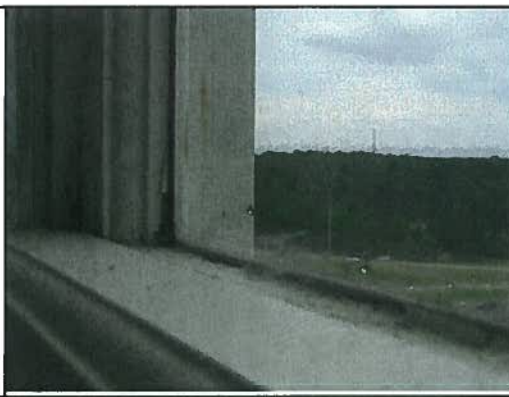
<p>23. Rust on exterior jamb of Unit E3.</p>

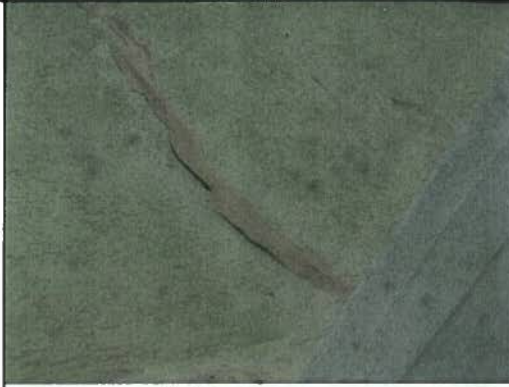
<p>24. Improper repair of EIFS damage at Unit E3.</p>

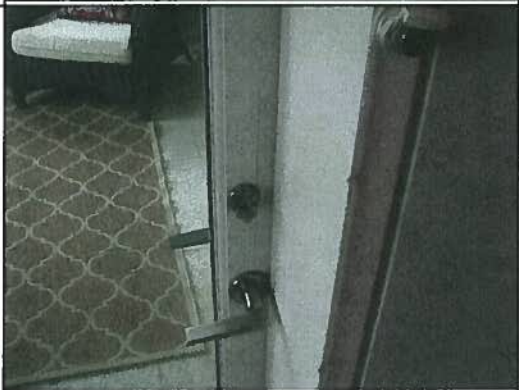
29. Split wood frame in Unit I.

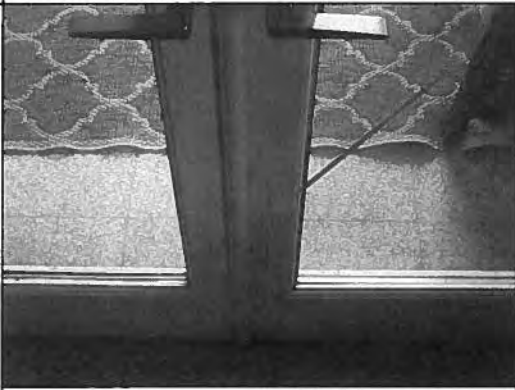
<p>32. Split frame on Unit J.</p>

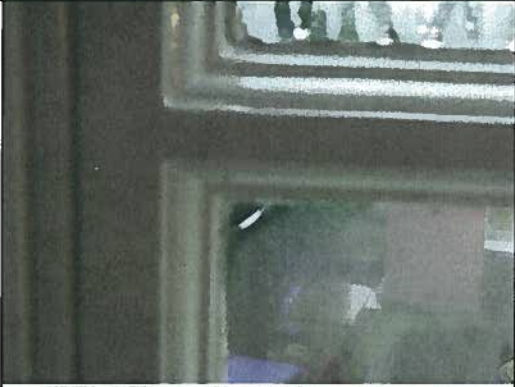
<p>34. Broken glass in Unit A2.</p>

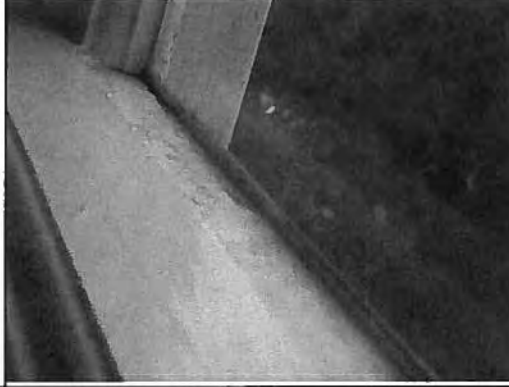
<p>36. Water stain on frame of Unit A2.</p>

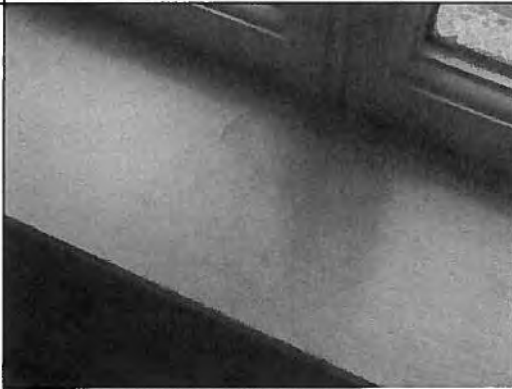
A black and white close-up photograph of a window frame. There is a prominent white water stain on the frame, and the window slide appears to be damaged or misaligned.
<p>41. Water stain on sill of Unit B2.</p>

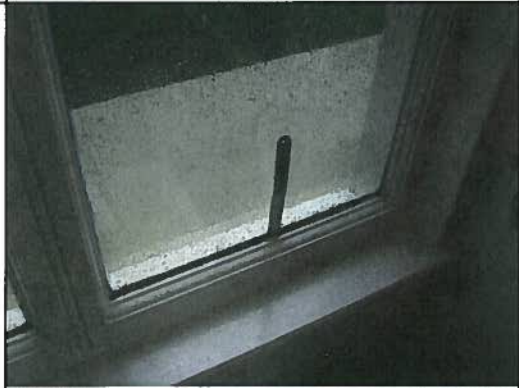
43. Loose seal at glass of Unit C2.

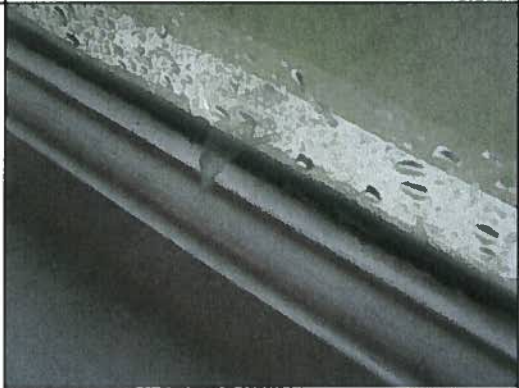
44. Loose solar film on Unit C2.
