DOCUMENT 009113 - ADDENDA

- A. Addendum No. 002.

- A. Project Name: The Barrington Exterior Refinishing
- B. Owner: The Barrington Condominium Association, Inc.
- C. Architect: Purser & Company, PA.
- D. Architect Project Number: 20230809001.
- E. Date of Addendum: 6/18/24.

Between August 12 and September 2, 2020 Dennis Walters, CSI, CDT, CCCA, Principal, Central Building Consultants, LLC visited the building and through Ms. Beth Hartness' introductions to the unit owners, observed the existing interior conditions of the windows and terrace enclosures of each of the four units on floors 3 through 9.

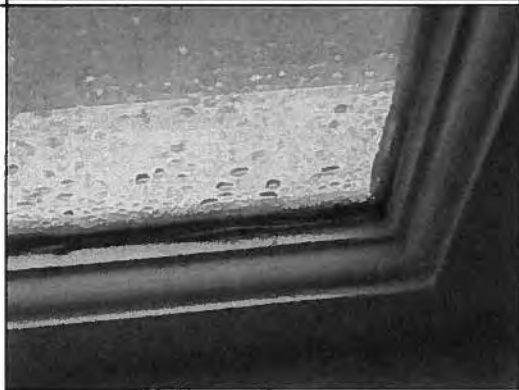
47. Loose seal at glass of Unit D2.

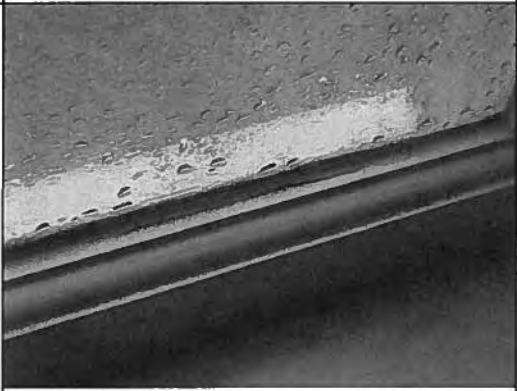
A close-up black and white photograph of a window sill. The sill is a light-colored material, possibly concrete or stone, and shows a dark, irregular water stain. The stain is located near the bottom edge of the window frame.
<p>50. Loose seal at glass of Unit E2.</p>

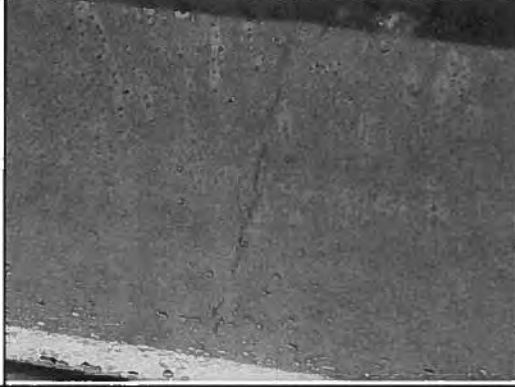
<p>51. Unrepaired crack in EIFS at Unit E2.</p>

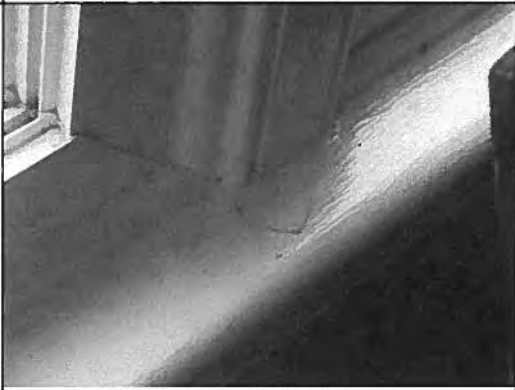
<p>53. Water stain on sill of Unit F.</p>

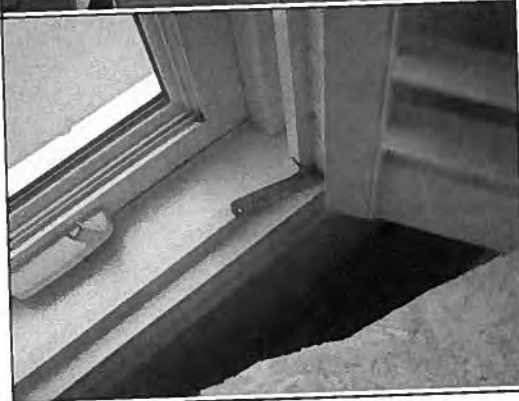
56. Loose joint at sill of Unit H.

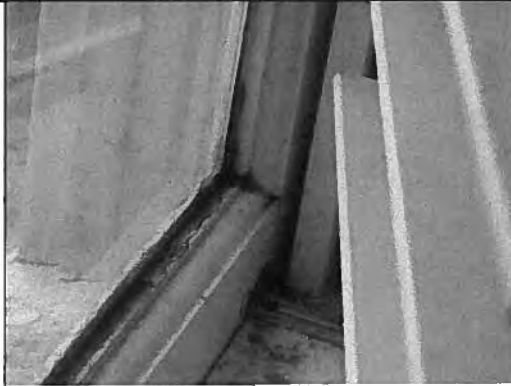
<p>59. Water stain and damaged finish on frame of Unit B3.</p>

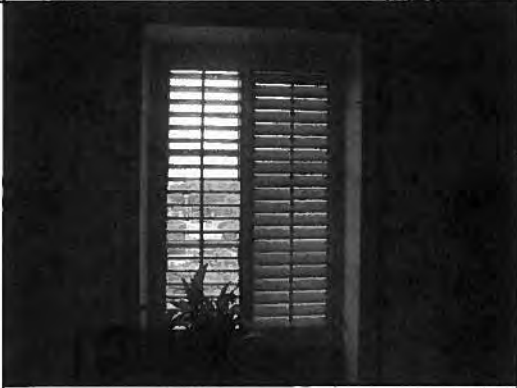
<p>63. Split exterior sill of Unit D3.</p>

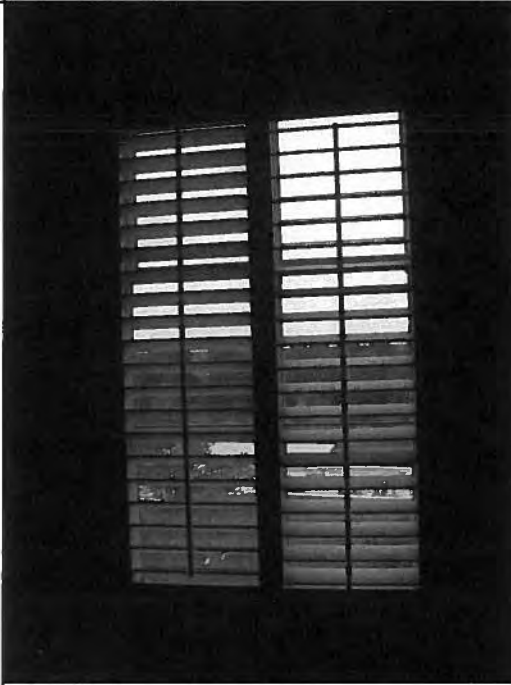
A photograph of a window with dark-colored shutters. The shutters are closed, and the window is set within a dark frame. The background is dark, suggesting an interior view.
<p>65. Water stain on head of Unit E3.</p>

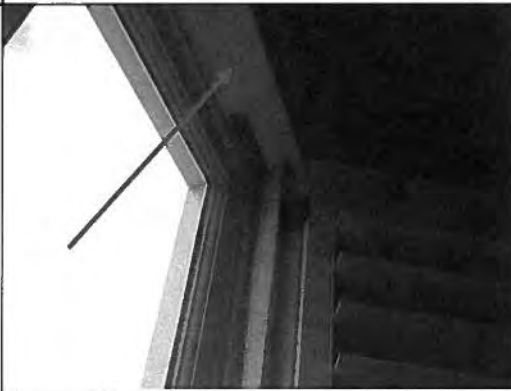
<p>66. Water stain on frame of Unit E3.</p>

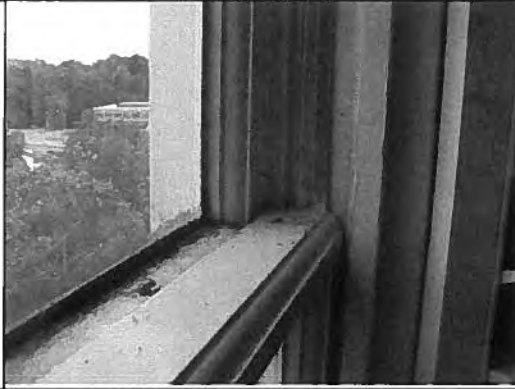
<p>67. Water stain on frame and sill with damaged finish on Unit E3.</p>

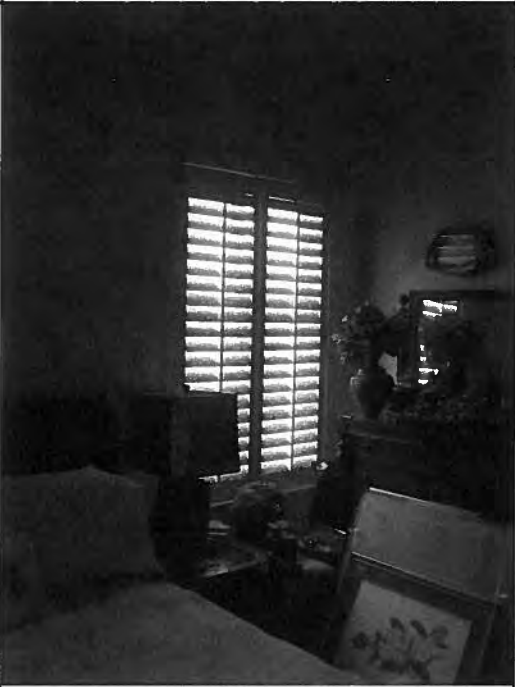
<p>69. Water stain on frame and likely loose seal at glass of Unit F3.</p>

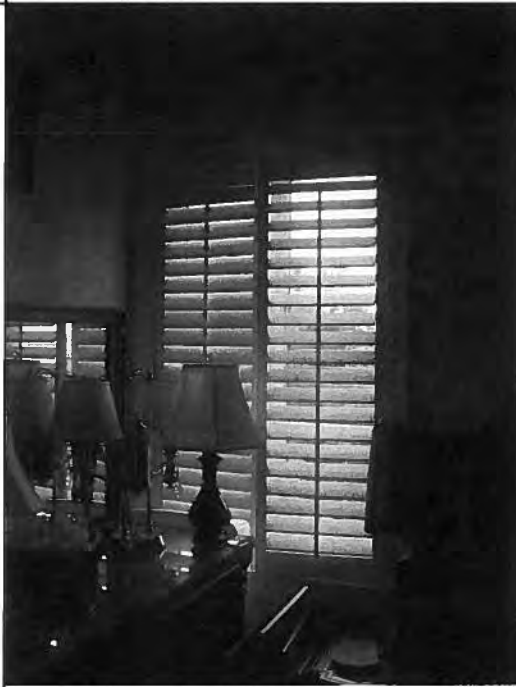
<p>71. Water stain on frame and sill of Unit G3.</p>

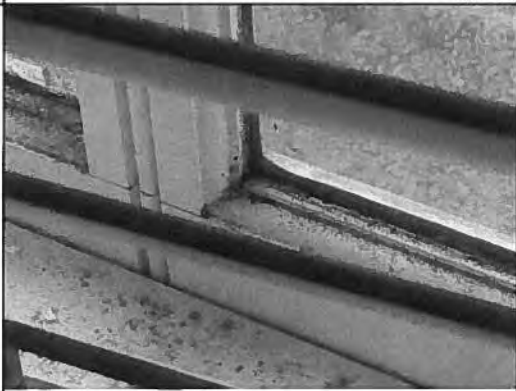
72. Loose seal at glass of Unit G3.

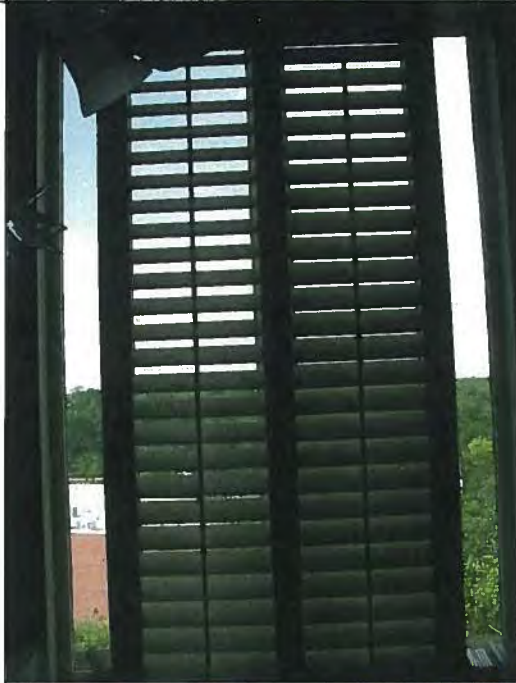
74. Water stain on sill of Unit H.

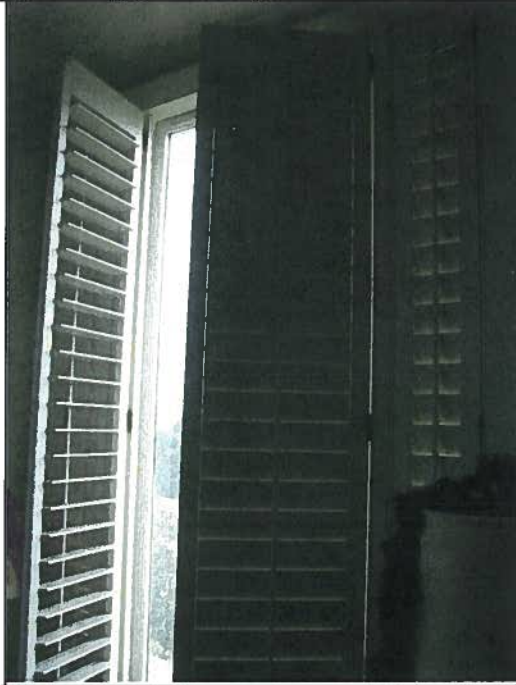
<p>76. Split frame of Unit I.</p>

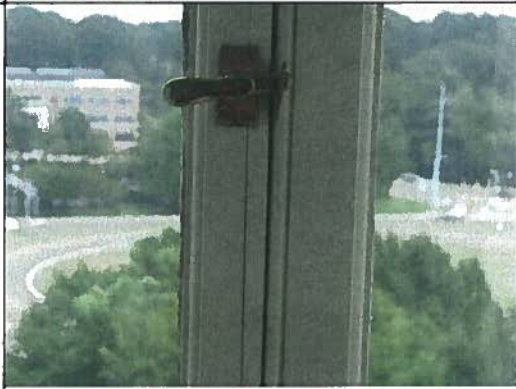
<p>77. Loose joint in frame of Unit I.</p>

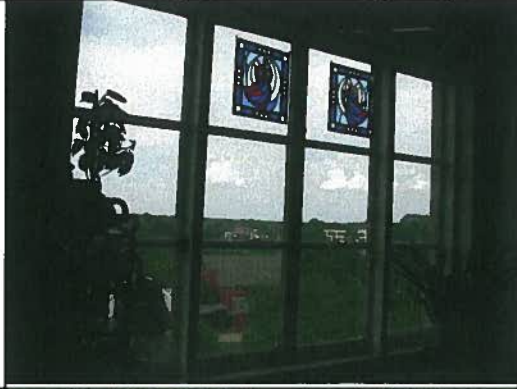
<p>79. Loose joint in frame of Unit J.</p>

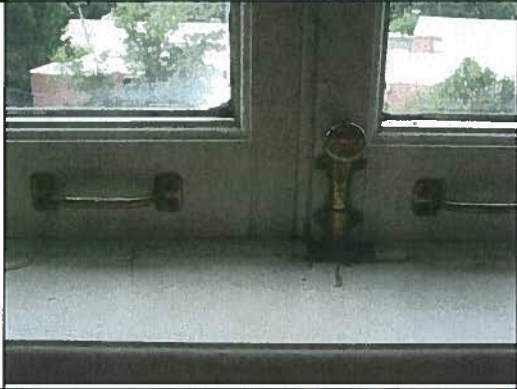
<p>80. Water stain at split frame of Unit J.</p>

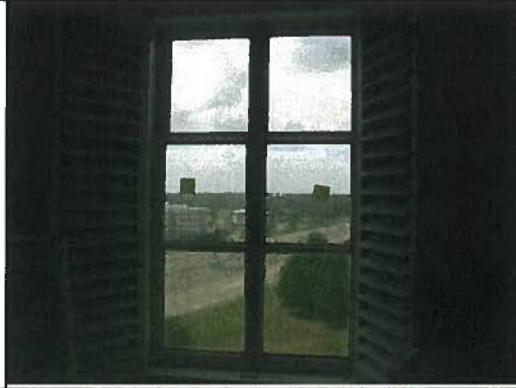
A photograph showing the exterior of a window unit, Unit A2. The window is a double-hung style with dark shutters on either side. The view through the window shows a residential area with greenery and buildings under a cloudy sky.
<p>82. Damaged finish on the frame of Unit A2.</p>

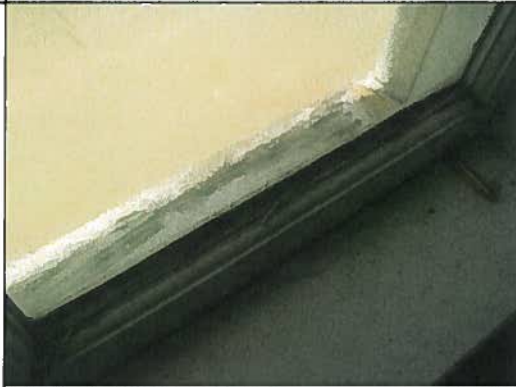
A close-up photograph of the window frame. The finish is peeling and damaged, particularly at the top edge where the frame meets the wall. The underlying material appears to be a light-colored substrate.
<p>83. Loose solar film on Unit A2.</p>

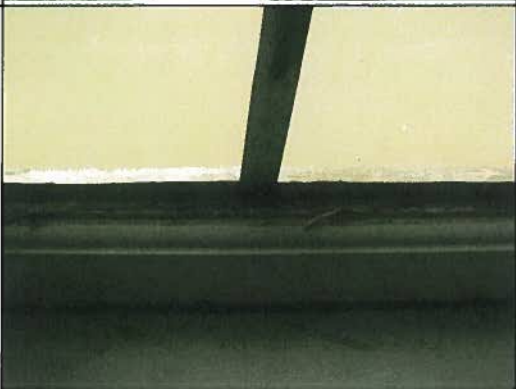
<p>85. Water stain on frame of Unit A2.</p>

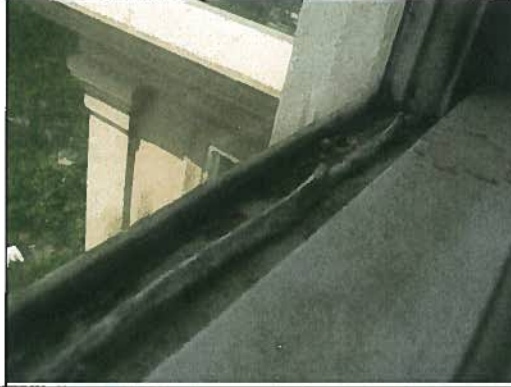
<p>86. Damaged finish on jamb and head of Unit A2.</p>

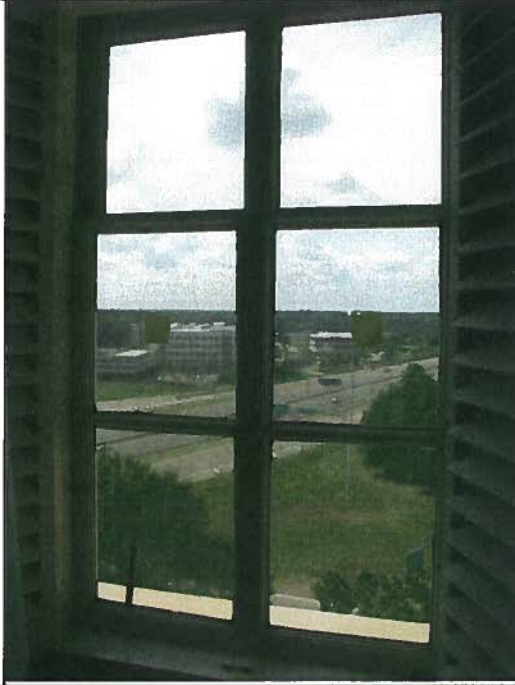
<p>89. Loose seal at glass of Unit B2.</p>

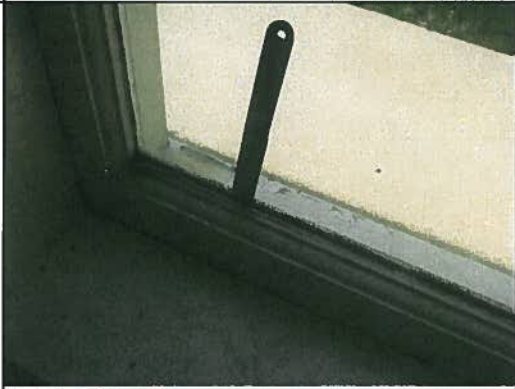
<p>90. Damaged slide of Unit B2.</p>

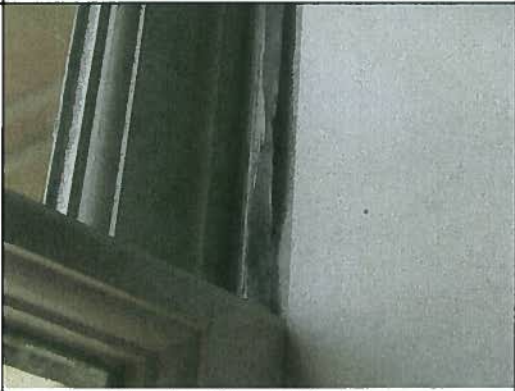
<p>91. Water stain on frame and jamb of Unit B2.</p>

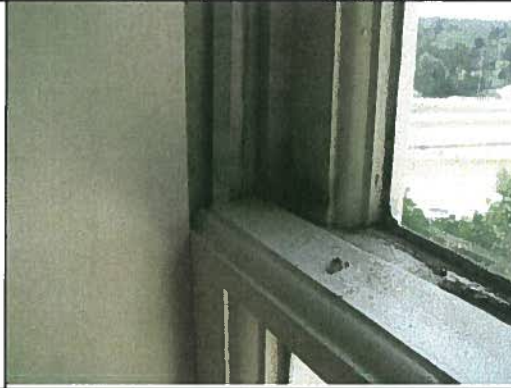
<p>92. Damaged finish on frame of Unit B2.</p>

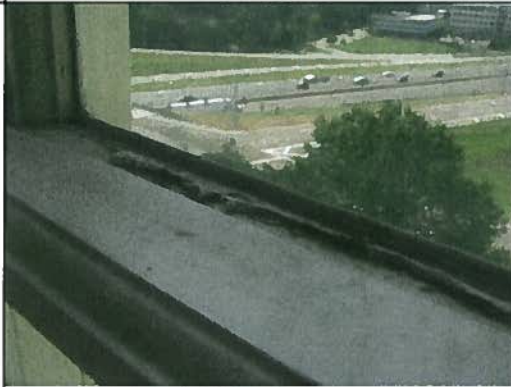
<p>93. Loose joint in frame of Unit B2.</p>

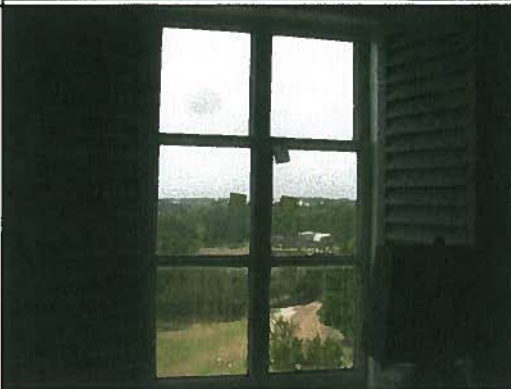
<p>95. Water stain on frame at loose joint of Unit C2.</p>

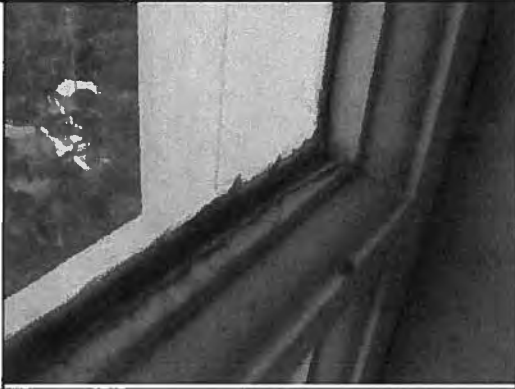
<p>97. Loose solar film on Unit C2.</p>

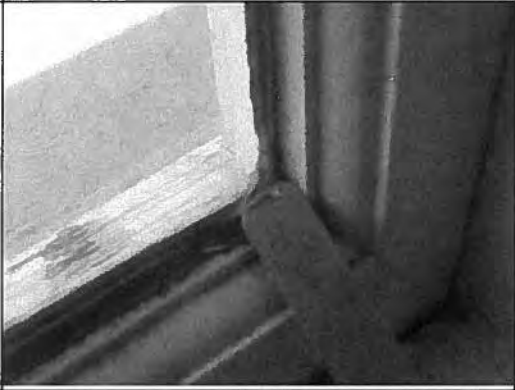
<p>98. Damaged slide of Unit C2.</p>

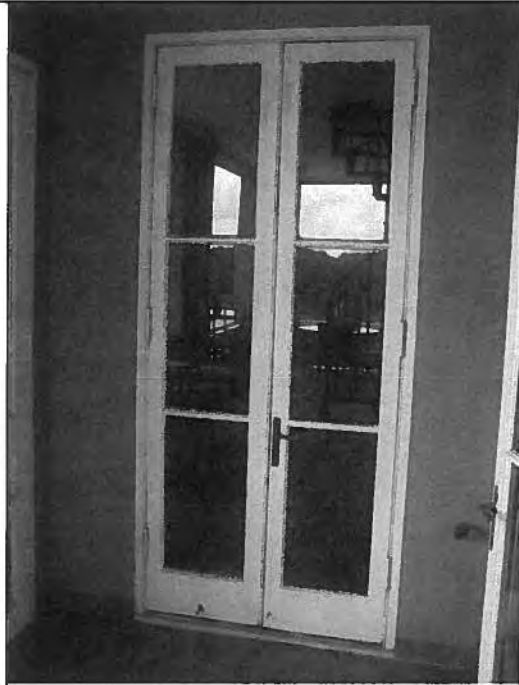
100. Split frame on interior of Unit D.

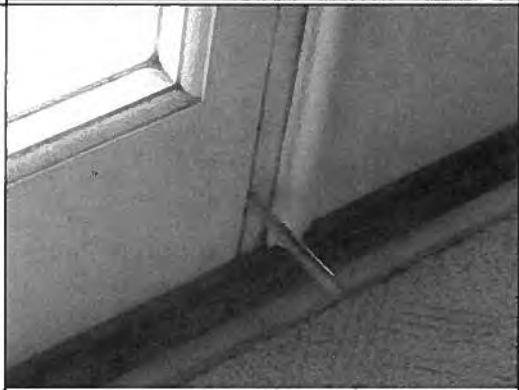
101. Split frame on exterior of Unit D.

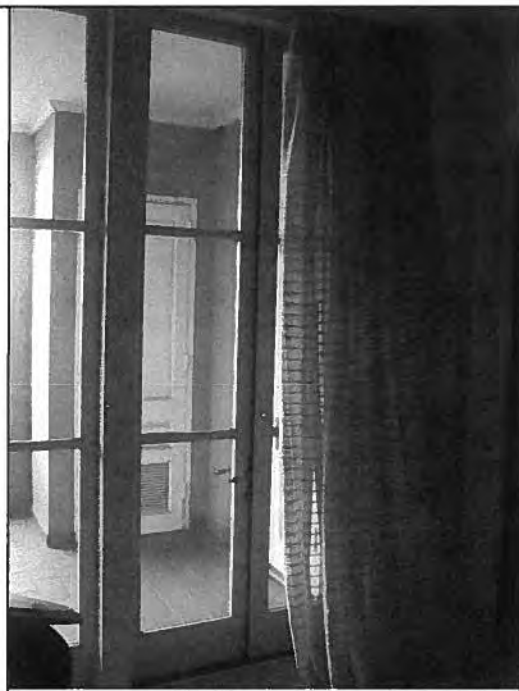
A black and white photograph showing an interior view of a window. The window has a dark frame and is partially open, revealing a glimpse of the room outside. A curtain is visible on the right side of the window.
<p>103. Split frame on interior of Unit E.</p>

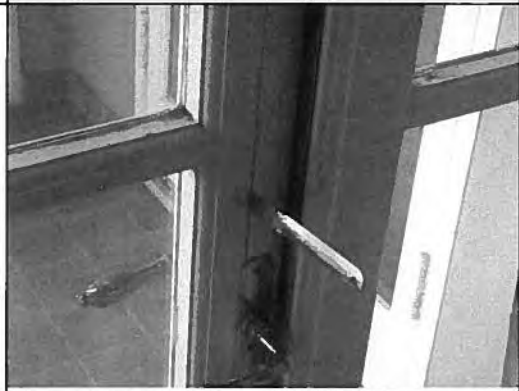
A close-up black and white photograph of a window frame. The frame is split, showing a gap between the panes. A screwdriver is visible on the surface below the frame, suggesting a repair or inspection.
<p>104. Split frame on exterior of Unit E.</p>

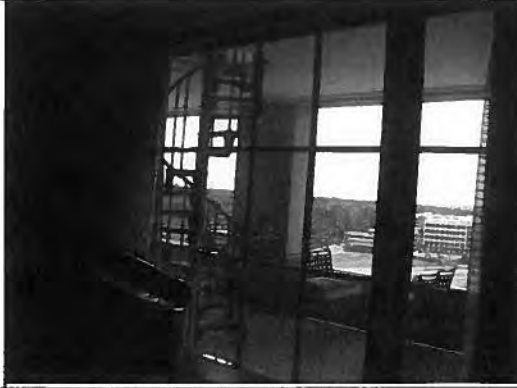
<p>106. Biological growth and stain on frame of Unit F.</p>

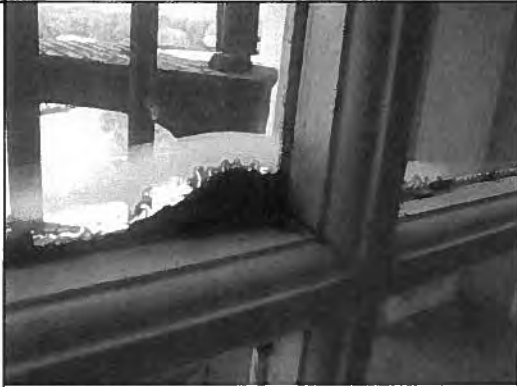
<p>107. Loose seal at glass on Unit F.</p>

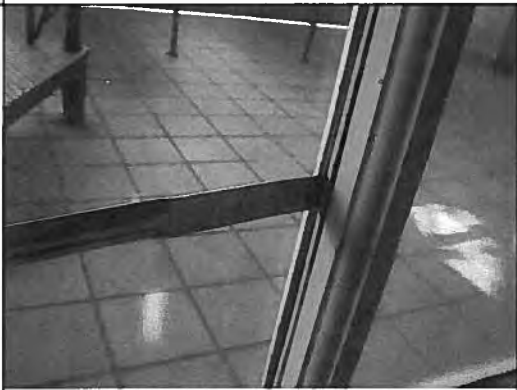
<p>108. Split frame on Unit F.</p>

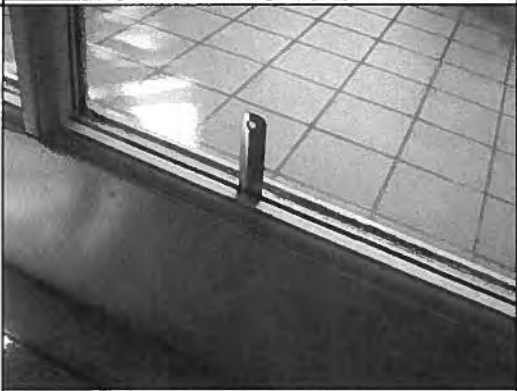
<p>109. Split frame on Unit F.</p>

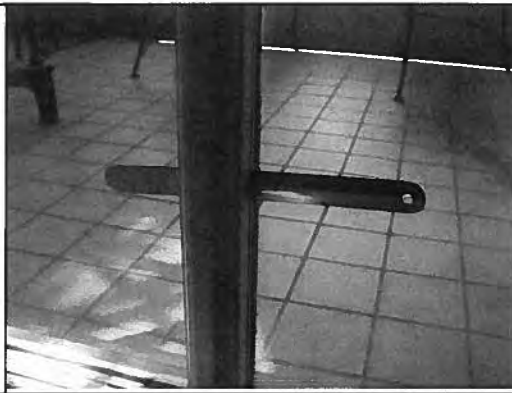
A black and white photograph showing a close-up of a window frame. The frame is split, and a dark handle is visible. The floor is tiled.
<p>110. Decayed wood on Unit F.</p>

Unless the frames have deteriorated and have decayed wood, the existing units should be able to be rebuilt by a qualified and experienced mill worker. As stated earlier in this report the original window units were fabricated by Scanlon-Taylor Millworks, Jackson, MS. They may be able to remake the units to perform an additional 15 to 20 years. A contractor will need to remove the existing, temporarily close the openings, and deliver the existing units to the fabricator. The fabricator will examine the units, determine pieces to be replaced and rework the joints. The contractor will retrieve the reworked units and reinstall in properly flashed rough openings. All windows should have the glass replaced or glazed by a qualified glazier.

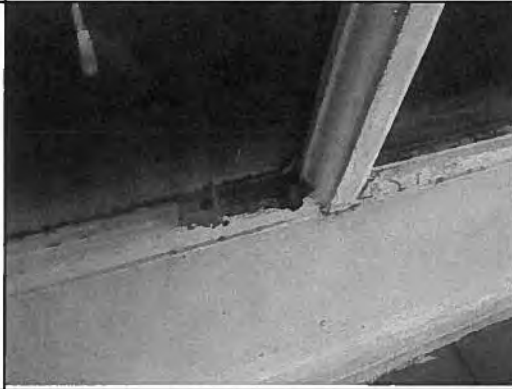
A black and white photograph showing a close-up of a window frame. The wood is decayed and peeling, and a metal support is visible.
<p>111. Loose seal at glass on exterior of Unit F.</p>

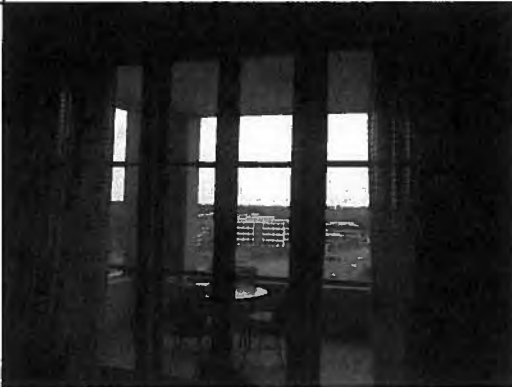
<p>113. Water stain on frame of Unit G.</p>

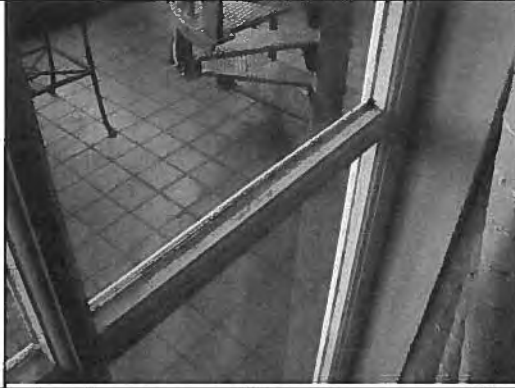
<p>114. Water stain on sill of Unit G.</p>

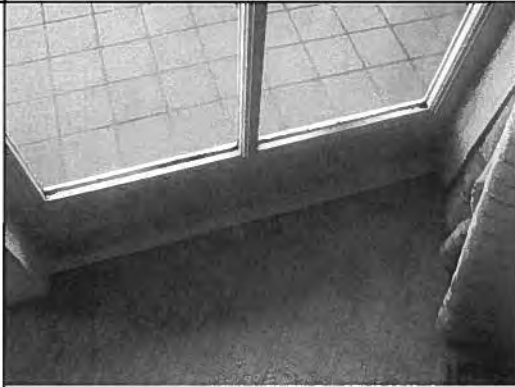
<p>115. Water stained carpet at Unit G.</p>

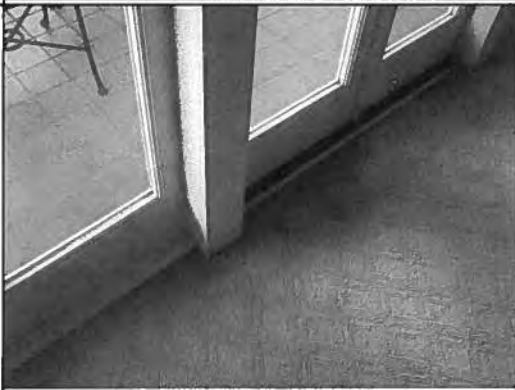
<p>116. Decayed wood at sill of Unit G.</p>

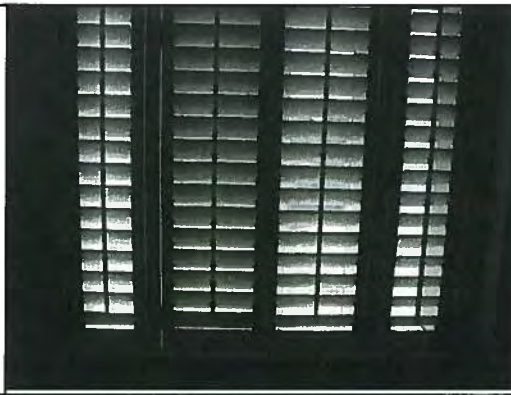
<p>118. Water stain on head of Unit H.</p>

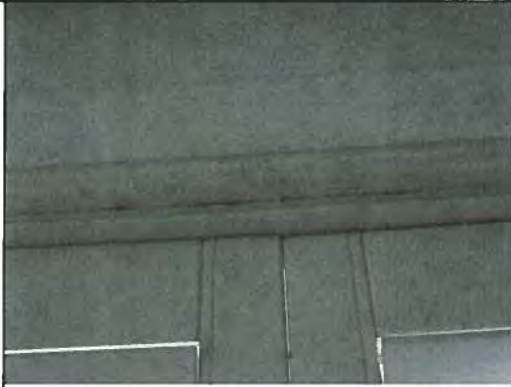
<p>119. Decayed wood at sill of Unit H.</p>

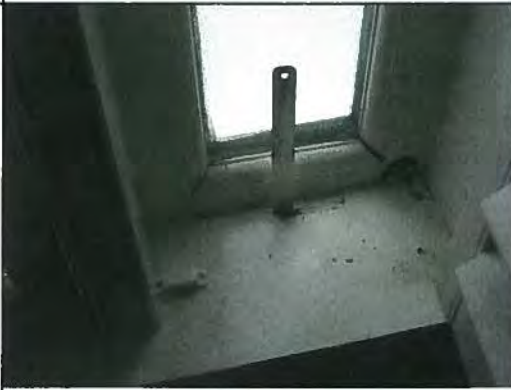
<p>120. Decayed wood on frame of Unit H.</p>

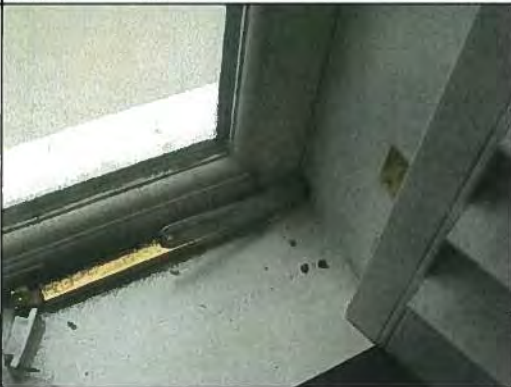
<p>121. Damaged wall above Unit H.</p>

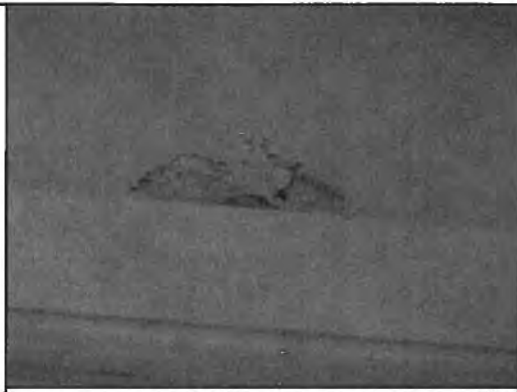
<p>122. Water damaged wall below Unit H.</p>

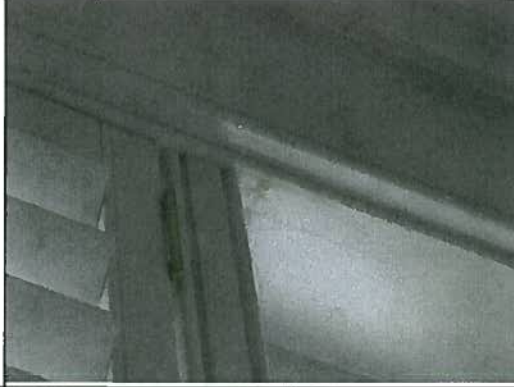
<p>125. Decayed and split wood at sill of Unit I.</p>

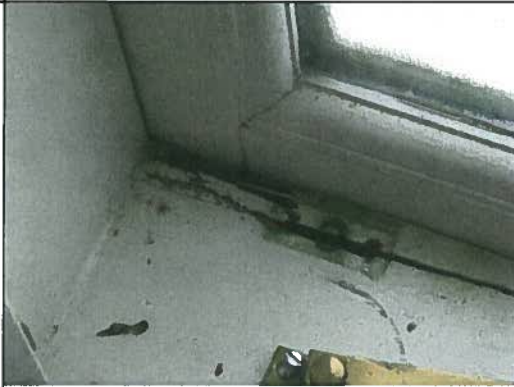
<p>126. Cloudy glass in Unit I.</p>
